Preliminary Information

PIT5533C Creak Click Pop Crack Type Noise From Front Suspension/Frame Area While Making Turns

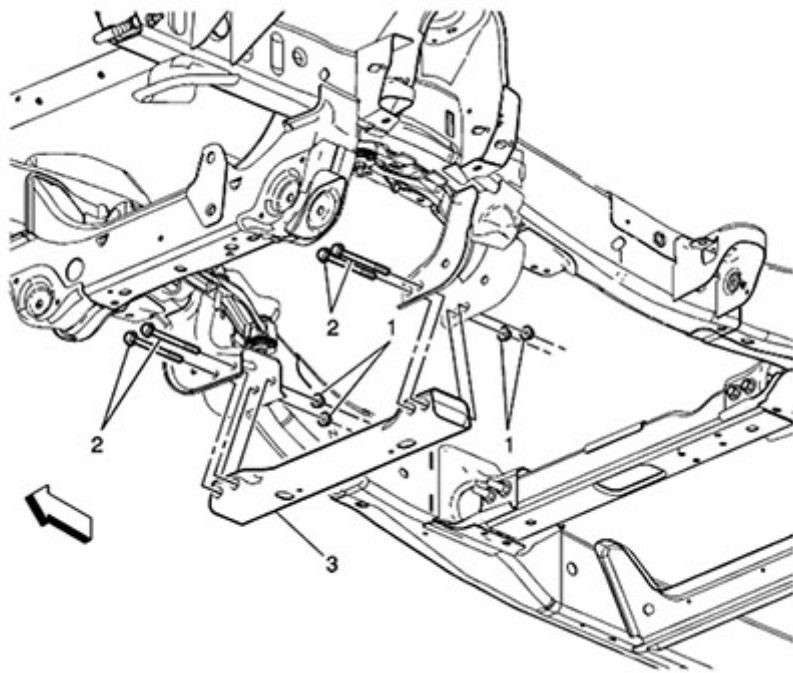
Correction 1

Involved Region or Country:	North America
Condition:	Some owners may comment of a creak, click, pop, crack type noise from the front suspension or front frame area while making tight turns. It may also be noted the noise can be felt in the foot well area.
Cause:	It has been found that this type of noise could be caused by either insufficient torque of the front suspension: <ul style="list-style-type: none">- Frame crossmember- Lower control arm bolts

To correct this concern loosen and then re-torque the four front frame crossmember bolts/nuts:

1. **First Pass: 70 Nm (52 lb. ft.)**
2. **Final Pass: 110 degrees**
