Preliminary Information

PIC5650H Diagnostic Tip - Security Light on Intermittently / No Crank/No Start or Start Stall / Keyless Access Vehicles May Display No Remote/Fob Detected / Poor or No RKE Range / Service TPM

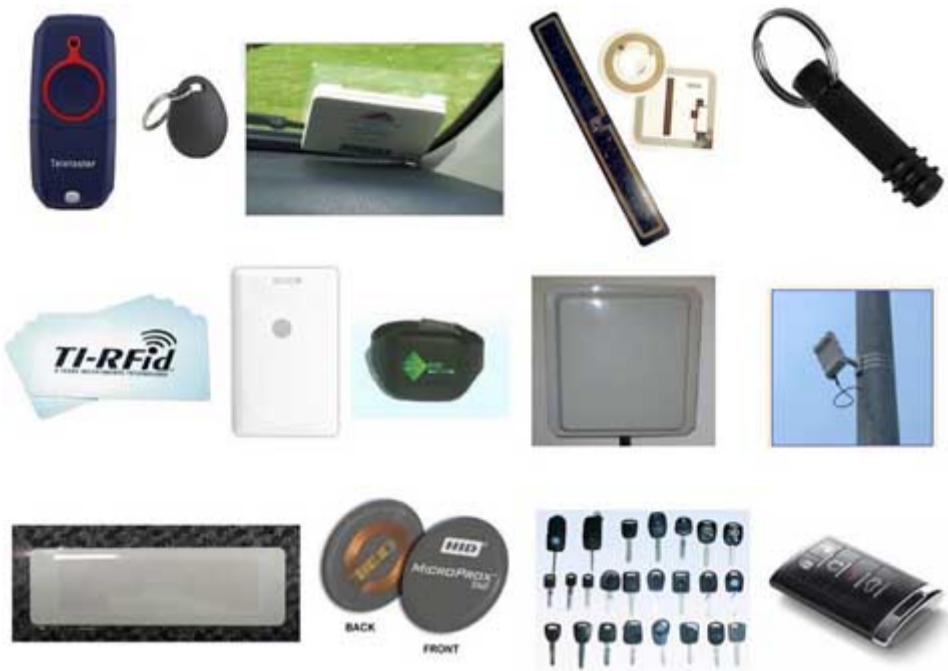
Listed below are a number of aftermarket devices that can cause RFI. In many cases, these types of devices will be attached to the customer's key ring and could be removed from the key ring or from inside the vehicle when the customer drops the vehicle off for service.

- Vehicle immobilizer keys from other vehicles
- Keyless access transmitters from other vehicles
- Interstate/bridge toll passes
- Gate/door passes to allow access to pools, driveways, entry doors, etc.
- Community/parking access cards
- Fuel station speed passes
- Building access swipe cards/ transponder devices

Before any in depth diagnosis is performed, question the customer or inspect the vehicle for any types of aftermarket equipment, like shown above, which could cause RFI. These items need to be removed and/or disconnected from the vehicle.

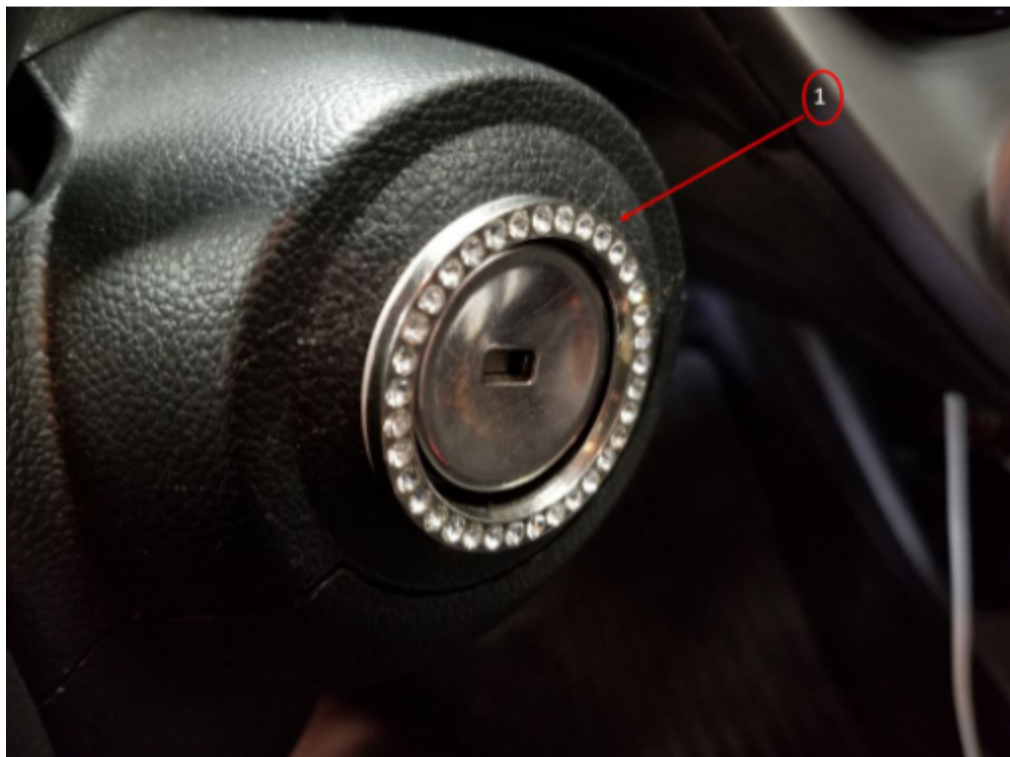
- Aftermarket LED dome, tail, turn, stop, strip, floor, door, Logo, head lights
- In many cases, when the LED lighting is turned on it can interfere with a RF signal. Example, RKE inoperative after the first fob button press. When the RKE fob button is pressed the dome lights may turn on, which if equipped with an aftermarket LED dome light, it can interfere with any additional fob button presses.
- Certain cell phone chargers
 - USB power banks
 - USB flash lights
 - Fans (12 volt or 110 volt)
 - Any type of USB, 12 volt or 110 volt chargers
 - "Bedazzle Trim Ring" surrounding ignition lock cylinder, shown below (1)
