TECHNICAL SERVICE BULLETIN

Illuminated MIL With DTC P203B - Urea Sensor Reprogramming

**20-
2270**
17 August
2020

Ford 2017 F-Super Duty	Engine: 6.7L
----------------------------------	--------------

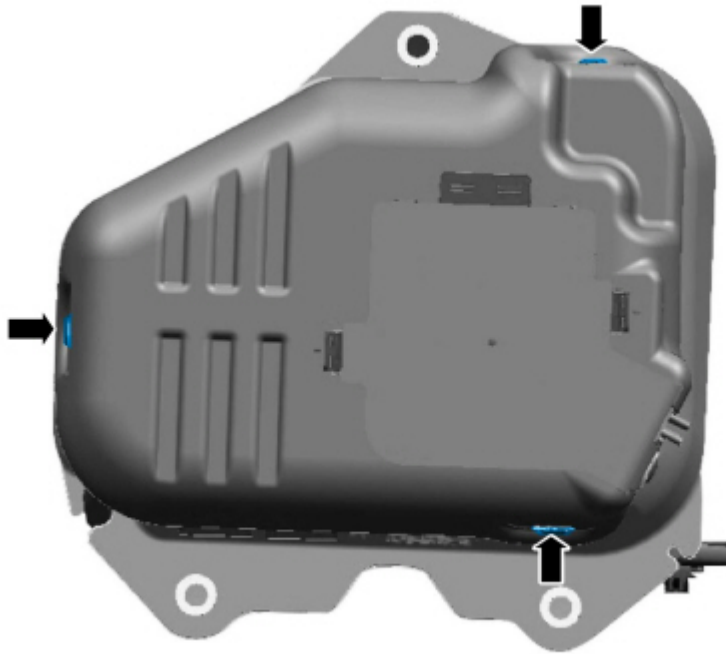
E341812

Figure 1 - Arrows indicate pushpin locations

3. For pickup vehicles, remove the 3 pushpins securing the tank shield around the perimeter of the tank. It is not necessary to remove the 4th pushpin on the access panel or the DEF line. The tank shield will lower enough to gain access to the reductant quality / level sensor. (Figure 1)

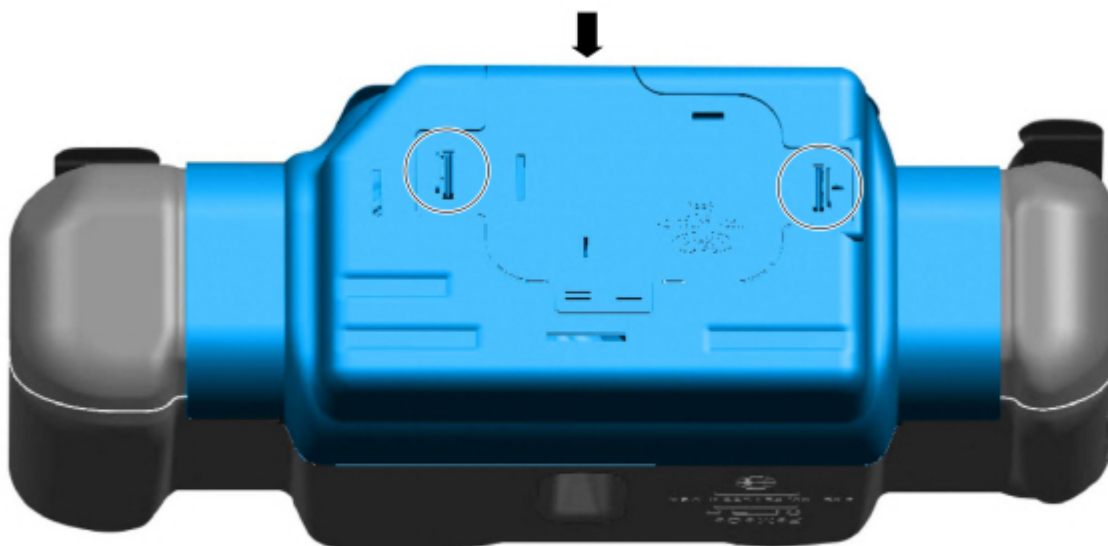
E341813

Figure 2 - Arrow indicates pushpin location, circles are the pinch tab locations

4. For chassis cab vehicles, remove the pushpin and pinch the tabs to open the access cover in the reductant tank cover to access the reductant level sensor/quality module. (Figure 2)

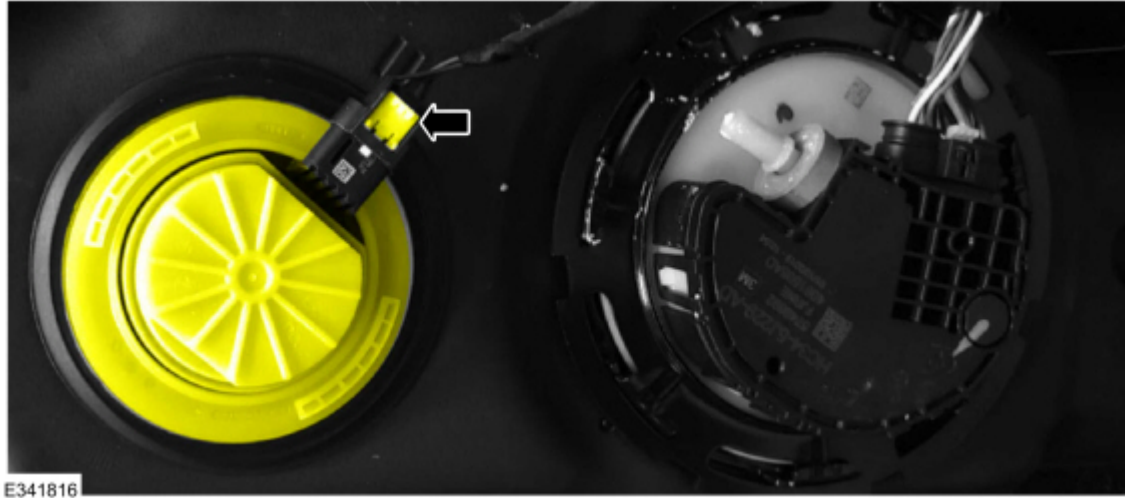
Figure 3 - Chassis cab shown, pickup similar - reductant level sensor/quality module highlighted with arrow pointing to white secondary lock tab

5. Locate the reductant level sensor/quality module. Carefully unlatch the white secondary lock, press the tab and disconnect the electrical connector from the reductant level sensor/quality module.

NOTE: Use of a metal pick tool can allow for access to unlatch the white secondary lock and then press the tab by hand. (Figure 3)

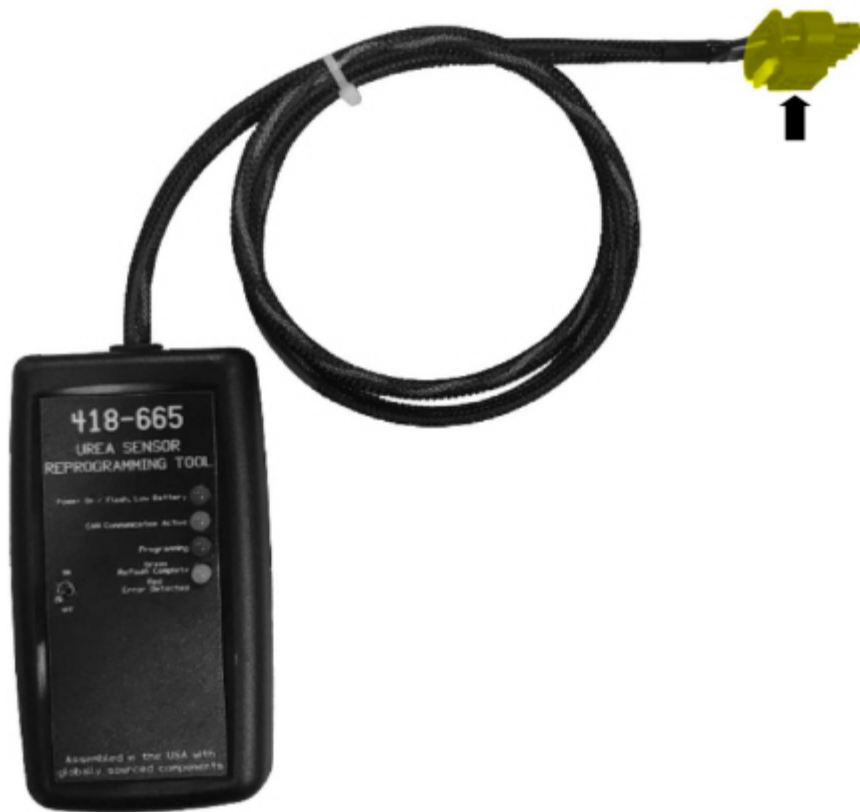
E341817

Figure 4 - Urea Sensor Reprogramming tool connector that goes to reductant level sensor/quality module

7. Connect the Urea Sensor Reprogramming tool (Rotunda tool number 418-665) into the reductant level sensor/quality module on the reductant tank.

NOTE: When using the Urea Sensor Reprogramming tool for the first time, remove the plastic tab from the battery compartment to power the tool. (Figures 4-5)

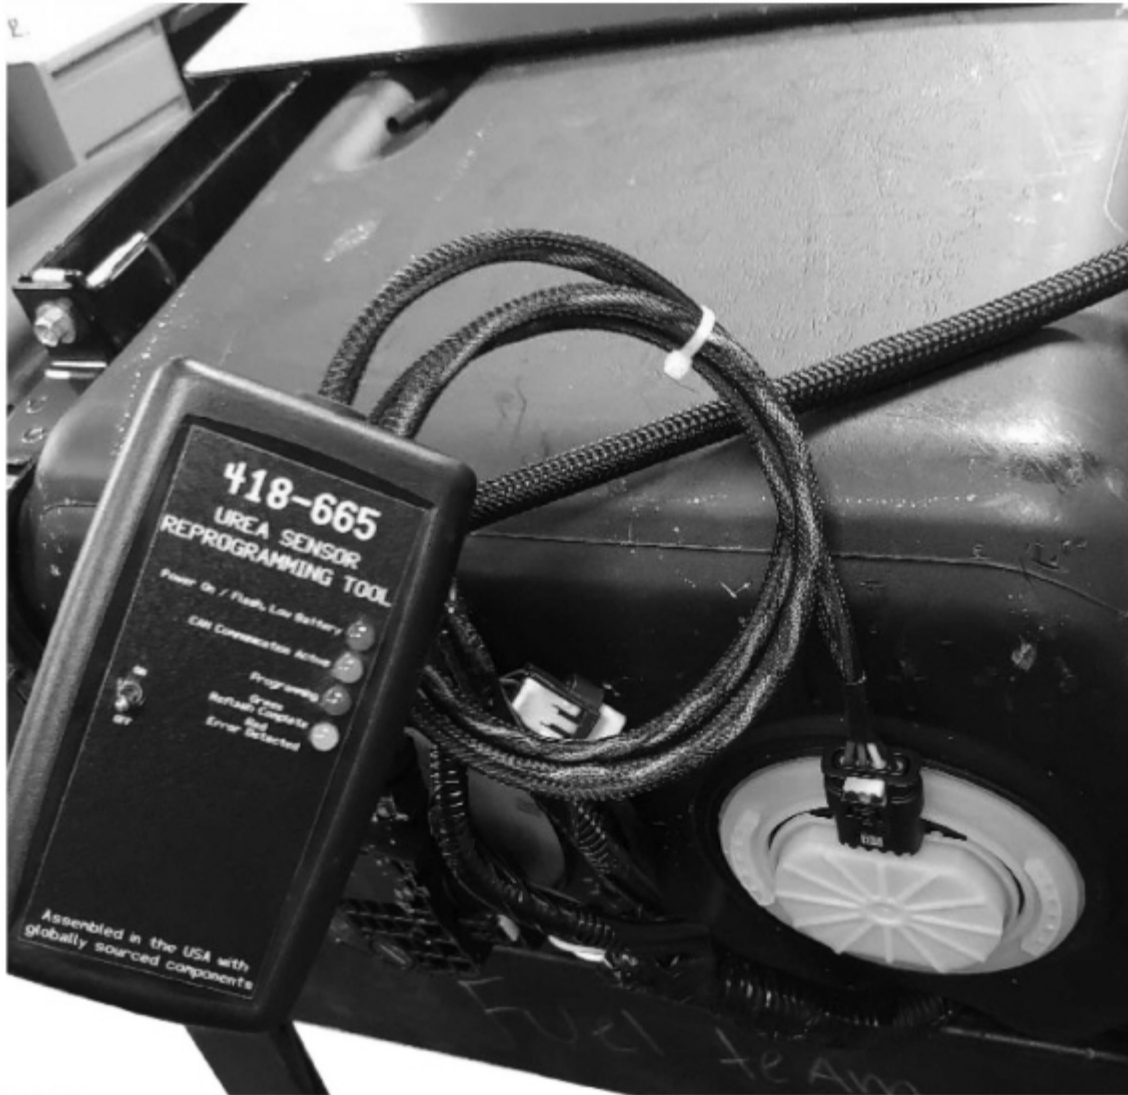
E341818

Figure 5 - Urea Sensor Reprogramming tool connected to reductant level sensor/quality module

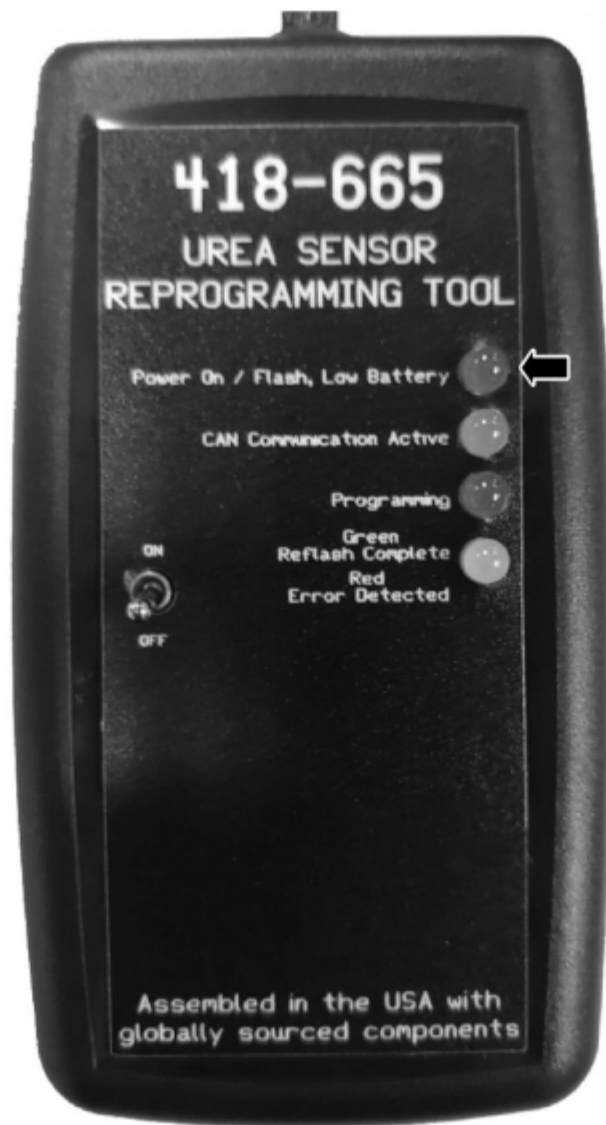
E341819

Figure 6 - Arrow indicates top green LED

8. Once the Urea Sensor Reprogramming tool is connected, move the toggle switch to the ON position. The top green LED light will illuminate and the software reprogramming process for the reductant level sensor/quality module will begin automatically. (Figure 6)

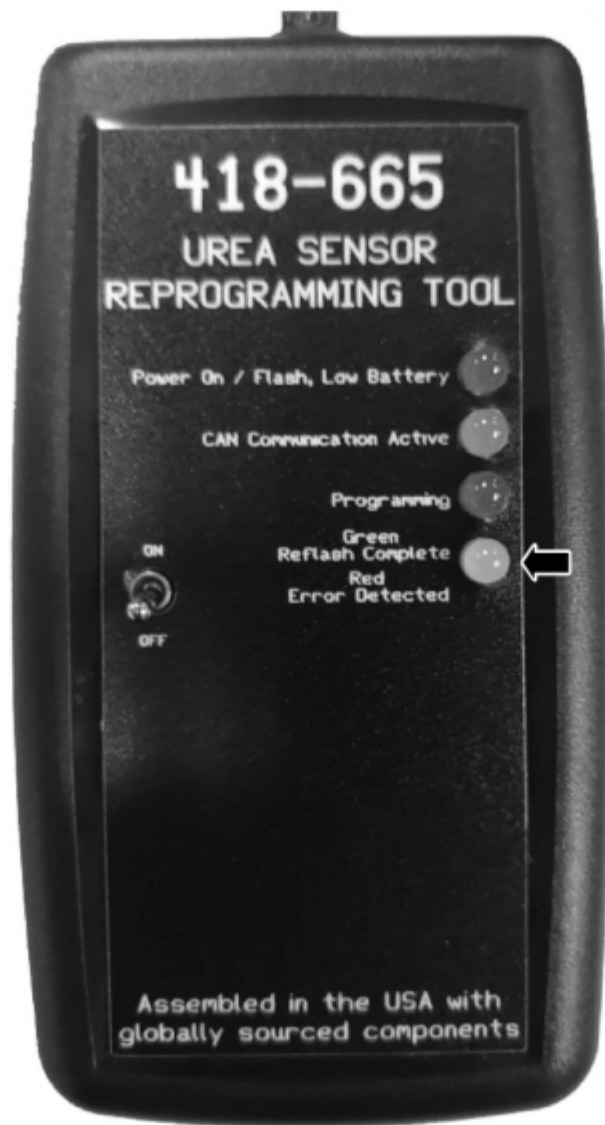
E341820

Figure 7 - Arrow indicates bottom LED

9. Allow up to 60 seconds for the tool to complete reprogramming the reductant level sensor/quality module.
10. Does the bottom LED on the Urea Sensor Reprogramming tool illuminate green? (Figure 7)
 - (1). Yes - the reductant level sensor/quality module has been successfully reflashed. Disconnect the Urea Sensor Reprogramming tool and reconnect the reductant level sensor/quality module wire harness. Install the reductant tank cover or reductant tank access cover onto the reductant tank. Repair is complete.
 - (2). No - proceed to Step 11.
