SERVICE BULLETIN

APPLICABILITY: 2020MY Legacy and Outback Models **NUMBER:** 15-261-20R
SUBJECT: Reprogramming File Availability for Optimization of Gen 4 Denso CP1 Infotainment Systems **DATE:** 03/10/20
REVISED: 08/13/20

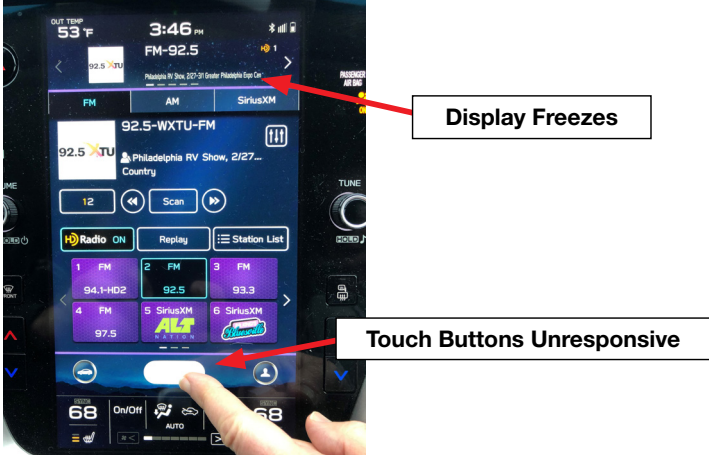
Symptom #	Description of Symptom:
1	<p>The CP1 display and/or center Combination Meter display freezes. No response from touch screen or voice guidance. After switching the ignition off and opening the driver’s door, the system does not recover**.</p>

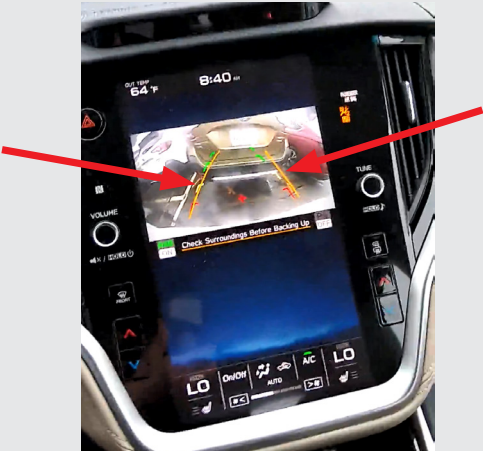
<p>**NOTE: After switching the ignition off and leaving the driver’s door open more than 70 seconds, the system <i>may</i> recover after switching the ignition back on.</p>
2	<p>Delayed response of rear view camera guide lines. When the rear view camera is activated and the steering wheel is turned, there is a delay before the steering-responsive guide lines respond to the steering wheel input.</p>

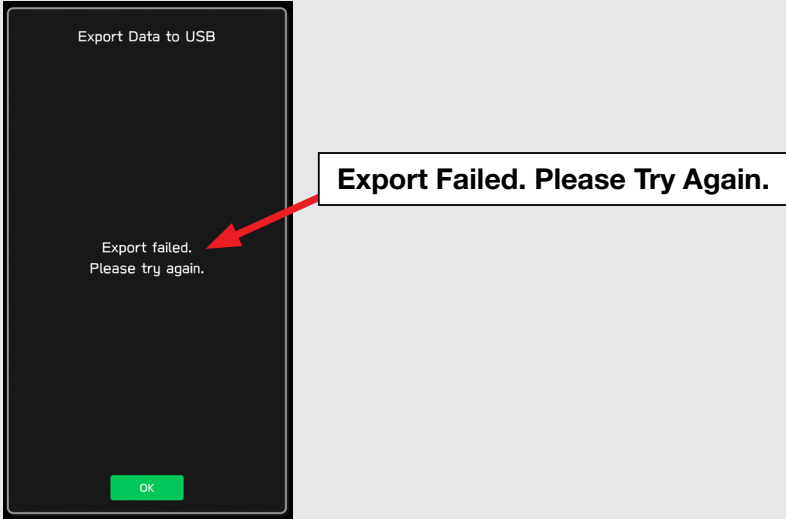
Symptom #	Description of Symptom:
4	<p>Diagnostics Recorder Data cannot be exported to the USB memory device. When the diagnostic log data is being downloaded (by selecting: Dealership Menu > Diagnostics Recorder > Export Data to USB), it fails after the progress bar reaches almost 90% with an error message of Export failed. Please try again.</p>

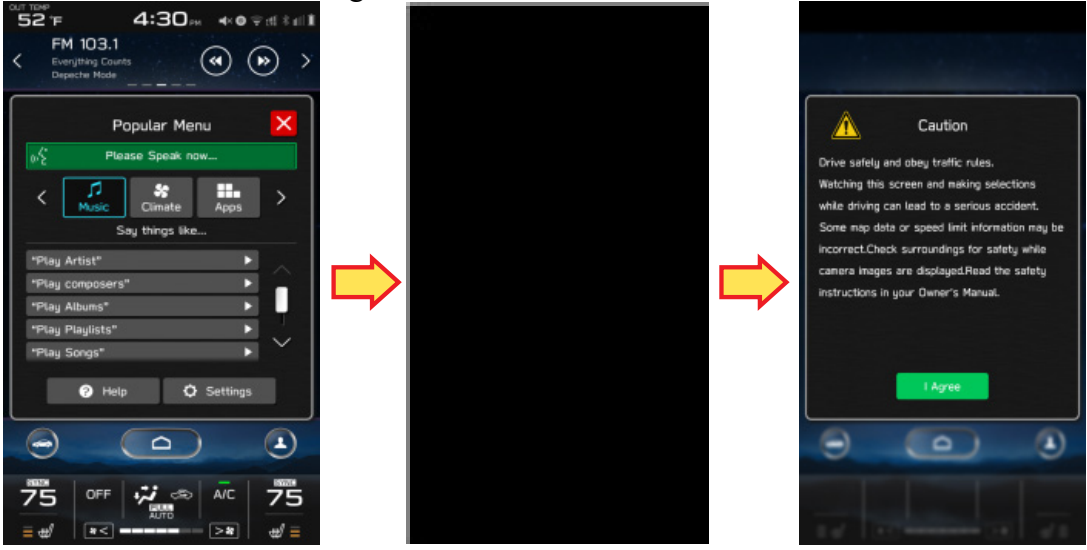
5	<p>When using Voice Recognition to search for a 'Nearby POI' (Point of Interest) in Canada with FRENCH language selected, the CP1 display turns black and displays a Caution / disclaimer message.</p>

<div style="display: flex; justify-content: space-around; margin-top: 10px;"> <div data-bbox="373 1501 690 1543" style="border: 1px solid black; padding: 2px;">Voice Recognition</div> <div data-bbox="771 1501 1079 1543" style="border: 1px solid black; padding: 2px;">Black Screen</div> <div data-bbox="1161 1501 1461 1543" style="border: 1px solid black; padding: 2px;">Caution / Disclaimer Message</div> </div>

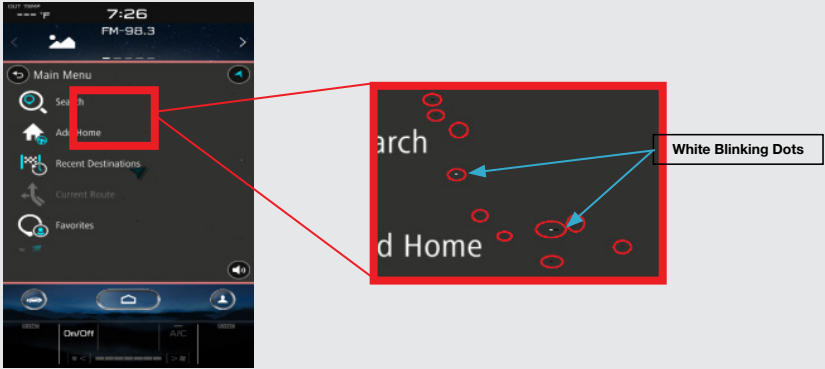
Symptom #	Description of Symptom:
1	Several minutes after Engine start, the Center Information Display (CID) reboots.
2	After an extended period of usage, some white blinking dots appear on the display.

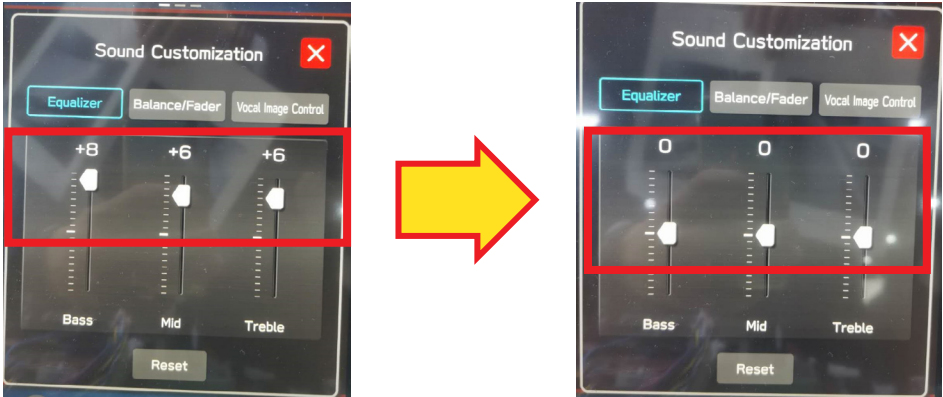
7	Customer-selected Equalizer settings are lost. Equalizer returns to the default settings after ignition switch is turned OFF and back ON.
