SERVICE BULLETIN

APPLICABILITY: 2020 Outback & Legacy **NUMBER:** 15-270-20
SUBJECT: FOTA (Firmware Over-The-Air) Reprogramming for **DATE:** 8/19/2020
DENSO Gen 4 Audio / Navigation Infotainment Systems

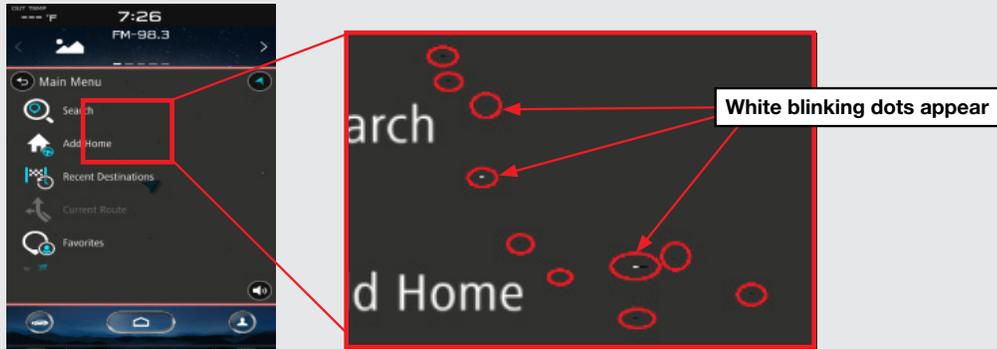
No.	Symptom to be improved	FOTA
1	Several minutes after Engine start, Center Information Display (CID) reboots itself	Yes
2	<p>After extended usage, white blinking dots appear on the display.</p>

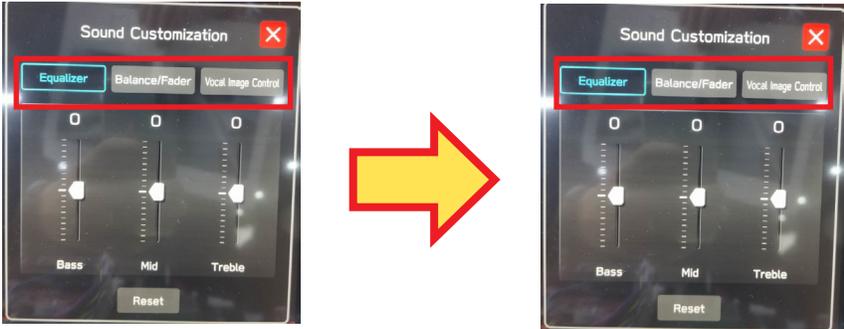
7	<p>Equalizer setting returns to default setting. After ignition switch is turned Off and ON, the equalizer returns to default setting.</p>

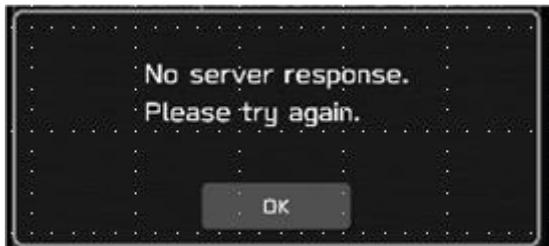
2. What if the server response error message below displays when downloading the update?

- a. Check the internet connection to ensure it is active and shows full signal strength.
- b. Try moving the vehicle closer to the WiFi source or if not possible, try a different WiFi connection such as a mobile hotspot.

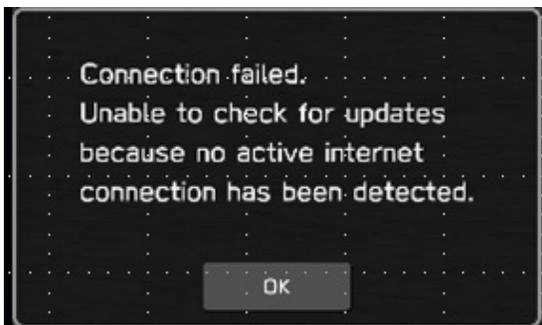
3. What if the below “Connection failed” error message appears before downloading the update?

- a. Follow Tips from Item 1 above.
- b. Change “Wi-Fi” to Off then back to On. This setting is found under the General tab on “Settings” screen.

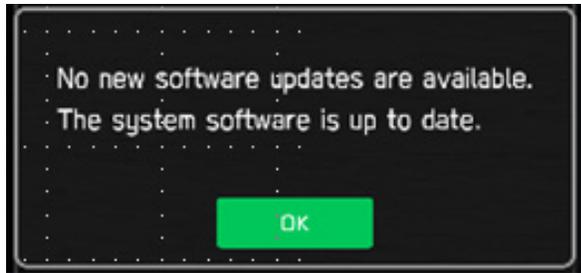
4. What if the system says the system is up to date when checking for updates?

- a. Go to Settings, General, System Information. If the version shows **F11GMM021-704**, or, if the last six digits are any of the following: 020-704, 021-704 or 022-504, the system is already up to date.
- b. If this version is not shown, ensure the clock time is correct.

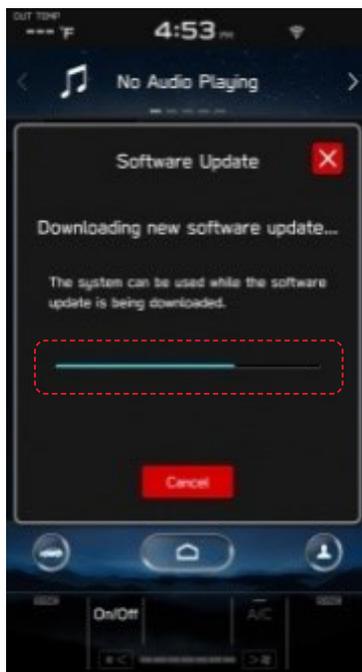
5. What if the “Progress Bar” does not progress for a long time after selecting “Download” or the screen shows the “Connect to Wi-Fi” pop-up when downloading?

- a. Reconnect to Wi-Fi device by following the instructions provided in **Step 1** above.
