Subarunet Announcement

FROM: Subaru of America, Inc.
DATE: August 21, 2020

SUBJECT: Concern with latest 2020 MY Legacy/Outback Gen 4 CP1 FOTA Software Update

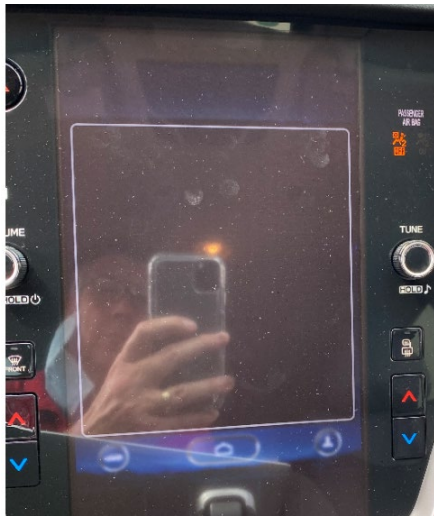
Following the update, SOA received isolated reports of a dark screen condition on initial boot up. See example image below showing white outline appearing during boot up prior to going dark. If this white outline is not observed, the condition may be a result of something other than this FOTA.

As a result of these reports, the FOTA update has been discontinued as of August 21, 2020. Customers potentially impacted will be notified via email that the FOTA release has been stopped and to contact their Subaru retailer should they be experiencing any concerns after attempting the update.

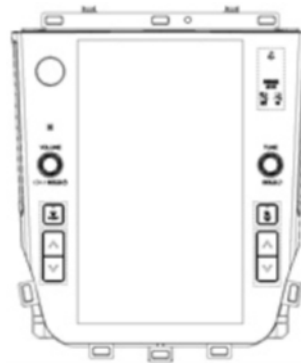
Currently the repair, should this specific condition occur, is to replace the CCU with an exchange unit. When the CCU is removed, please note the serial number and include that with your claim submission. Please note the CID is not affected this condition and should not be ordered as part of these repairs.
