Subarunet Announcement

From: Subaru of America, Inc.

Date: 08-28-2020

Subject: Update on Exchange Unit Backorders- Concern with latest 2020 MY Legacy/Outback Gen 4 CP1 FOTA Software Update

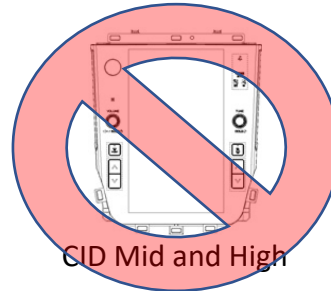
Due to the FOTA update concerns there has been an increased demand for the CCU (Cockpit Control Unit) and the 11.6" (Mid and High) CID. This increased demand has created a temporary backorder at the exchange unit vendor for both components.

This backorder is being addressed and the supplier expects to begin shipping backordered CCUs starting next Wed 9/2.
