Preliminary Information

PIP5598C Diagnostic Tip: Possible Crank No Start Or Extended Crank And Potential DTC P0014 P0017

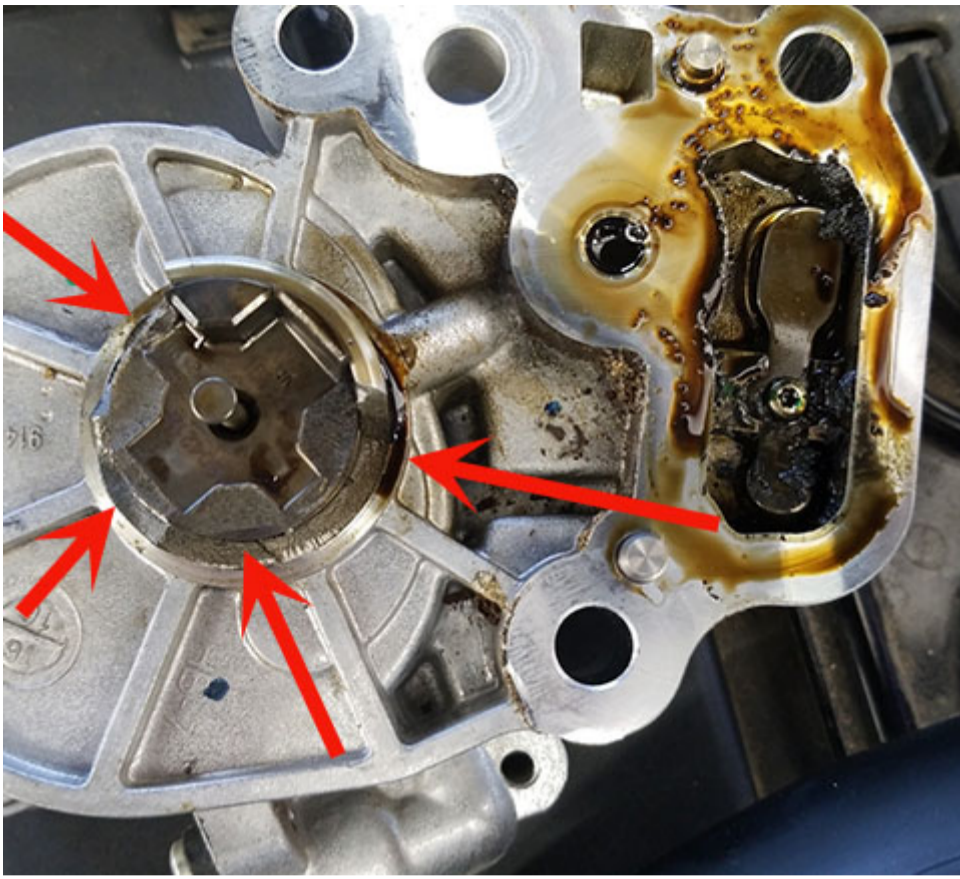
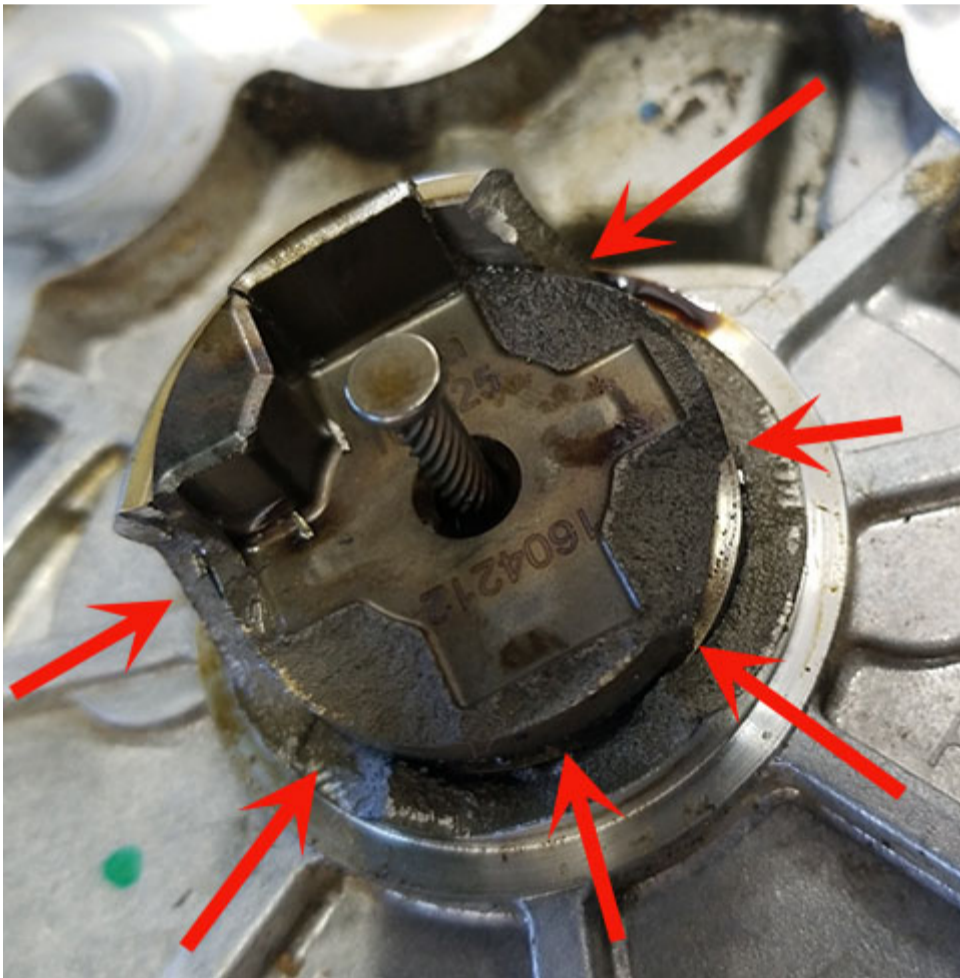
Remove cam cover assembly and perform steps below to confirm exhaust camshaft reluctor orientation. During disassembly the vacuum pump drive lugs should also be inspected for damage. (Photo below show damaged vacuum pump drive lugs)

If you find the vacuum pump drive lugs are broke and/or the exhaust camshaft retractor is out of position then replacement of the exhaust camshaft and vacuum pump will be required.

Note: If needed, It will also be necessary to locate and remove the broken vacuum pump drive lugs and other metal debris during repairs.
