Service Bulletin

Bulletin No.: 20-NA-136

Subject: 9T65 Automatic Transmission Replacement Pilot Program (U.S. Only)

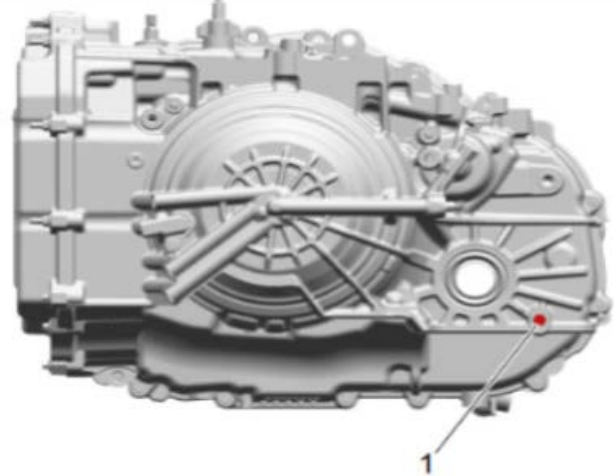
5619626

6. While the vehicle is idling, remove the oil level set plug (1). Allow any fluid to drain:
 - If the fluid is flowing as a steady stream, wait until the fluid begins to drip.
