TECHNICAL SERVICE BULLETIN High Roof Bus/Passenger Wagon - Headliner Loose Or Unseated At The C And/Or C 1/2 Pillar(s)

20-2341
29 September 2020

| Ford 2015-2020 Transit |

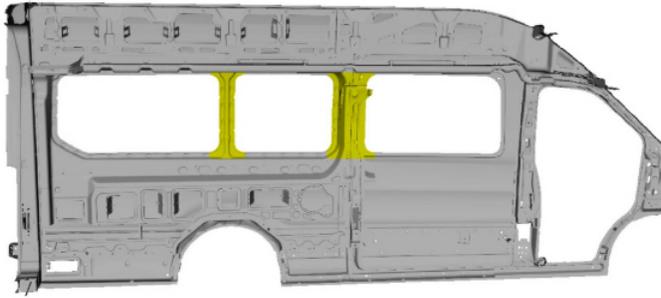
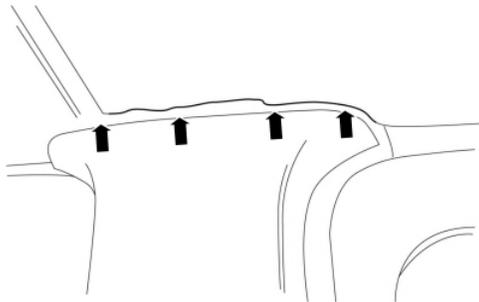
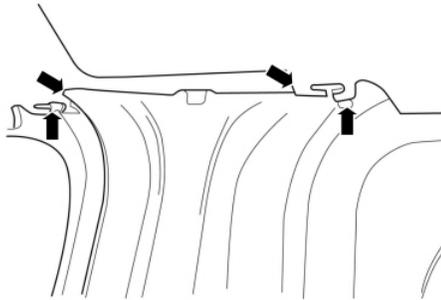
Issue: Some 2015-2020 Transit high roof bus/passenger wagon vehicles may experience a loose or unseated headliner at the C and/or C 1/2 pillar(s) causing visible gaps. This may be due to a lack of retention capability of the headliner locator tabs to the pillar block pins. To correct the condition, install repair coupons to the headliner and replace the headliner air conditioning (A/C) vent foam gaskets.

1. Does this vehicle have a high roof with a loose or unseated headliner causing a visible gap at the C and/or C 1/2 pillar(s), misalignment between headliner locator tab and pillar block pins? (Figures 1-3)
