TECHNICAL SERVICE BULLETIN

SYNC Screen Concerns, Wi-Fi Connection Message, Rear View Camera Operation, CarPlay And/Or Voice Prompt Concerns

20-2363

19 October
2020

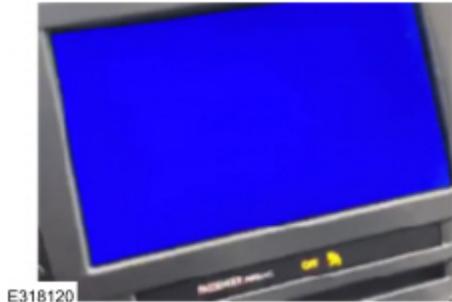
Figure 1

- Solid blue screen when moving forward at speeds above 16 km/h (10 mph) (Figure 1)
 - The rear parking aid camera remains on the screen at speeds below 16 km/h (10 mph) (Figure 2)

This may be due to the SYNC Software. To correct the condition, follow the Service Procedure to update the accessory protocol interface module (APIM) software.

1. Disconnect all customer connected USB items from all media hub locations.
2. Start the vehicle.
3. Insert the SYNC 3 universal thumb drive into the USB port on the media hub.
4. The module automatically updates with no user input required.
 - (1). Modules already at the latest software level will indicate this after approximately 30 seconds.
 - (2). Module programming for a non-updated module does not need to be monitored and can take approximately 20-30 minutes.
 - (3). Once the reprogramming has completed, the screen will display a message indicating the module is up to date.
5. Remove the SYNC 3 universal thumb drive when complete. The screen returns to the SYNC 3 home screen. Reconnect any of the customer USB items. No vehicle or system restarts are required.
