**SERVICE BULLETIN**

**APPLICABILITY:** 2012-16MY Impreza 4-Door  
2015-20MY WRX and STI

**NUMBER:** 12-301-20  
**DATE:** 10/20/2020

**SUBJECT:** Rattling Sound from Rear Package Shelf Area

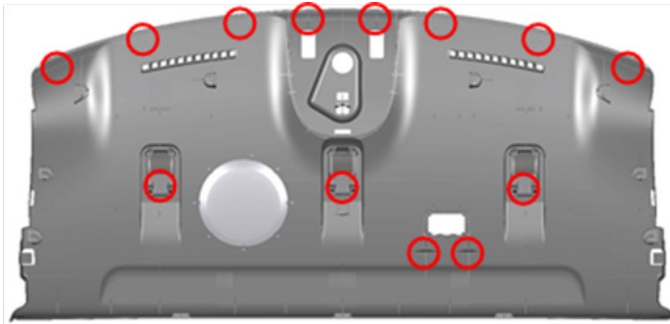
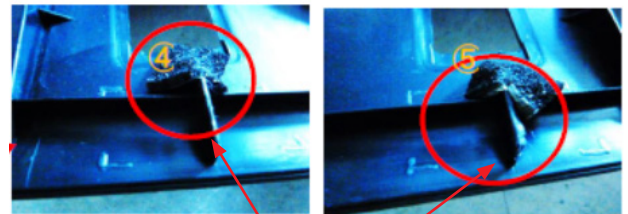
**Dislocated Cushions**

- the mounting points for the center stop lamp where it fits into the package shelf
- the package shelf itself rattling against the inside of the rear glass
- the rib and/or stand portions located on the underside of the package shelf contacting the shelf portion of the vehicle body.

A higher durability material will be used for the cushions placed at the red circles below.

2. If the rattle sound is confirmed, and the Trimming Panel Assembly- Rear Shelf is not damaged, if any of the 13 cushions are deformed/worn/dislocated, replace the cushions by following the procedure below.
