GENERAL MANAGER	IMPORTANT - All Service Personnel Should Read and Initial in the boxes provided, right.		
SERVICE MANAGER QUALITY DRIVEN® SERVICE SERVICE INFORMATION			
APPLICABILITY:	2015-2017MY WRX 2.0L DIT Models 2017MY Forester 2.5L Models		07-88-15R 01/20/15
SUBJECT:	SOA821B200 Replacement Battery Installa Procedure	tion	08/30/16

INTRODUCTION

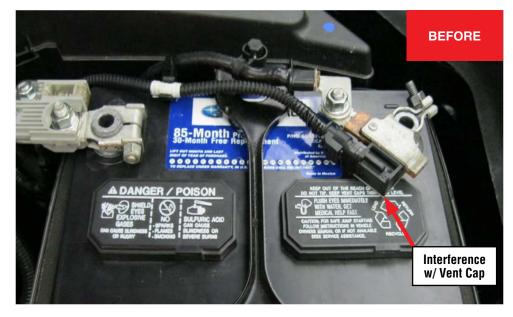
This Service Information bulletin provides a procedure to use when installing a SOA821B200 replacement battery in a 2015MY WRX (2.0L). The sensor located on the battery ground terminal interferes with the battery vent cap used on the replacement battery in the "BEFORE" photo below.

- Disconnect the current sensor harness connector from the negative terminal assembly.
- Remove the 12mm hex nut securing the negative battery cable to the terminal assembly.
- Loosen and lift the battery rod cover off the rod so the negative battery cable is free to move.
- Loosen the 10mm AFTER battery terminal nut and rotate the terminal assembly clockwise to the position shown in the photo on page 3. Re-torque the 10mm terminal nut to 4.4 ft. lbs.
