Service Bulletin

Bulletin No.: 16-NA-206 Date: October, 2020

Subject: A New Way to Look at NOx Sensor Readings and Exhaust Temperature During a DPF Regeneration or a Reductant System Malfunction Warning Service Bay Test

Brand:	Model:	Model Year:		VIN:		Engine:	Transmission:
		from	to	from	to	Engine.	mansinission.
Chevrolet	Colorado	2016	2021			2.8L	
GMC	Canyon					Diesel (LWN)

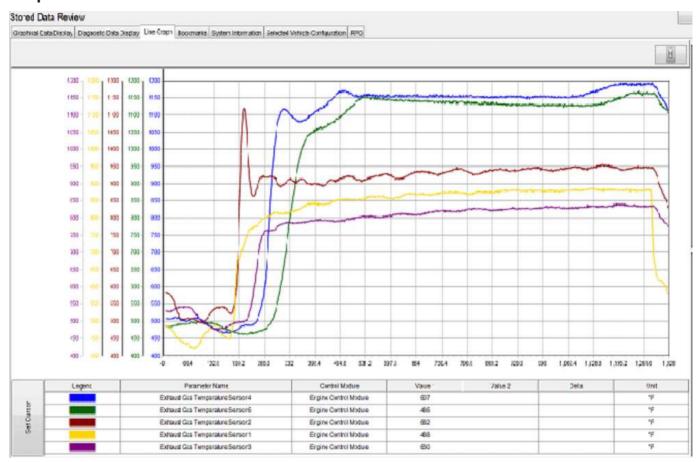
4530964

Graphed results of the exhaust temperatures during the DPF Service Regeneration. Recommended parameter values;

- Enter 400 under MIN.
- Enter 1200 under MAX.

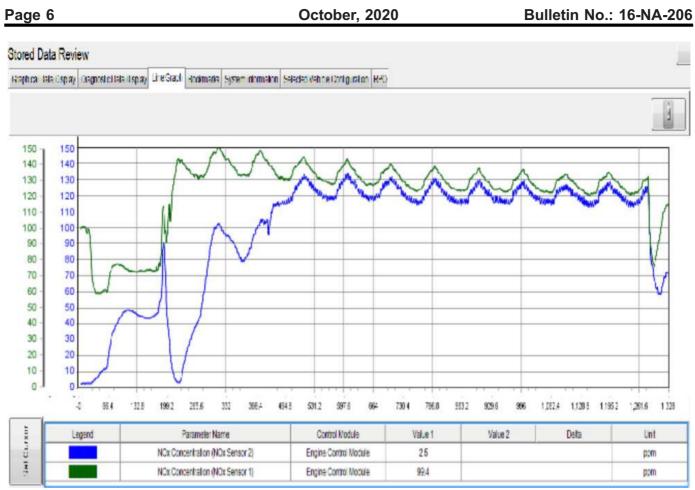
4533023

Note: NOx Sensor 2 may have higher readings than the NOx sensor 1 during a regeneration.

Graphed results of the NOx sensors during the DPF Service Regeneration.

Recommended parameter values;

- Enter 0 under MIN.
- Enter 200 under MAX.

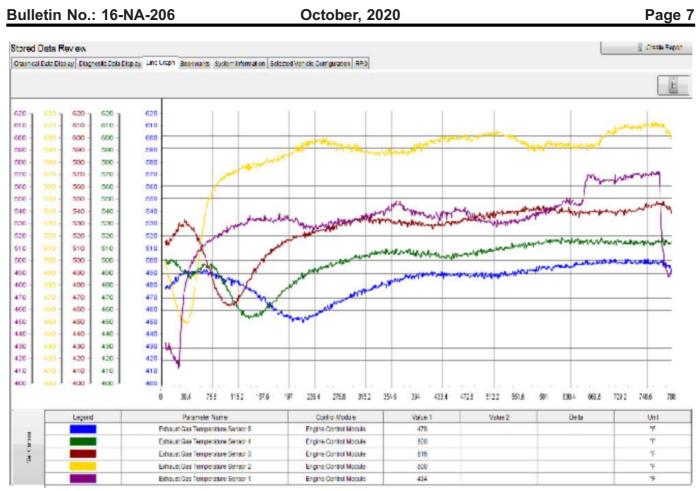
4532848

Graphed results of the exhaust temperature readings during the Reductant System Malfunction Warning Service Bay test.

Recommended parameter values;

- Enter 400 under MIN.
- Enter 620 under MAX.

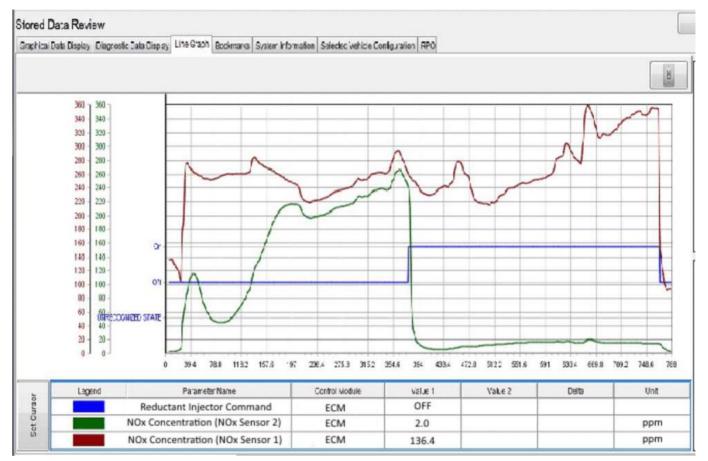
Graphed results of the NOx sensor readings during the a Reductant System Malfunction Warning Service Bay test.

Recommended parameter values;

- Enter 0 under MIN.
- Enter 360 under MAX.
