Service Bulletin

Bulletin No.: 16-NA-222

Subject: Information for Engine Concerns Resulting from Lack of Scheduled Maintenance, Improper Service or Aftermarket Calibrations

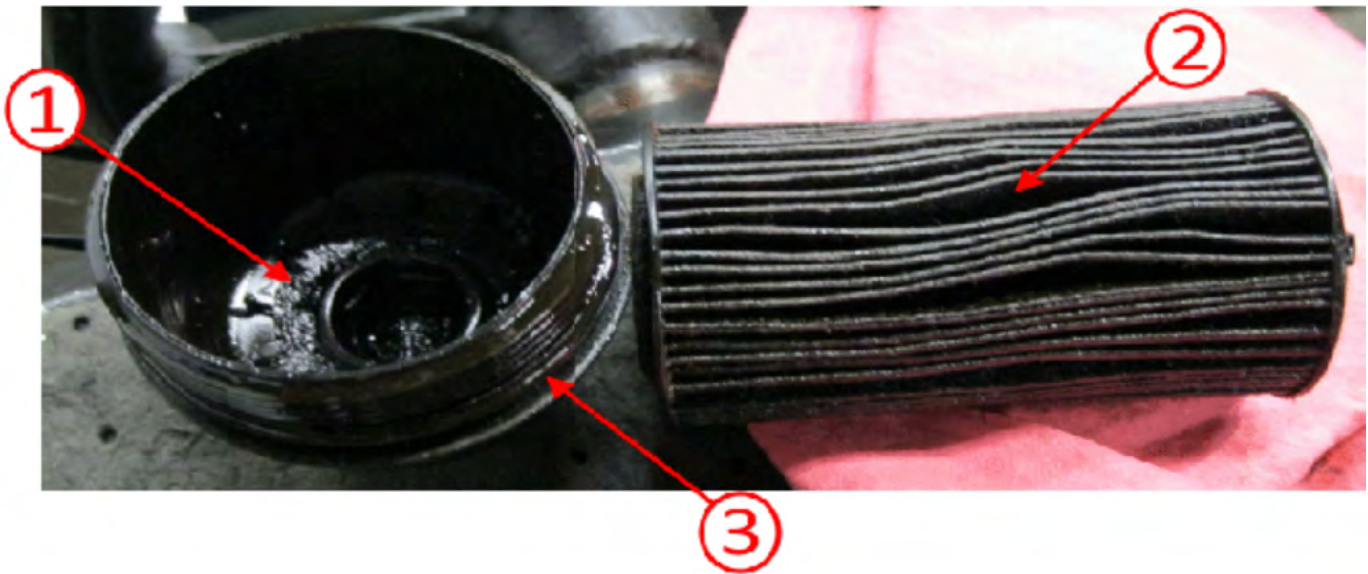
4543496

Oil filter blocked by debris and oil sludge.

- On vehicles equipped with an oil filter cartridge, inspect the cap (1) for sludge.
- Oil filter pleats (2) with heavy debris or sludge.
- Damage, holes, tears, improper installation, or missing seals (3).

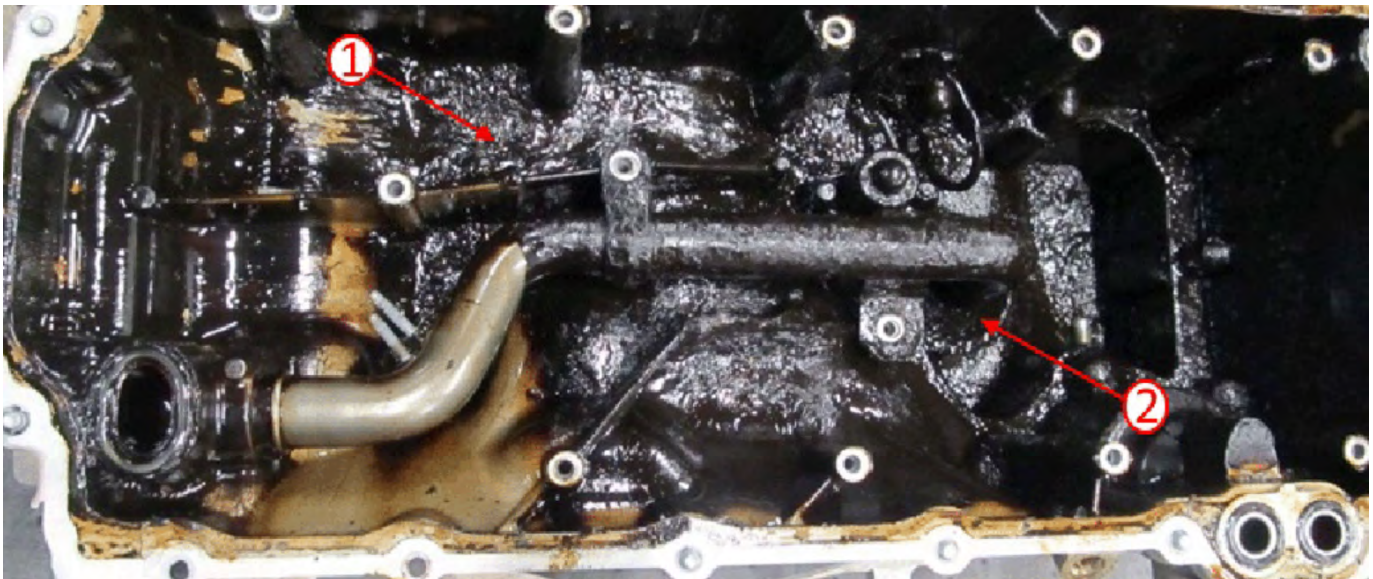
4543483

Sludge build up in the bottom of the oil pan.

- Sludge (1) or debris found in the bottom of the pan blocking the pick up tube (2) screen.
- Light debris in the oil pump pick-up tube screen is normal, from normal engine wear.
- Some determination must be used to validate what is or what is not considered normal wear.

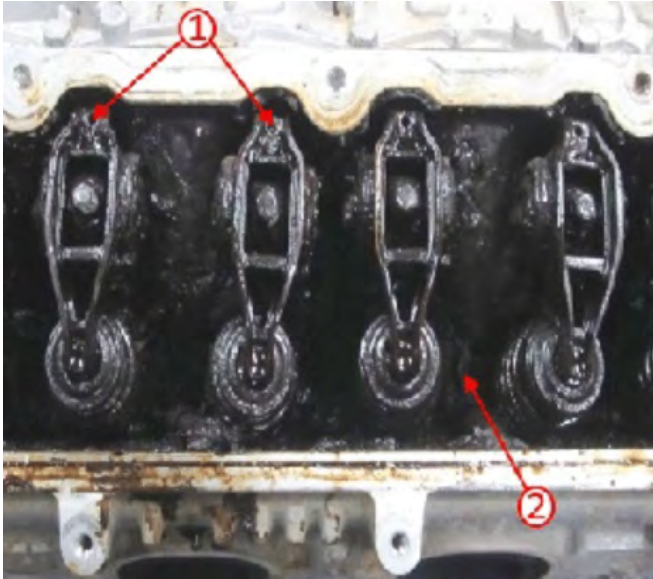
4543670

The valve covers blocked at the engine breather, vacuum or oil return ports.

- The rockers and rocker oil supply ports (1) blocked.
- The return ports blocked by sludge (2).

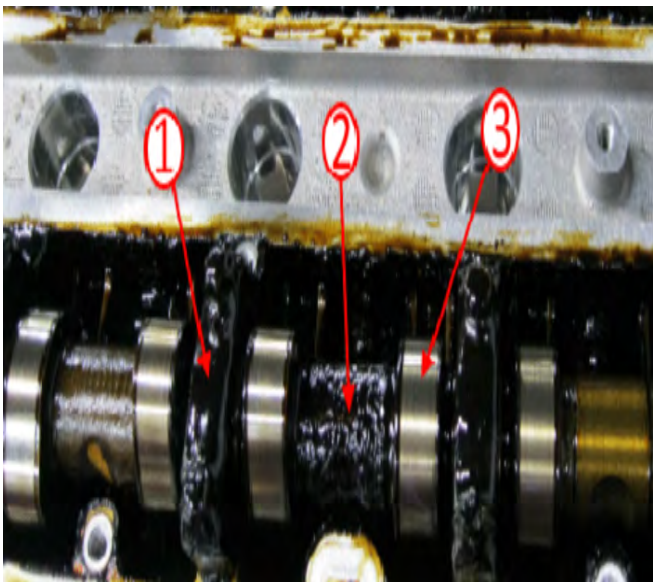
4544568

- Sludge build up on the camshaft (2) and camshaft caps (1).
- Scratches or gouges on the journals or lobes (3) of the camshaft causing a low or loss of oil pressure condition.
- Lack of oil on the lifter tappet creating ticking noise.

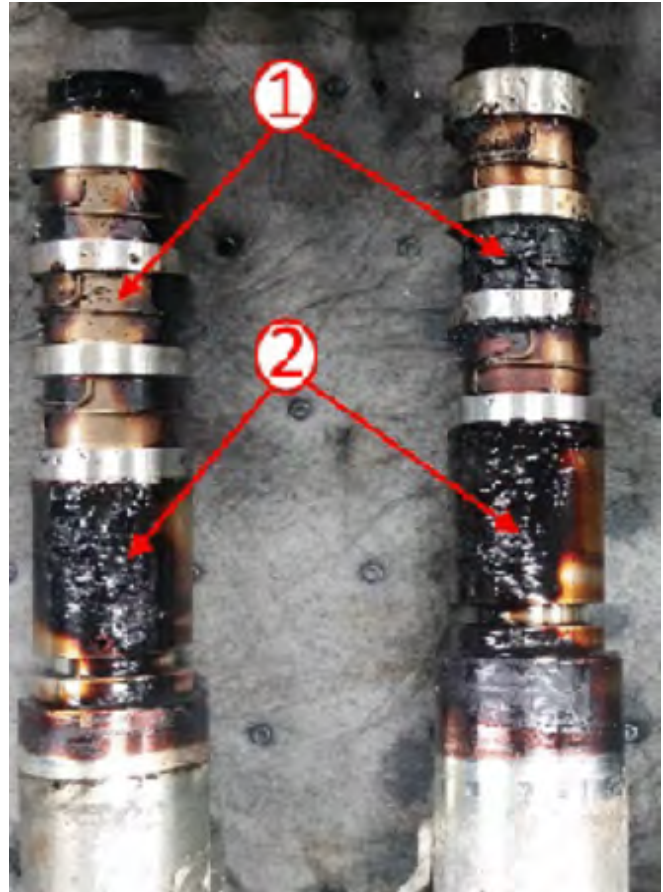
4548494

- Sludge (2) build up on the camshaft position actuator solenoids.
- Debris (1) on solenoid screen may cause engine performance concerns.

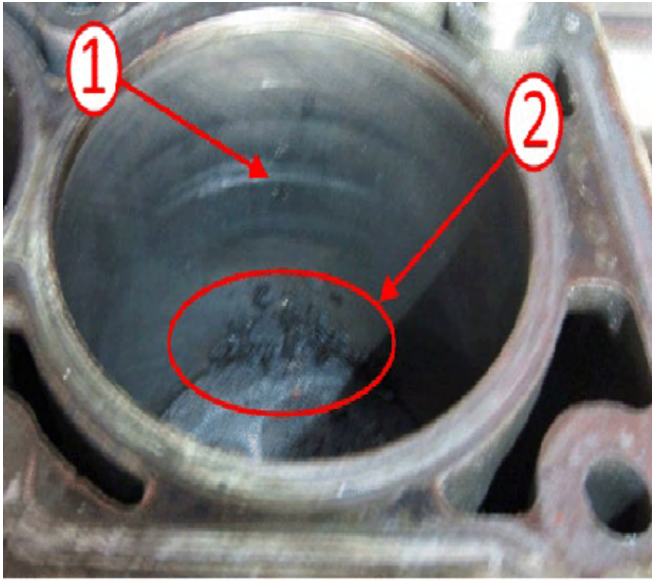
4543465

Conditions that May Result From Improper Service
Improper installation of the air filter into the air filter housing or the use of aftermarket air filter.

- Foreign debris bypassing the air filter and/or the air filter housing outlet ducts.
- Faulty installation of the air filter in the air box housing causing the dirt and debris (2) to enter the combustion chamber.
- Damage to the piston and the piston cylinder wall (1).

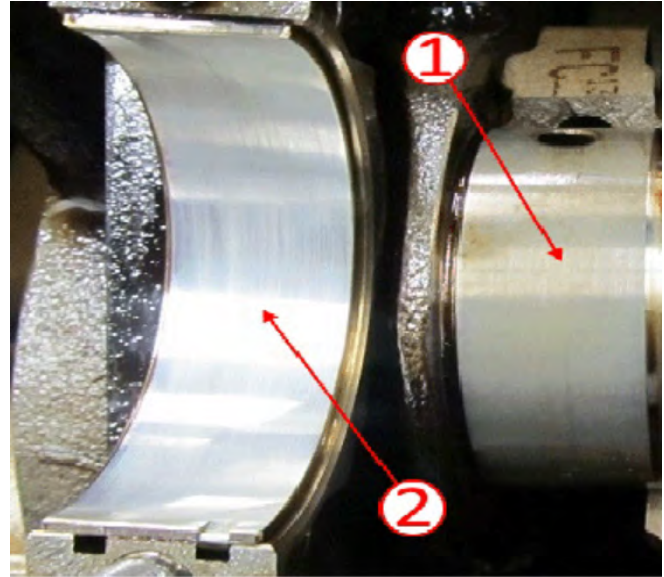
4543396

Main and rod bearing damage caused by foreign debris.

- Dust and debris on the crankshaft, crankshaft bearings, rods (1) or rod bearings (2) caused the chrome finish of the journals to prematurely wear away causing the clearance to increase, possibly causing low oil pressure or a knocking noise.
- Scratches or gouges on the journals result in low or loss of oil pressure condition.
- Possible previous engine repair may result in some debris entering the engine through open ports that are normally sealed or closed off.

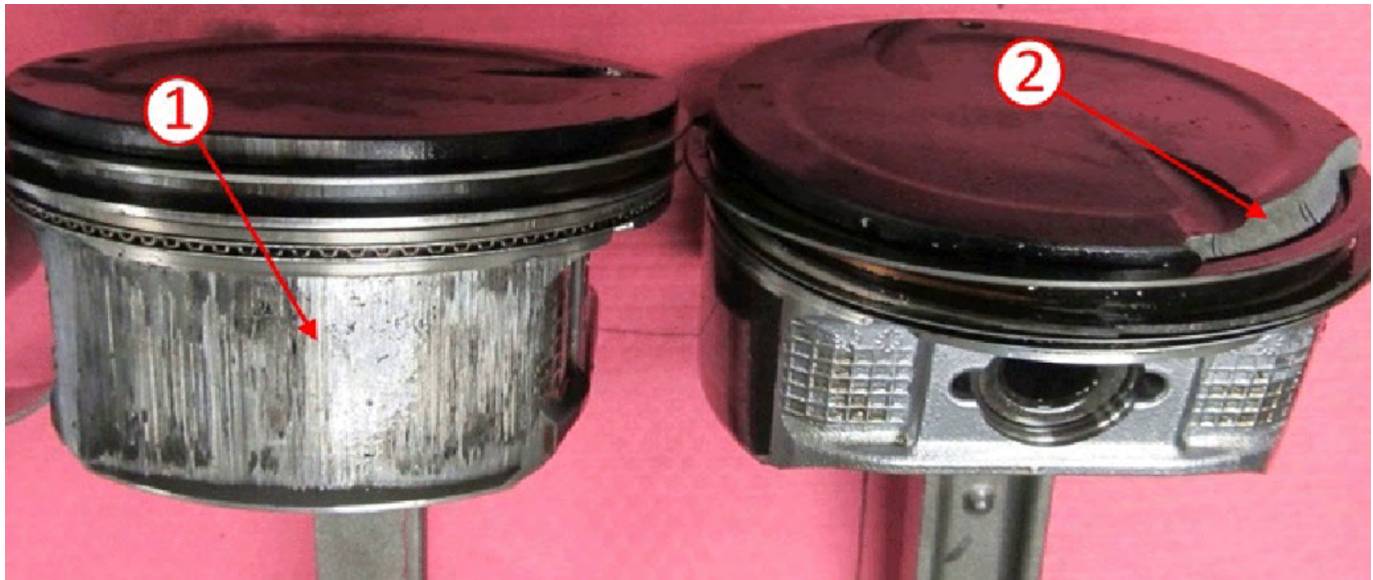
4547308

Incorrect calibrations or modifications that may cause engine damage.

- Piston damage (1) caused by a pre-detonation lean event.
- Improper engine warm up creates excessive heat to the piston causing them to seize to the cold cylinder walls cracking the piston lands (2).
- Aftermarket cold air filter, air filter housing and intake system not allowing proper engine warm up.
