Service Bulletin

Bulletin No.: 16-NA-334

Subject: Water Leak/Drips at Left or Right Side of Windshield Header/A-Pillar Area

Brand:	Model:	Model Year:		VIN:		Engine:	Transmission:
		from	to	from	to		
Chevrolet	Camaro Convertible	2016	2021	—	—	All	All

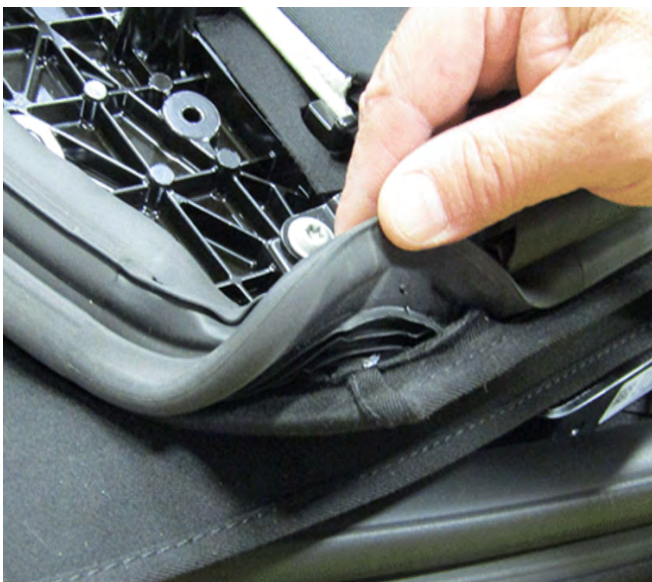
4588943

Involved Region or Country	North America, Europe, Russia, Middle East, Israel, Argentina, Brazil, Bolivia, Chile, Colombia, Paraguay, Peru, Uruguay, Japan, GM Korea Company, China
Condition	Some customers may comment on water dripping at the left or right side of the windshield header/A-pillar area of the convertible top.
Cause	The cause of the condition may be due to a gap between the weatherstrip and the stop on the windshield header.

4. Pull the weatherstrip, stretching it to gain some additional length in the corner.

5. Refit the corner until it lines up with the stitch line of the top cover fabric.
