Service Bulletin

Bulletin No.: 17-NA-114

Subject: Oil Leak from Turbocharger Inlet or Outlet Duct

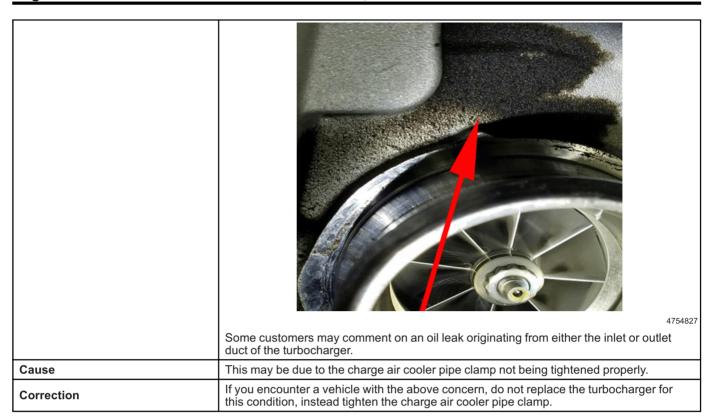
Involved Region or Country	North America, Middle East, Israel, Palestine, GM Korea Company		
Additional Options (RPOs)	Equipped with Diesel Engine (RPO LWN)		
Condition			
	4754826

Refer to Charge Air Cooler Inlet/Outlet Duct Replacement in SI for the procedure to gain access to the clamps needed to be tightened.
