Service Bulletin

Bulletin No.: 17-NA-222

Subject: Information on Turbocharger Whine Noise

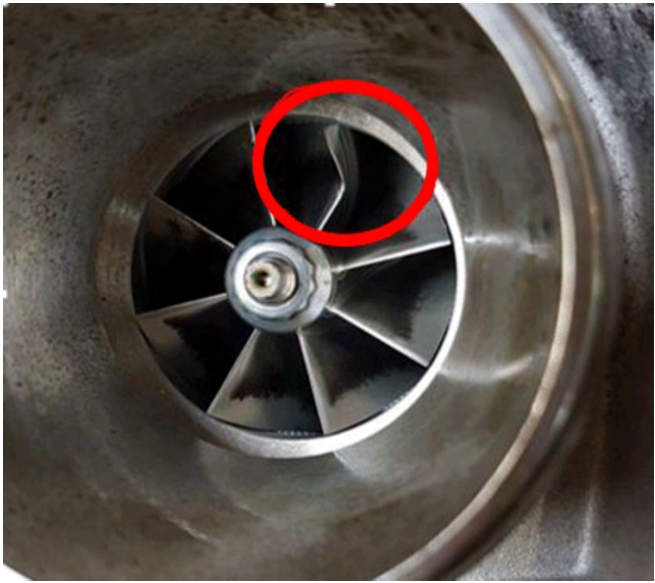
Involved Region or Country	North America, Guatemala, Peru, Korea, Saudi Arabia, Israel, Thailand, Venezuela, South Africa
Additional Options (RPOs)	Equipped with 2.8L Diesel Engine (RPO LWN)
Condition	Some customers may comment on a whine noise during acceleration, in gear, or Neutral.
Cause	This condition may be caused by a bent turbocharger compressor blade.
Information	<p>If you encounter a vehicle with the above concern, inspect the turbocharger compressor blades.</p>

<p style="text-align: right;">4818843</p> <p>If one of the blades is bent as illustrated above, replace the turbocharger. Refer to <i>Turbocharger Replacement</i> in SI. If none of the blades are bent, continue diagnosis referring to SI.</p>
