Service Bulletin

Bulletin No.: 17-NA-231

Subject: Information on Replacement of Video Processing Module Due to Water Intrusion

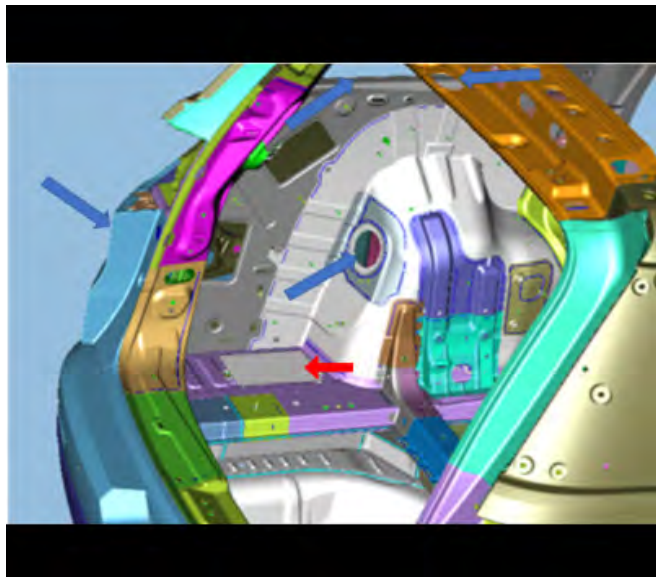
5660052

Possible Water Leak Paths

Note: Not all possible paths are shown.

3. Perform a water leak test/wash test on the vehicle to determine any leak path(s).
4. If a leak path is found, seal and ensure the leak is contained.
5. The following are areas to inspect for water intrusion:

- Ensure the Body harness in left quarter panel to exterior harness grommet is seated fully.
 - Inspect the tail lamp assembly, grommets, and clips.
6. Ensure the body seams are sealed.

- Left rear roof to outer body panel
 - Left rear quarter window
 - Tail lamp pocket seam
 - Sunroof drain hose properly installed in quarter panel
 - Liftgate weatherstrip

- Liftgate wiring harness grommets
 - Liftgate glass
7. Once any water entry point has been determined and contained, replace the Video Processing Module. Refer to *Video Processing Module Replacement* in SI.

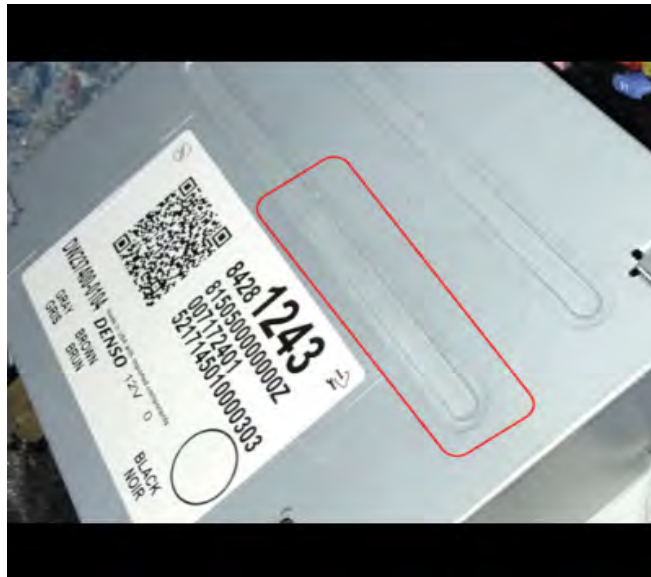
5653593

Examples of Video Processing Module with Visible Signs of Water Damage

Important: Please do **NOT** dismantle the VPM. If there is suspected water damage, send the VPM back to GM for evaluation and please ensure, before replacing the VPM in the vehicle, all potential water routes are sealed to prevent a repeat issue.
