Service Bulletin

Bulletin No.: 20-NA-163

Subject: Rearview Camera Displaying Narrow Guidelines and Zoomed Out/Fisheye Appearance

Brand:	Model:	Model Year:		VIN:		Engine:	Transmission:
		from	to	from	to		
Chevrolet	Silverado 2500HD/ 3500HD	2020	2020			All	All
GMC	Sierra 2500HD/ 3500HD	2020	2020

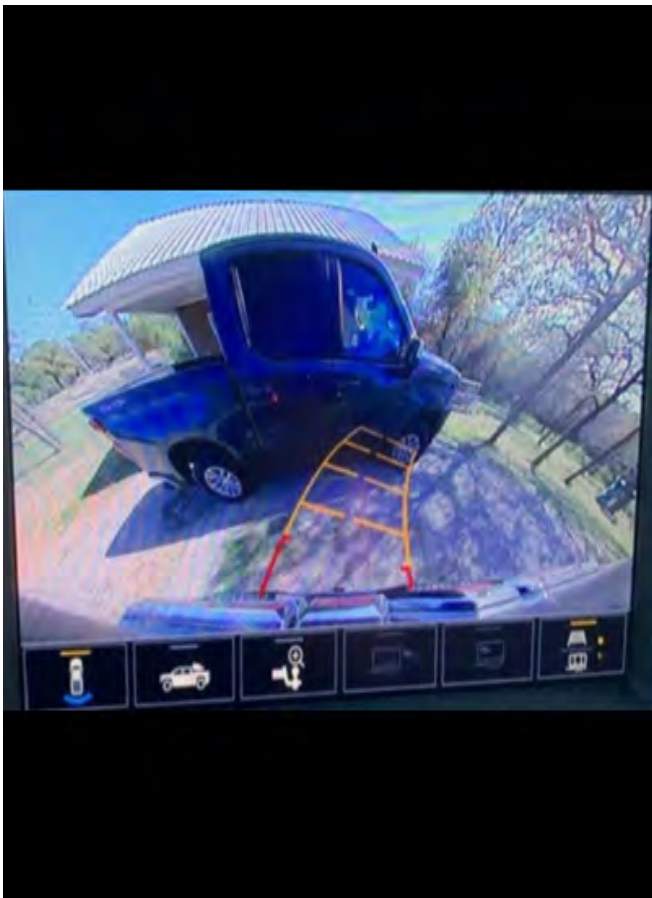
5642270

Involved Region or Country	United States, Canada, Mexico, Israel, Palestine, Chile (West), Paraguay (West), Uruguay (West), Thailand (ASEAN)
Additional Options (RPOs)	Equipped with RPO UVI
Condition	<p>Some customers may comment on narrow guidelines and a zoomed out/fisheye appearance from the rearview camera.</p>

Cause	The cause of the condition may be an issue with the Video Processing Control Module (VPCM) calibration distorting the view from the rearview camera and decreasing the width of the guidelines.

Correction	Utilizing the MDI or GDS/GDS2 tool, verify the VPCM Bootloader P/N is 84809742 then reprogram the VPCM. Follow Service Procedure below. If the VPCM Bootloader P/N is NOT 84809742 (ex. 84650325, 84513776), the VPCM must be replaced with the latest version. Refer to Parts Information and the EPC for the latest VPCM and program with the latest released software.
-------------------	--
