# Service Bulletin

Bulletin No.: 20-NA-175

**Subject:** Vertical Misalignment Between Cab and Pickup Box on Driver Side of Vehicle

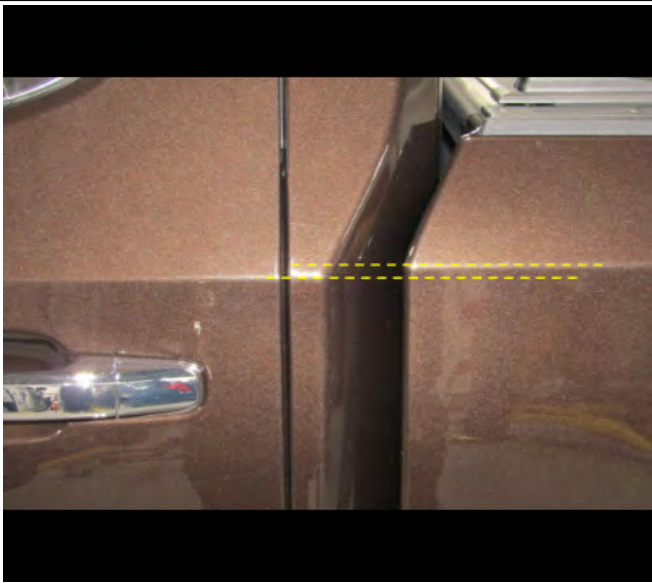
<p>5645798</p> <p>Some customers may comment on noticing anywhere from 2 –10 mm (0.08 – 0.4 in.) vertical misalignment of the body feature line between the cab and the pickup box, on the driver's side of vehicle.</p>
<b>Cause</b>	The cause of the condition may be pickup box structure variation.
<b>Correction</b>	Realign the left side of the cab and install shim washers, following the steps in the Service Procedure below.
