SERVICE BULLETIN

APPLICABILITY: 2019-20MY Forester
2020MY Outback
2019-20MY Ascent

NUMBER: 12-300-20R

SUBJECT: Power Rear Gate (PRG) Switch Trim- Design Change

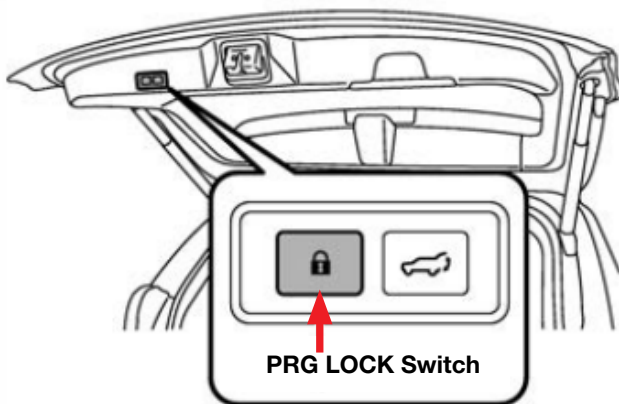
Trim Cover

This bulletin announces design changes made to the trim cover for the rear gate PRG control switches located on the bottom of the rear gate inner trim panel as shown below. In some cases, if the buttons are pressed in a certain way, they may become stuck below the surface of the switch cover and not function properly. Changes were made to enhance the rigidity of the part along with increasing the thickness of the locking tabs.

Here, the **LOCK** button is shown stuck below the surface of the switch trim cover.

The part number for the new “CAP-TRIM PANEL,REAR GATE” is: **94381SJ011VH**.
