## SERVICE BULLETIN

**APPLICABILITY:** 2015-19MY Legacy and Outback  
 2017-19MY Impreza  
 2019MY Ascent

**NUMBER:** 03-85-20R

**SUBJECT:** Propeller Shaft- High-Pitched Sound from Center Support Bearing

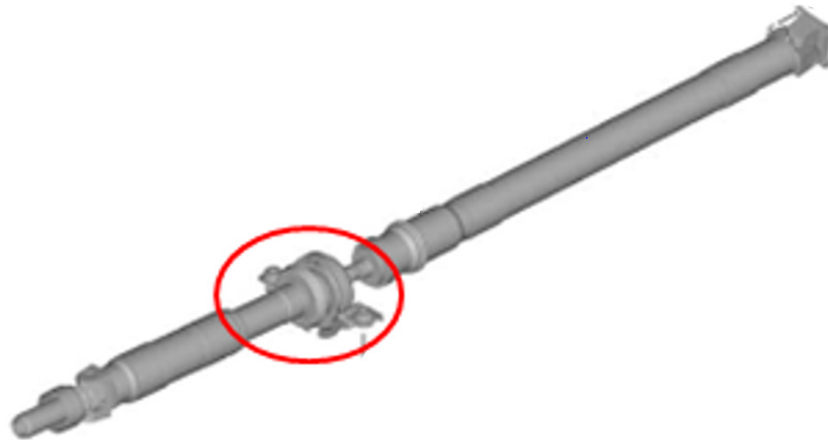
This bulletin announces the availability of new propeller shaft assemblies. The new parts incorporate a production change made to address a small number of reports describing a high-pitched, squeal-type sound heard under certain low-speed driving conditions in colder temperatures (~20 mph in mid-teens F). The center support bearing has been identified as the source of the sound. New bearings with additional grease capacity have been incorporated to address the concern. If the condition is confirmed, the propeller shaft assembly must be replaced as the center support component is not a serviceable part.
