SERVICE INFORMATION BULLETIN

APPLICABILITY: 2019MY Legacy and Outback w/ 8-in. Navi System **NUMBER:** 15-255-19R
 2019-21MY Impreza and Crosstrek w/ 8-in. Navi System **DATE:** 11/08/19
 2019-21MY Crosstrek Hybrid w/ 8-in. Navi System **REVISED:** 11/23/20
 2019-21MY Forester w/ 8-in. Navi System
 2019-21MY WRX WRX STI w/ 7-in. Navi System
 2019-21MY Ascent w/ 8-in. Navi System
 2019-21MY BRZ with 7-in. Navi System

SUBJECT: Map Data Update Procedure for Harman Gen 3.1 Navigation Equipped Head Units (H/U)

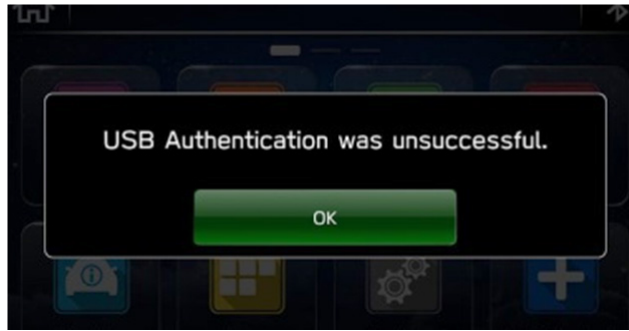
CAUTION: NEVER attempt to install this software update on any 2017 or 2018 MY vehicles as they are equipped with Gen 3.0 Navigation systems. This update is ONLY for models equipped with Gen 3.1 Navigation systems. Should an attempt be made to install any of these files into a Gen 3.0 H/U, the USB Authentication error screen below will be displayed.

- The USB Authentication error screen will also be displayed when attempting to install the map data bundled with a software version older than the version already installed in the H/U.
- Move the vehicle to an outside location where the engine can be safely started and kept idling during the update process.
- Never idle the vehicle in a closed space such as a garage, even if the garage door is open.
- Once the vehicle is in a safe location, be sure the vehicle is in Park if CVT or Neutral if MT and the parking brake is fully engaged.
- Unplug any cables or available devices from the USB ports.
