Service Bulletin

Bulletin No.: 13-08-116-001F

Subject: Aftermarket ALDL or DLC Interface Devices Causing Multiple Issues

Models: 2021 and Prior GM Passenger Cars and Trucks

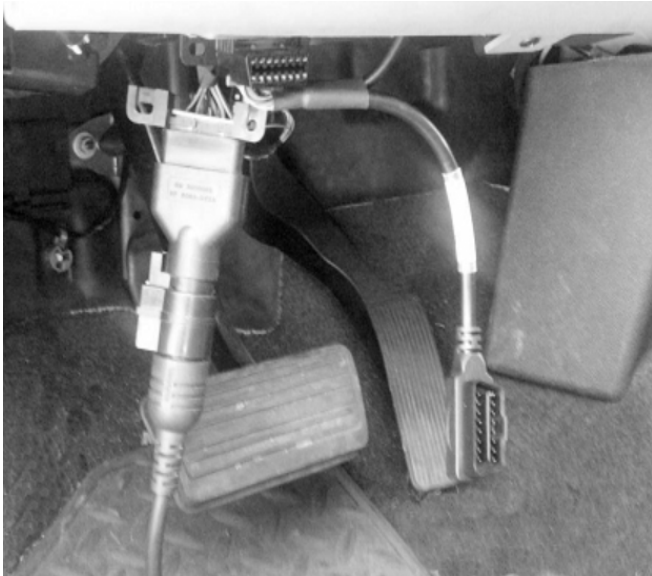
3346643

Device W/Secondary DLC Connector

This device has another DLC connector on it. The rest of the harness along with the device can be placed out of sight hidden from the technician, who may not notice the diagnostic connector is not in the factory location.

If SI diagnostics do not identify the source of the issue and if the device is available, attempt to duplicate the condition, and then remove the device to determine if the condition is eliminated.

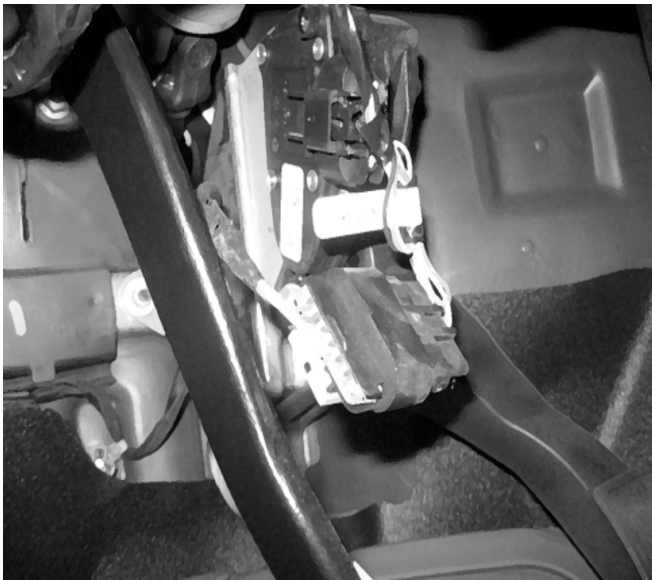
3346646

Pedal Mounted Aftermarket Device Interface

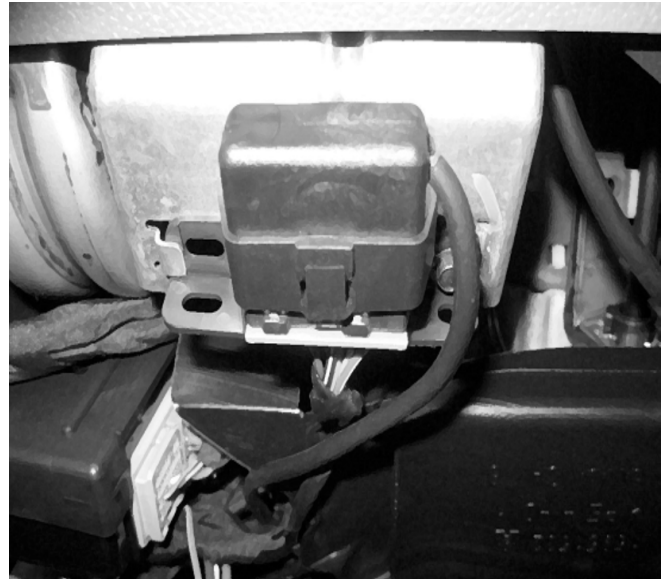
3346648

Aftermarket Device at ALDL

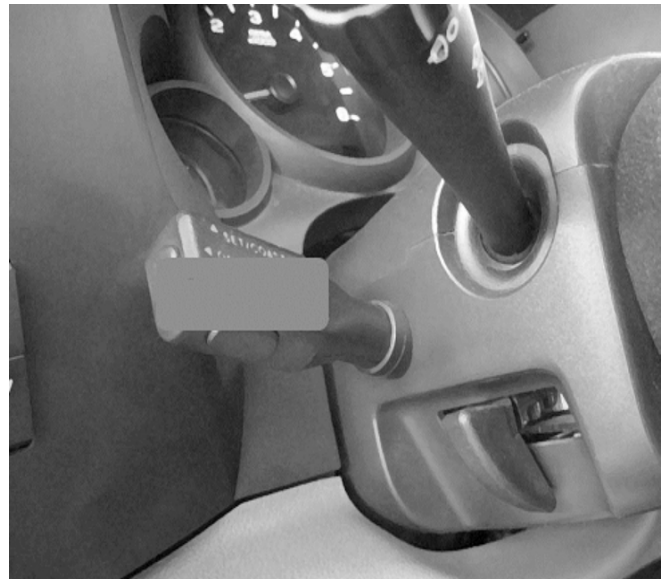
3346650

Aftermarket Device Switch

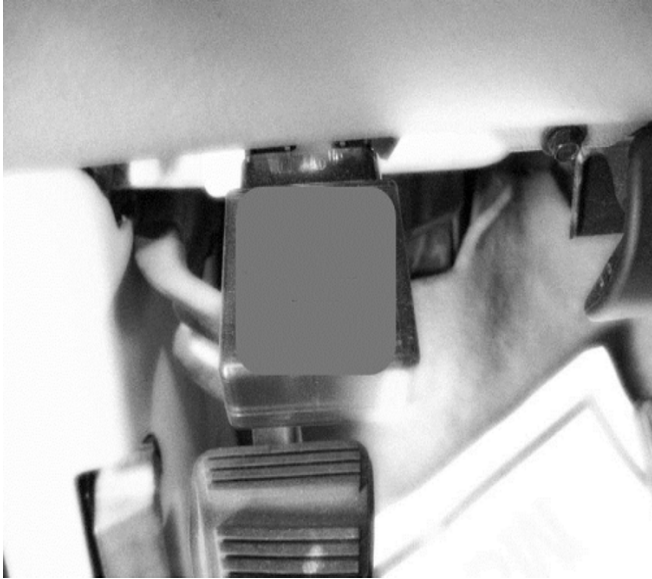
3346651

Monitoring Device Example

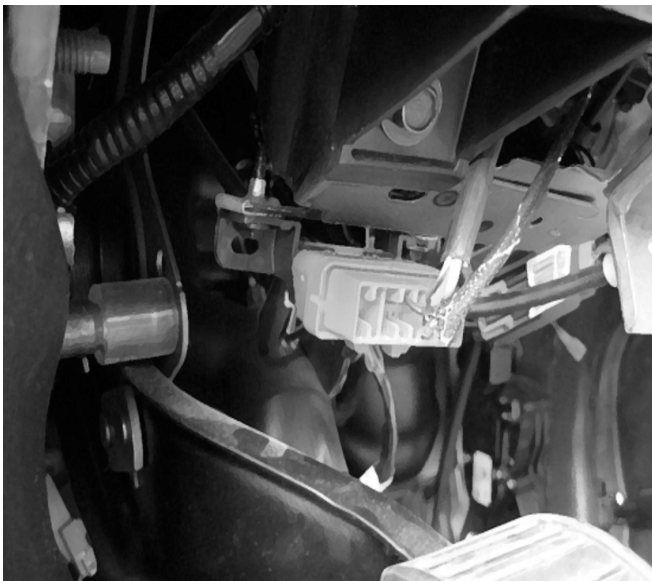
3346652

Fleet Tracking Device Interface (May Include Rental and Lease Vehicles)

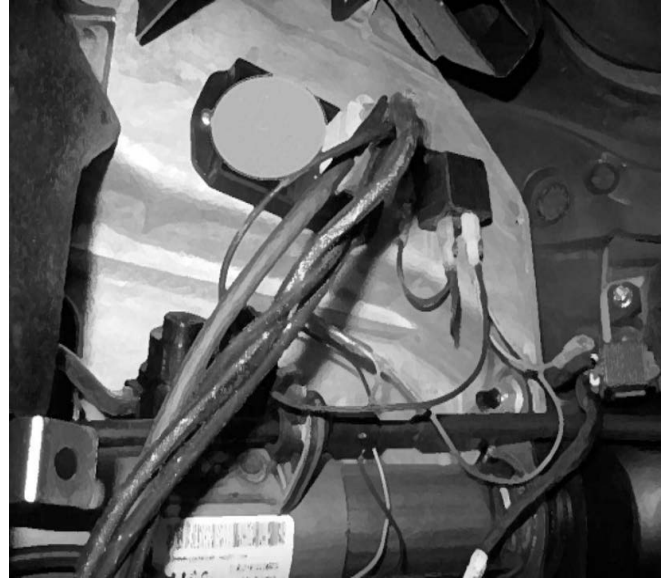
3346654

Fleet Tracking Module Plugged Into the DLC
