Preliminary Information

PIP5416D Instrument Panel Cluster (IPC) Warning Lamps And / Or MIL Are Illuminated Diesel Exhaust Fluid (DEF) Message Displayed Various DTCs Set (Inspect Wiring Harnesses for Chafing).

Models

Brand:	Model:	Model Years:	VIN:		Engine:	Transmissions:
			from	to		
Chevrolet	Colorado	2016 - 2021	All	All	2.8 LWN	All
GMC	Canyon	2016 - 2021	All	All	2.8 LWN	All

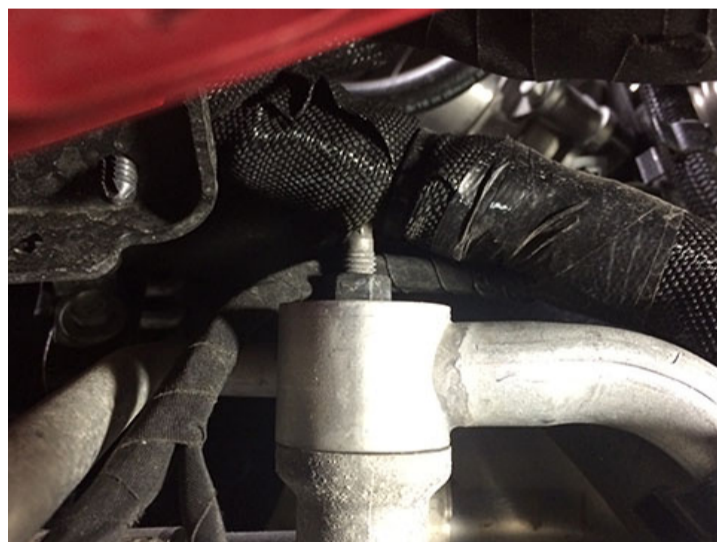
Air Conditioning (AC) compressor, AC compressor suction and discharge line manifold, AC line and AC compressor clutch.

Concerns in the area of the AC compressor, lines or suction / discharge pipes may cause:

DTCs associated with chaffing in this area include:

B127E, C0306, C0321, C0398, C0800, P0071, P0072, P0117, P0119, P0340, P0341, P0406, P0483, P0522, P0628, P0641, P06A3, P0700, P20BB, P20BF, P227E, P24B1, U0073, U0077, U0121, U0131, U0140, U0151, U0415, U2099, U0401, U0415 and U0420.

If you encounter these scenarios, inspect, repair (as necessary) and route the wiring harness away from these possible chafe points.

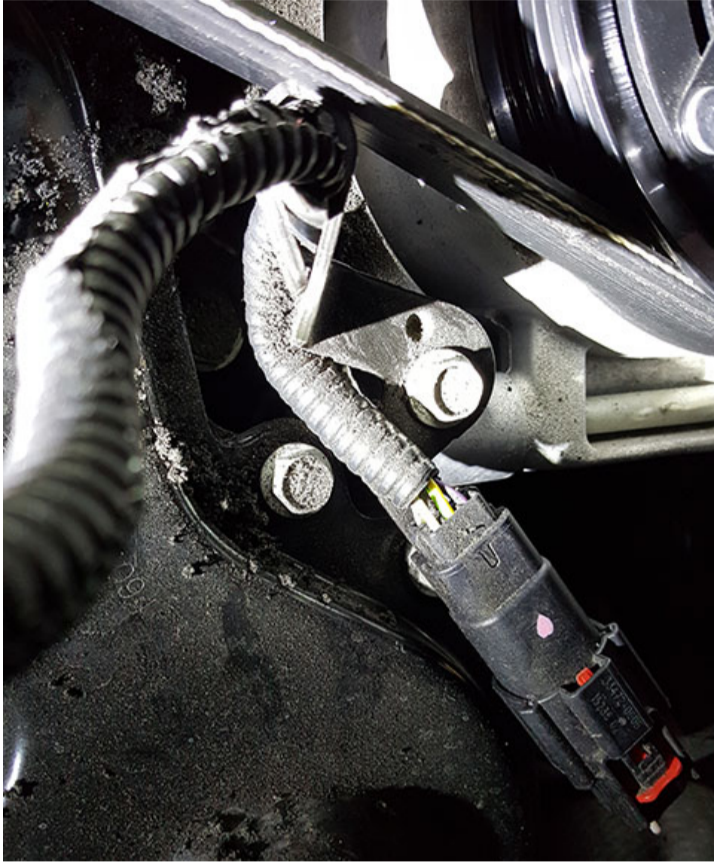
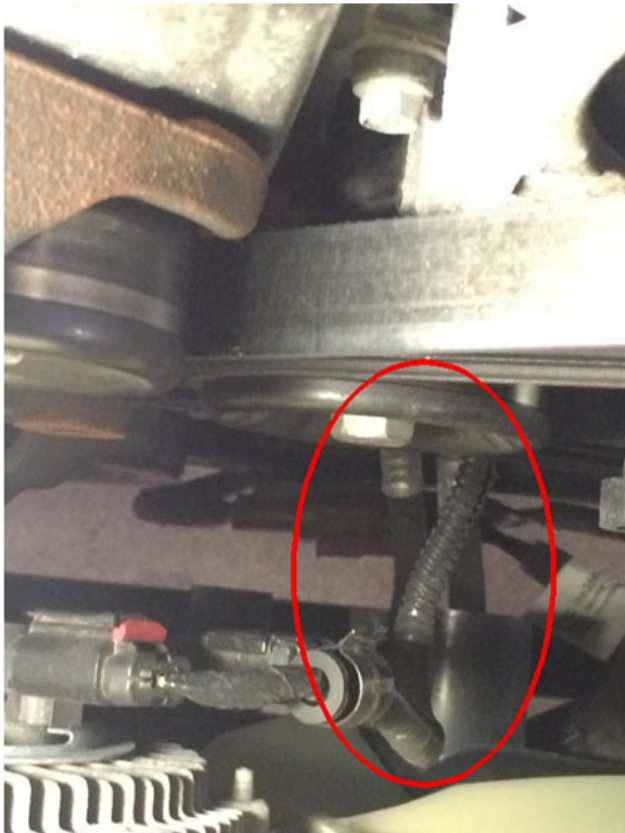
Serpentine Belt. The fan clutch wiring harness support bracket may be out of position allowing the harness to rub on the belt.

Concerns in the area of the serpentine belt may cause:

DTCs associated with chaffing in this area may include:

C0273, P0526, P0480, P0336, P0526, P0641 and P0651.

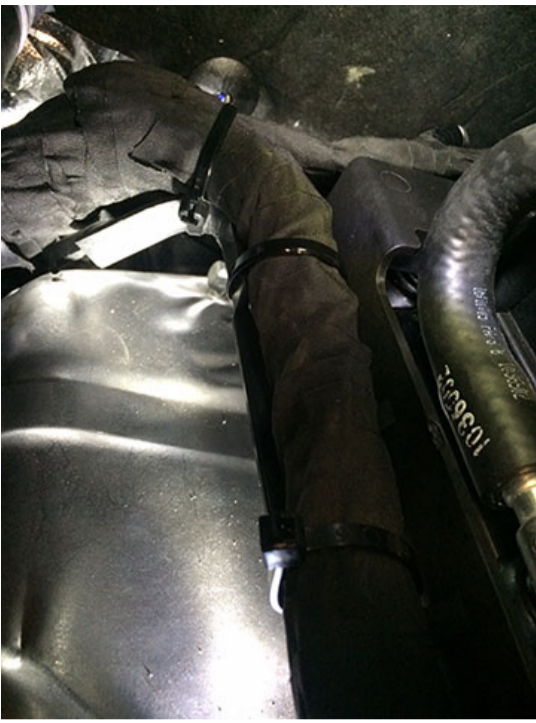
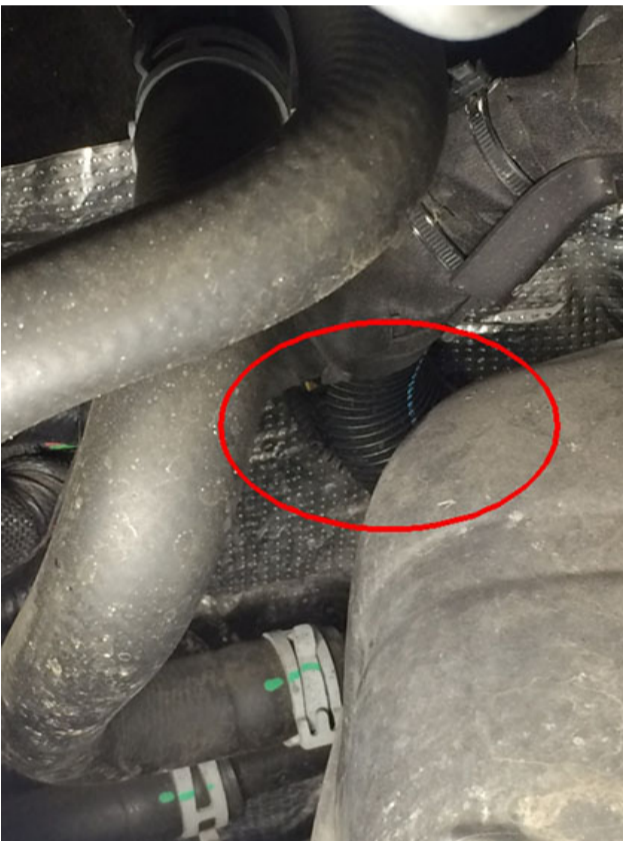
Right rear of engine. Check for harness damage on the exhaust heat shield as described in the latest version of bulletin [16-NA-081](#).

Concerns in the area of the right rear of engine / exhaust heat shield may cause:

DTCs associated with chafing in this area may include:

B1011, C0306, P0201, P0202, P0203, P0204, P0410, P0575, P062D, P0697, U0073, U0100, U0121, U0140, U0415 and U0420.

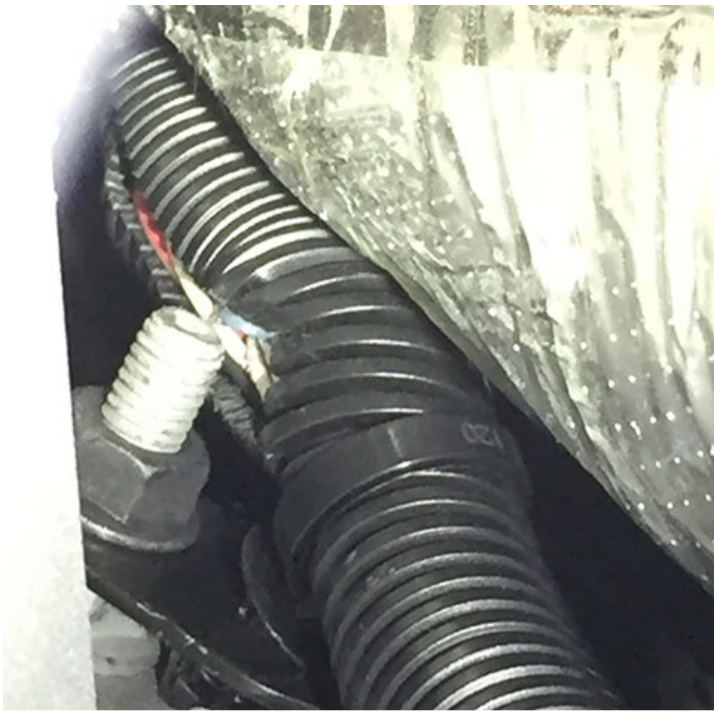
Transmission bell housing bolt / stud.

Concerns in the area of the rear of engine / transmission bell housing bolt / stud may cause:

DTCs associated with chaffing in this area may include:

P0201, P0202, P0203, P0204, P0392, P0401, P0420, P062D and U0073.

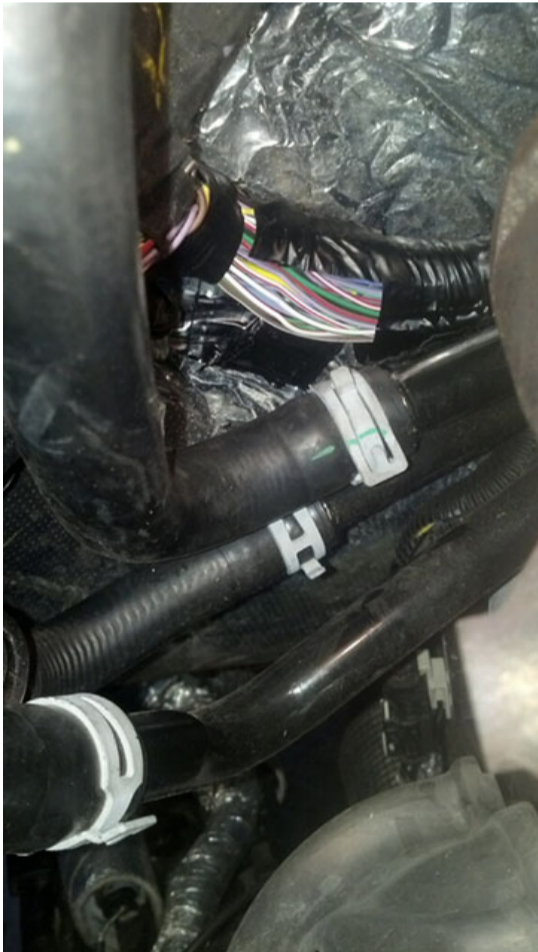
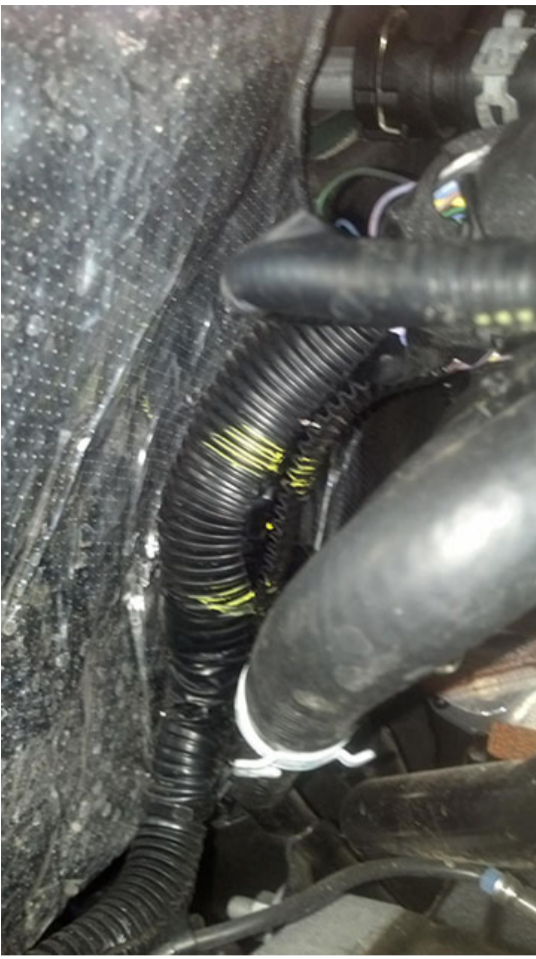
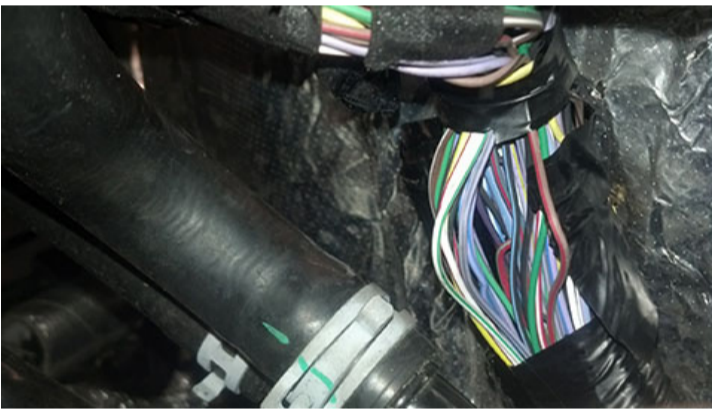
Coolant pipe and clamp tabs between engine and cowl.

Concerns in the area of the coolant pipe / clamp / clamp tabs between engine and cowl may cause:

DTCs associated with chafing in the area may include:

B1011, P0575, U0073, U0100, U0121, U0140, U0415 and U0420.

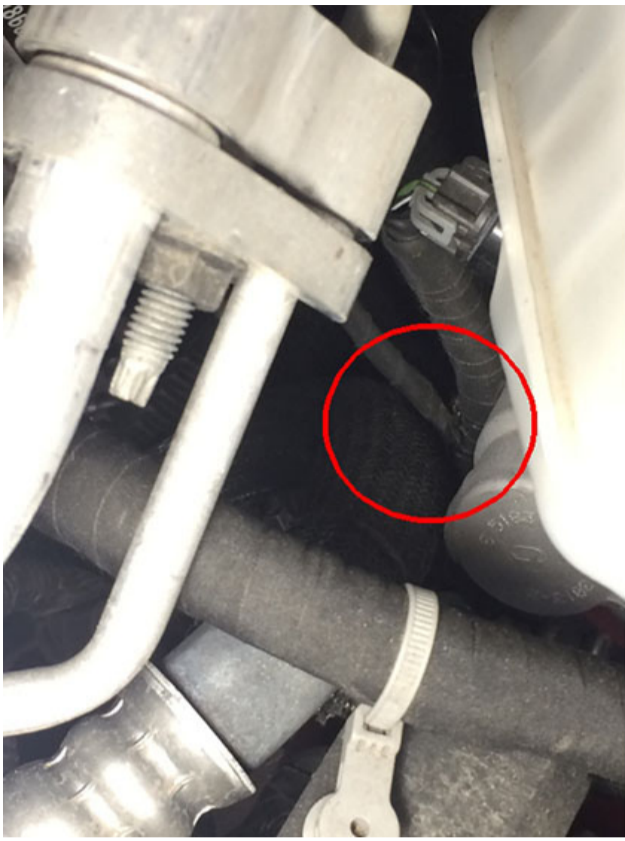
Near the brake fluid level switch.

Concerns in the area near the brake fluid level switch may cause:

DTCs associated with chafing in this area may include:

C0273 and P0641.

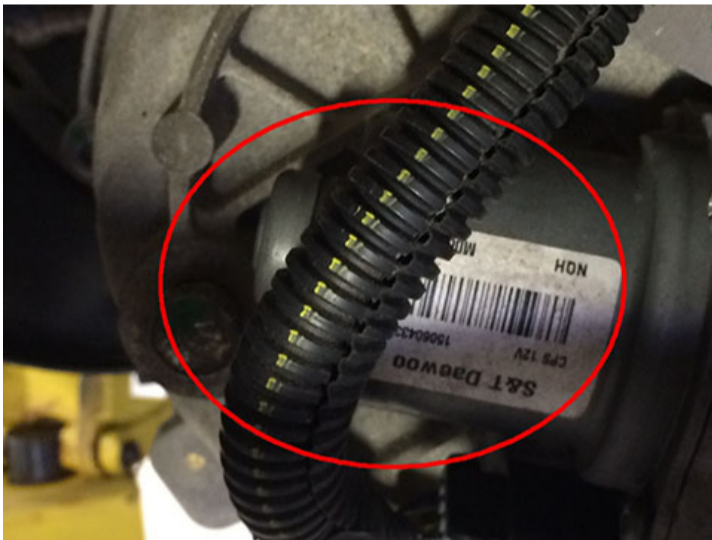
Transfer case encoder motor.

Concerns in the area near the encoder motor on the transfer case may cause:

DTCs associated with chafing in this area may include:

C0396.

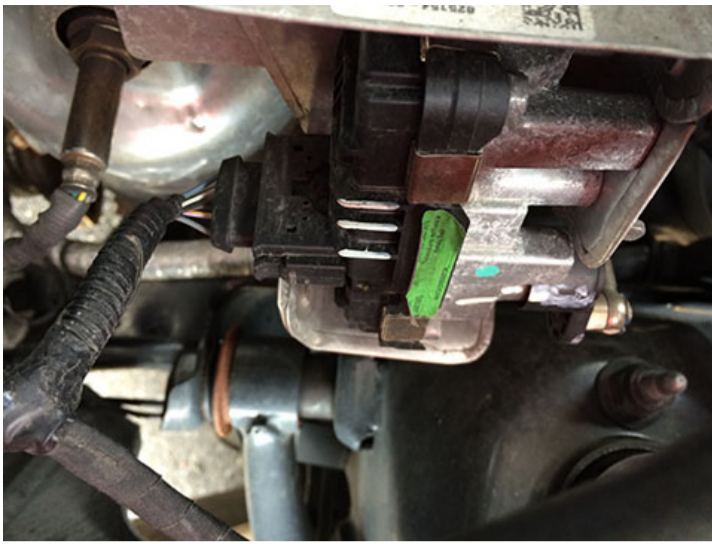
Turbocharger Vane Position Actuator Connector

Concerns with loose terminals or connector not fully seated at the Turbocharger Vane Position Actuator may cause:

DTCs associated with a loose connector or terminals include:

P0045 or P2599.
