### PIP5680C Excessive Oil Smoke From the Exhaust On Cold Start

Brand:	Model:	Model Years:	VIN:		Engine:	Transmissions:
			from	to		
Cadillac	ATS	2016	All	All	3.6L LF4	All

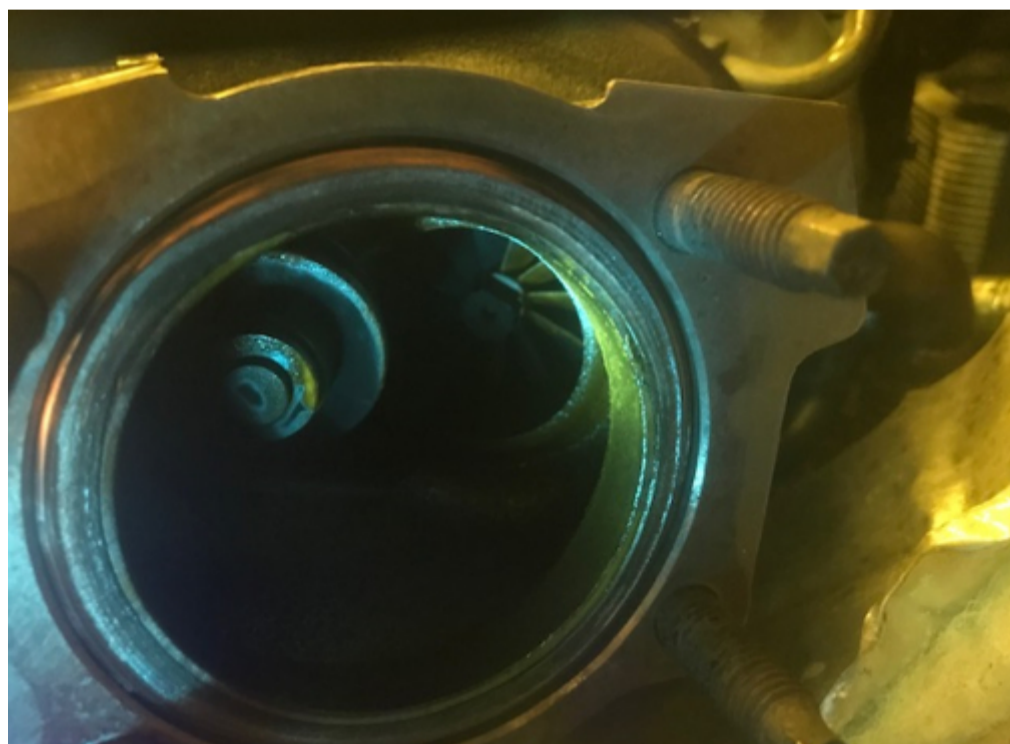
To check for this concern first inspect the outlet of the turbochargers for the presence of oil with dye in the system. (See below)

If oil is found at the outlet of the turbocharger on either side, then replace the turbocharger, drive to clean out the exhaust and then let sit to get cold and reevaluate.
