Preliminary Information

PIC6163C Normal Characteristic - Fasteners Under the Hood Appear to be Loose

Brand:	Model:	Model Years:	VIN:		Engine:	Transmissions:
			from	to		
Chevrolet	Camaro	2016 - 2021	All	All	All	All

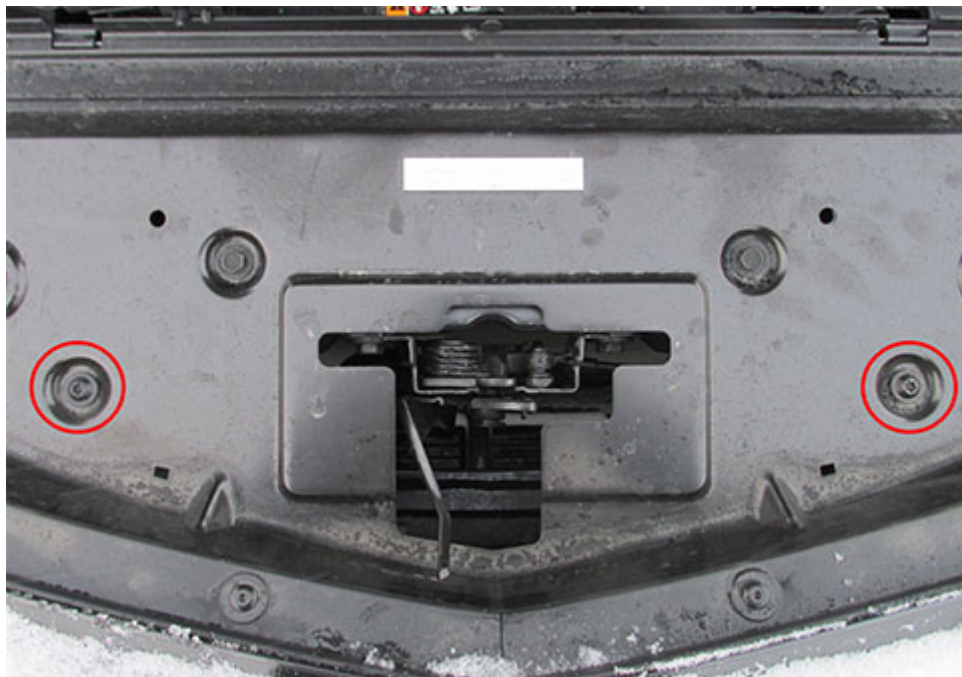
Some customers / technicians may comment that several fasteners, located on either side of the hood latch, appear to be loose.

The first photo shows both fasteners as a point of reference in relation to the hood latch.

These fasteners are part of the front fascia support bracket.

They have a preset gap by design, and they have Loctite applied to the threads of the fastener so that this preset gap does not change.

IMPORTANT: Do NOT tighten, or otherwise move these two fasteners.

These two screws are adjustable to allow for hood to fascia alignment, but they should only be adjusted if the fascia is too high or too low in reference to the hood.

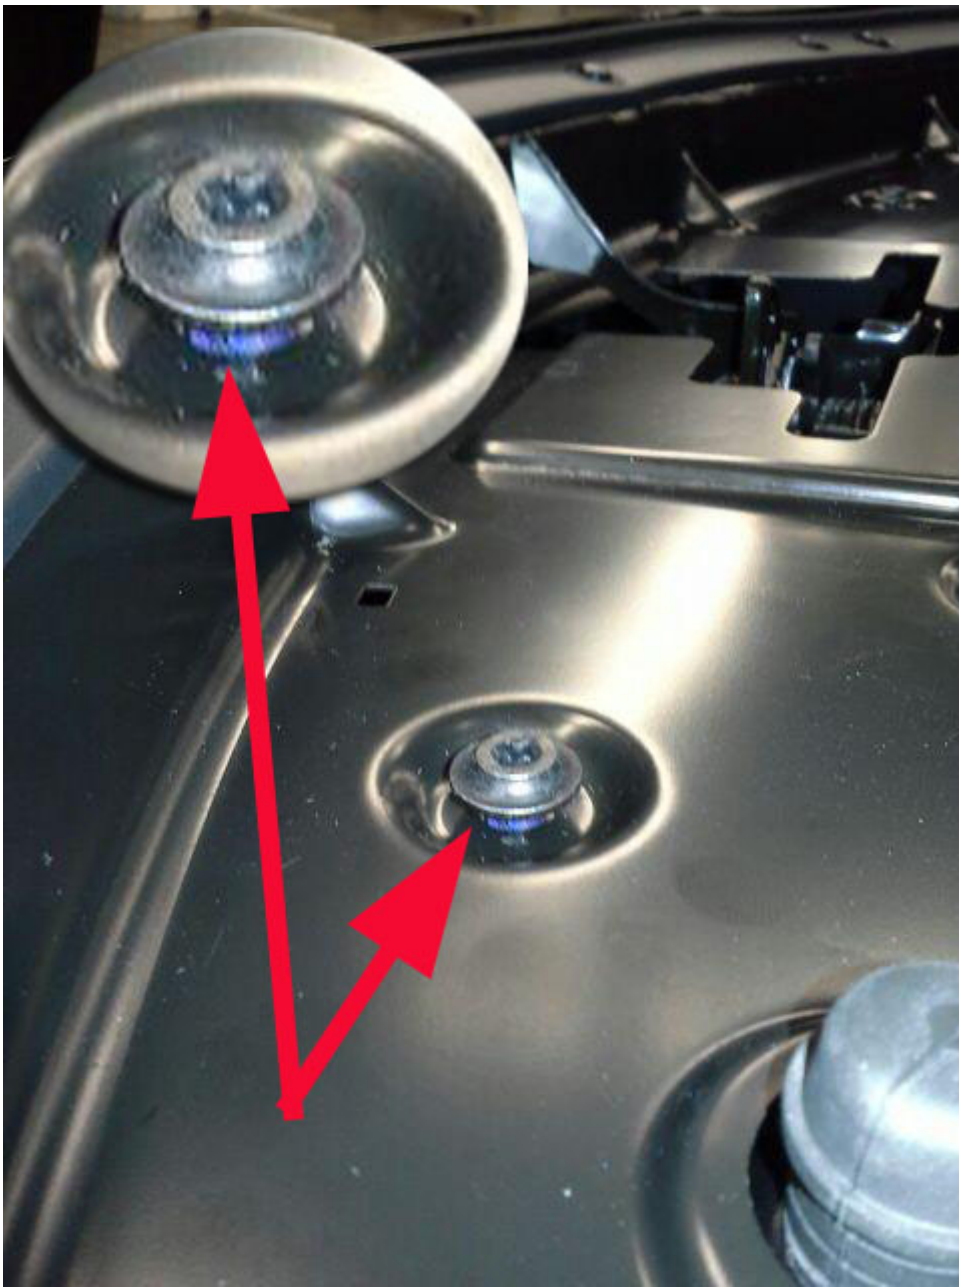
The second photo is a close-up of these fasteners to clearly show the gap that exists between the head of the fastener and the plastic trim panel underneath.
