Preliminary Information

PIT5800 Service Theft Deterrent System / SES MIL / Fuse F49DR Open / DTCs B113C, B13AC, B1AC3, B195D, B195E, U3018, U3501

Models

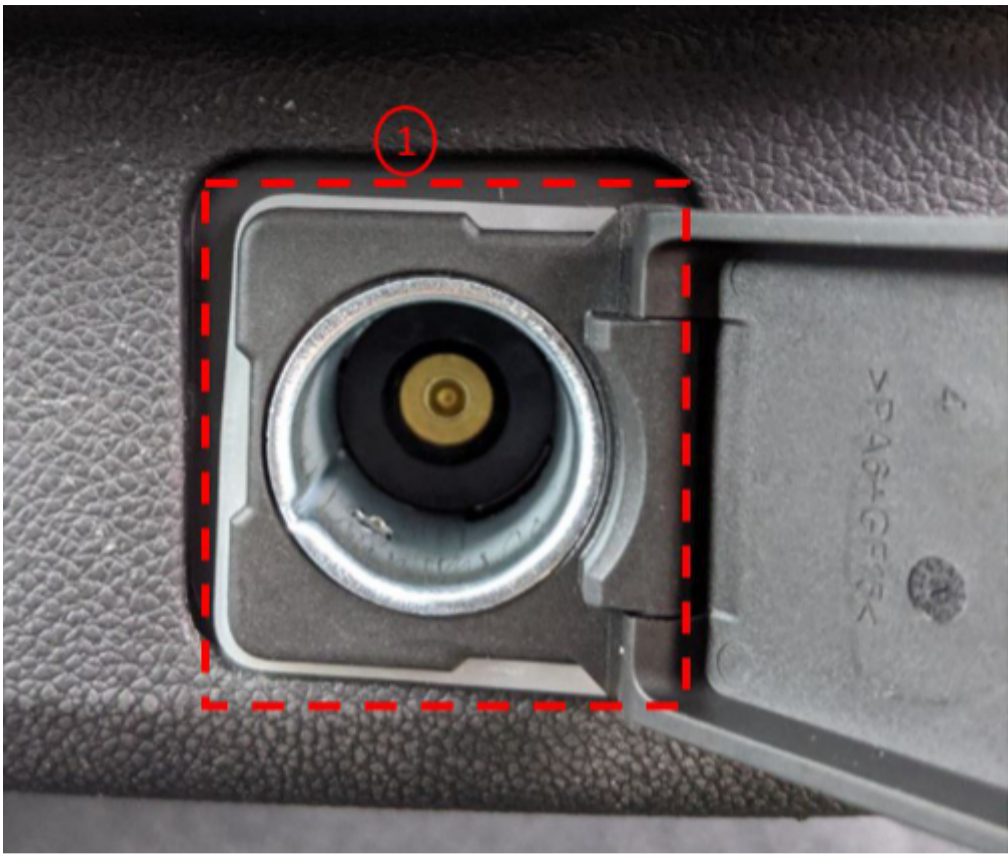
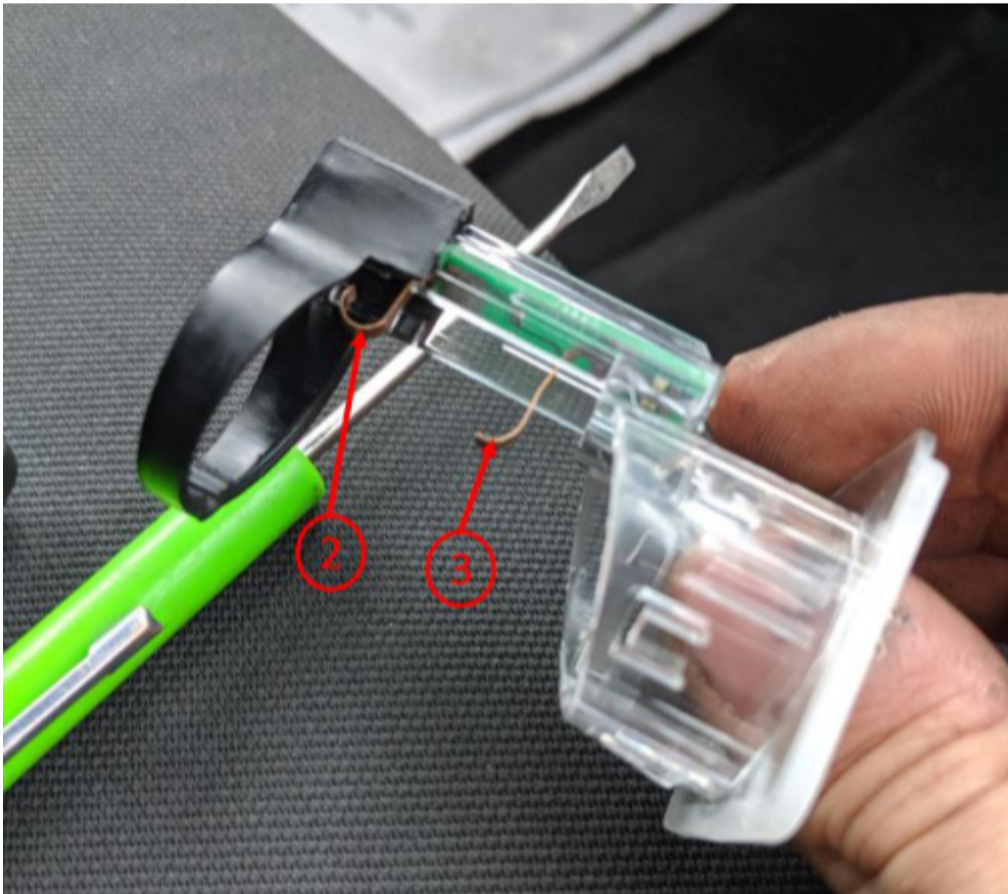
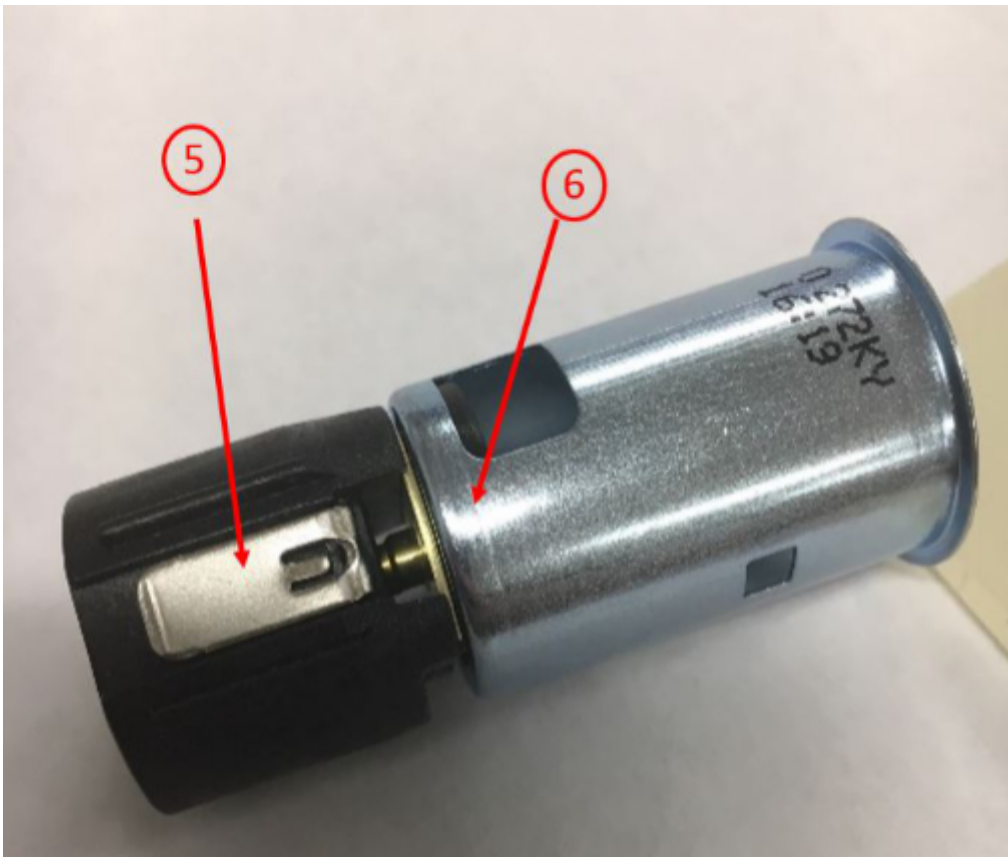
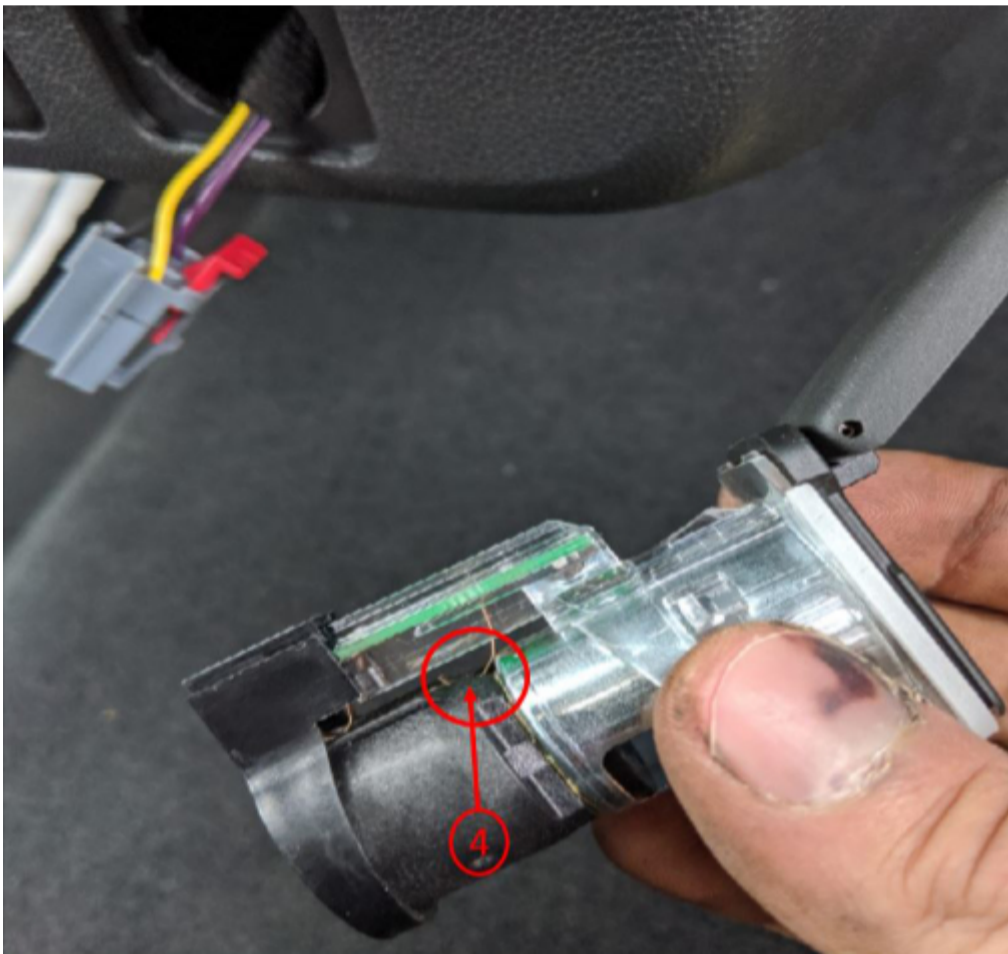
Involved Region or Country	North America
Condition	Some customers may comment on a SES MIL and a Service Theft Deterrent System message displayed in the DIC. When checking for DTC's, any of the following DTC's may be set: B113C, B13AC, B1AC3, B195D, B195E, U3018 and/or U3501. Also, fuse F49DR in the right IP fuse block will be open.
Cause	The 12 volt power accessory port X80H has a LED illuminated ring around its perimeter (1), shown below. The LED illuminated ring is part of the 12 volt accessory port receptacle retainer, see 2nd photo. The 12 volt accessory port receptacle retainer has two contact tabs for the LED illuminated ring (2 and 3) which mate to the 12 volt accessory port receptacle (5 and 6), see 3rd photo. Tab 2 is for the power to the LED illuminated ring circuit 6817 and tab 3 is the ground which should only contact the outer metal body (6) of the 12 volt accessory port receptacle. If tab 3 is improperly formed or gets bent, it can short out between the metal body (6) and the slide contact (5) for tab 2, as shown below in call out 4. Tab 3 should only contact the metal body of the 12 volt accessory port receptacle (6).

Following SI, remove the 12 volt power accessory port X80H and inspect grounding tab 3. If the tab is shorting out between the metal body (6) and slide contact (5) for tab 2 then replace the 12 volt Accessory Power Port Receptacle Retainer.
