Preliminary Information

PIP5764 3.0L Diesel with DTC P2B60

Models

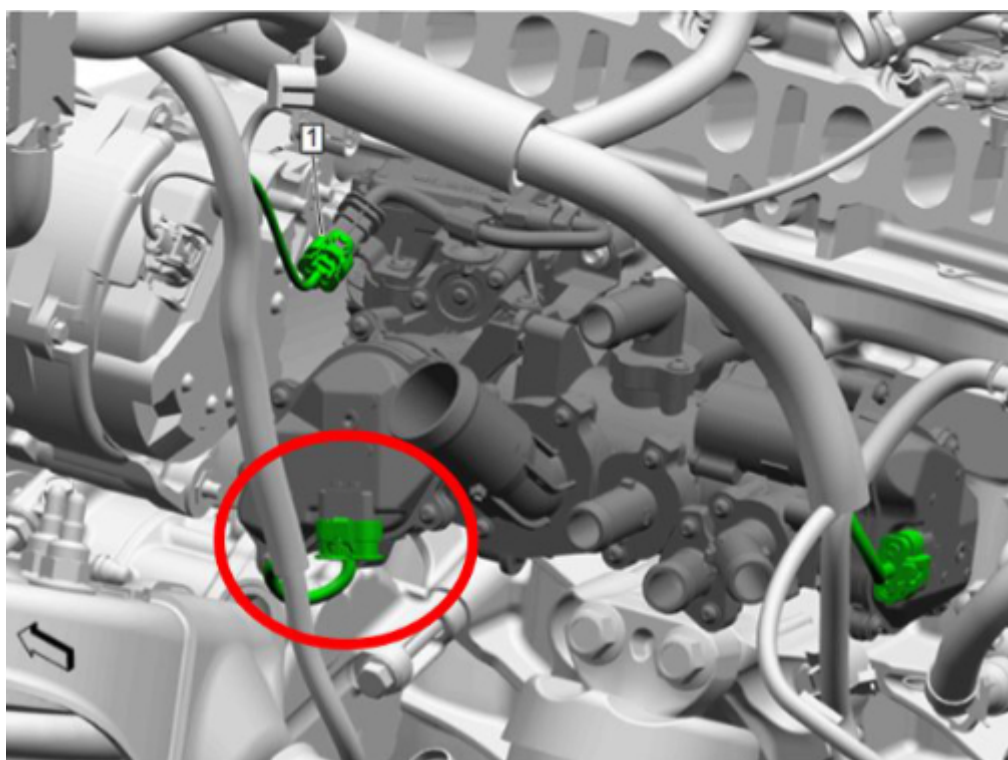
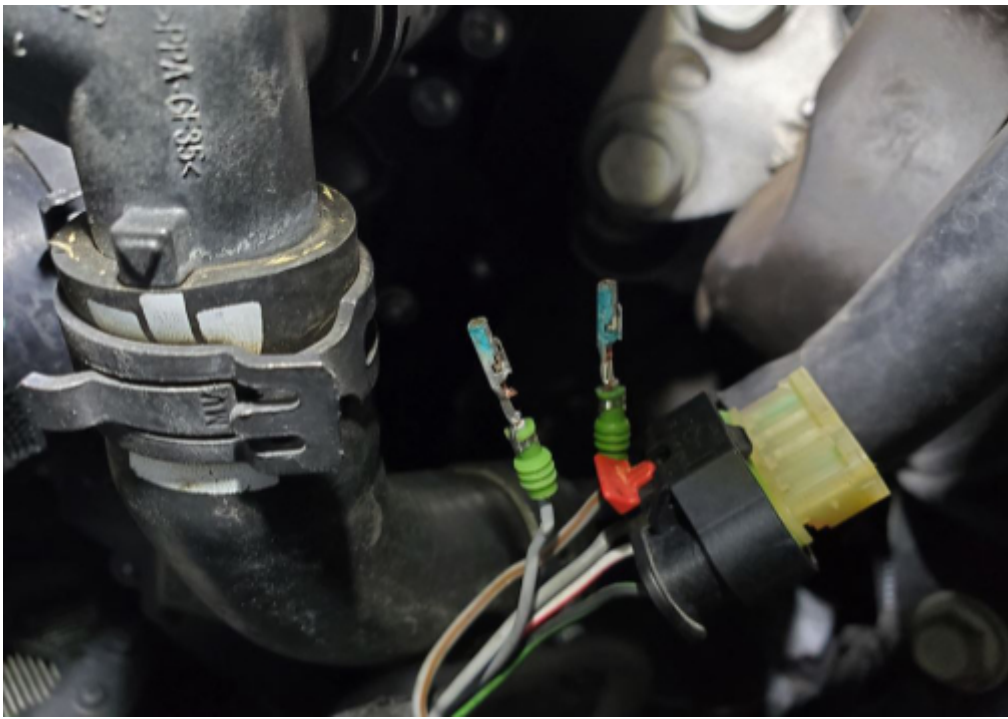
Involved Region or Country	North America
Condition	SES Light On with DTC P2B60 set.
Cause	Possible terminal corrosion in the Coolant Flow Control Valve Actuator harness connector

1. Inspect for corroded terminals at the Flow Control Valve Actuator connector (it's the center actuator circled below). If corrosion on the terminals is found, replace the harness connector and inspect the Flow Control Valve Actuator pins for corrosion damage.
2. If the actuator pins are also corroded, replace the Coolant Control Valve.
3. If there is no corrosion on the connector terminals or the pins, continue with normal SI diagnostics.
