Preliminary Information

PIT5801 Diagnostic Tip / Vehicle Sits Unlevel / Leans / Sags / Leveling Unavailable Message / Speed Limited Message / Service Air Suspension Message / DTC C1190 C1191 C1192 C1193 C1187 C1188 C1189 C118A C118B C118C C118E C118F

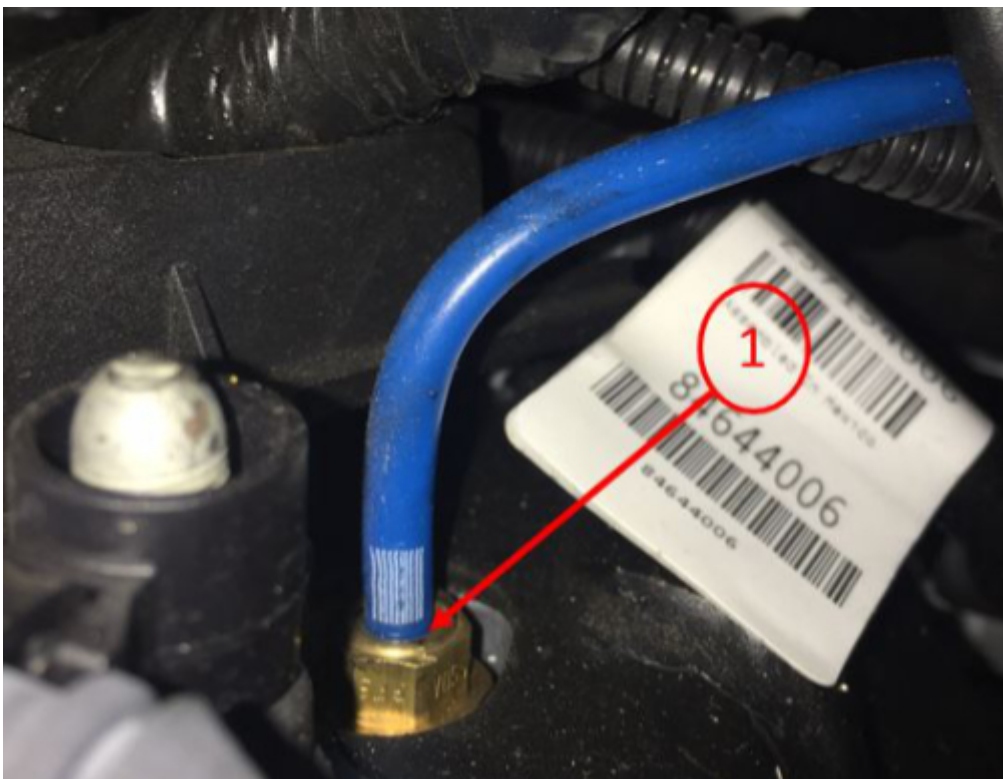
Involved Region or Country	North America
Additional Options (RPO)	F47 - Air Ride Suspension
Condition	<p>Some customers may notice one or more of the following conditions related with the air ride suspension.</p> <ul style="list-style-type: none"><li>- Vehicle suspension trim height is too high or too low at one or more corners.</li><li>- DIC Messages "Leveling Unavailable", "Service Air Suspension" and/or "Speed Limited"</li><li>- DTC's: C1190, C1191, C1192, C1193, C1187, C1188, C1189, C118A, C118B, C118C, C118E, C118F</li></ul>
Cause	<p>The cause of these concerns could be one or more of the air lines not being fully seated into an air spring or air manifold block assembly. An air line that is not fully seated can cause the air spring to be either over inflated or under inflated.</p> <p>It can be easy to understand and explain why an air line that is not fully seated can cause an air spring to be under inflated, due to the air leaking out, but over inflated air springs will require some additional details. The air springs use a unique air line fitting that contains a one way check valve. This one way check valve was needed for manufacturing purposes to keep a small amount of air inside the air spring before it is installed on the vehicle. Once the air spring is installed in the vehicle and the air line is fully seated into the air spring fitting, the one way check valve is no longer needed and the air line holds the check valve open. If the air line is not fully seated into the fitting, it will not fully open the one way check valve. When this happens, air can be pushed past the one way check valve into the air spring, but air can not be released. This will cause the air spring to inflate but during a deflate it cannot release the air from inside the air spring.</p> <p>Because it is critical for the air lines to be fully seated into the air fittings, there are white marks on each air line to indicate when the air line is fully seated. The air line has to be inserted into the air fitting until it bottoms out AND the white marks are going into the top of the fitting. Below is a picture of an air line, at one of the air springs, which is NOT fully seated (1). This is indicated by the white markings not actually going into the fitting. The second photo below shows the air line after it was fully seated (2). You can see the white marks are now down into the top of the air line fitting (2) and the air line is bottomed out in the fitting.</p>

**NOTE:** It is recommended to push the line into the fitting as far as it will go. At least part of the white marking **MUST** be into the top of the fitting.

Typically, performing a very thorough inspection of each air line at the four shocks and manifold valve block will prove to be the most fruitful way at discovering the root cause within the system. Make sure the white marking on each air line is into the top of the fitting and that the air line is bottomed out in the fitting, as both shown and described above. If an air line is not fully seated, then push the air line into the fitting until it is fully seated and the white marking is into the top of the fitting. In most cases, there is no need to loosen the air line fitting to fully seat the air line.

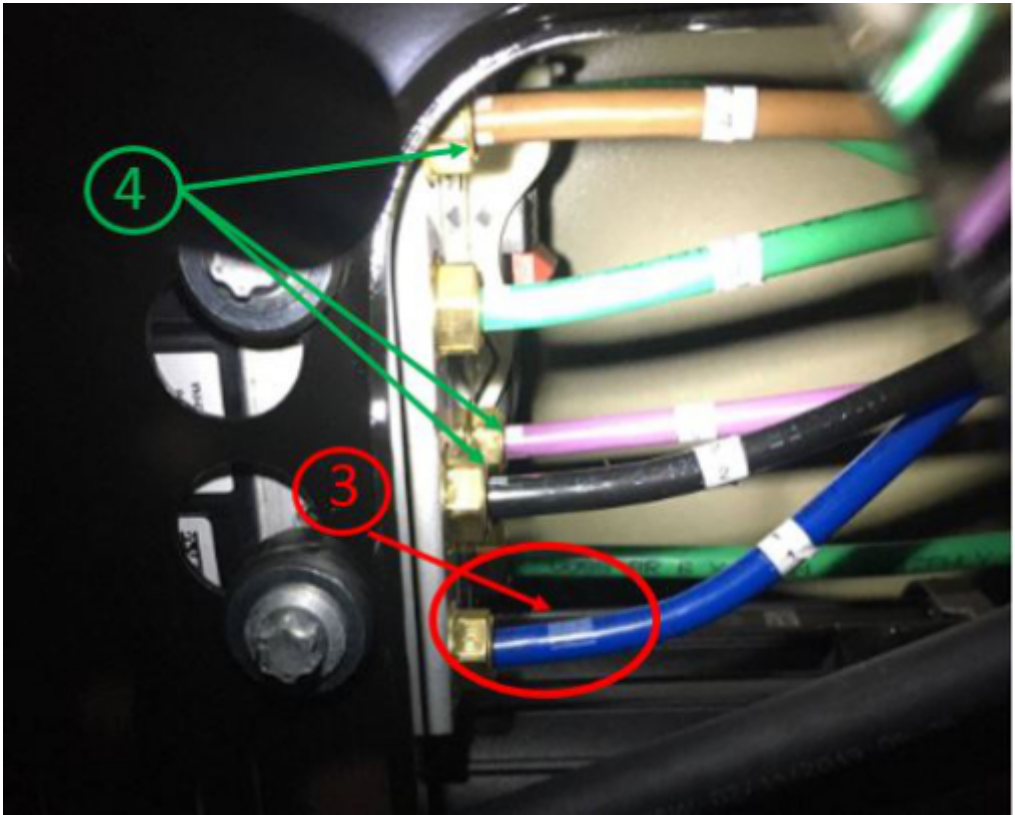
For additional examples see the third photo below. This is a picture of the air lines at the air manifold block. In this example, there are several fully seated lines as shown in call out 4. Each of these lines are fully seated as indicated by the white markings being into the top of the air line fitting. Call out 3 is an example of a line that is not fully seated. In call out 3 you can see the white marking is not into the air line fitting as it should be.
