TECHNICAL SERVICE BULLETIN

Water Leak In Rear Of Vehicle And/Or Spare Tire Area

20-2425
14 December 2020

Ford 2020-2021 Explorer
Lincoln 2020-2021 Aviator

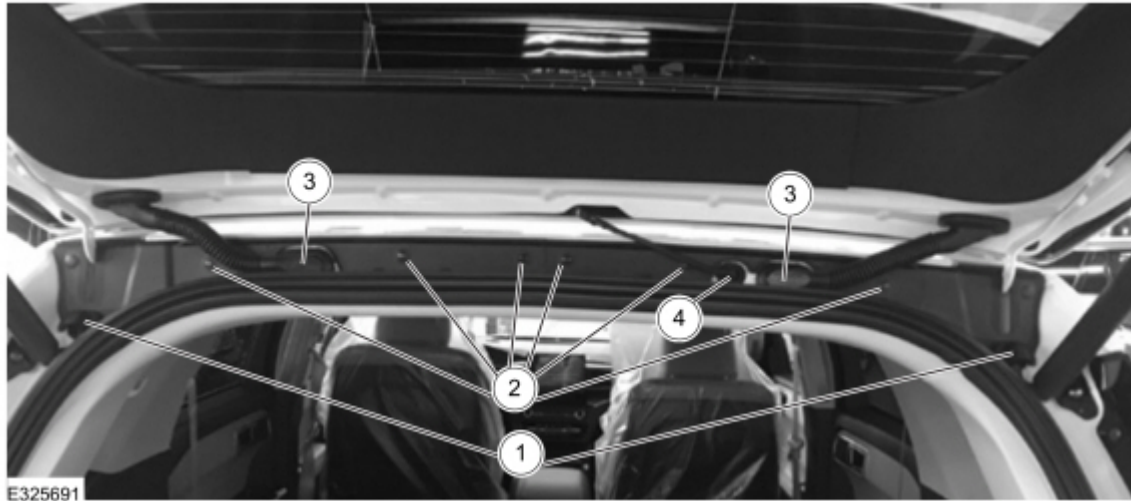
Figure 1

1. Open the rear liftgate.
2. Inspect the following for being loose, disconnected or missing:
 - (1). Power liftgate grommet (if equipped). (Figure 1 Callout 1, Figure 2)

- (2). Margin seal and margin seal pushpins. (Figure 1 Callout 2, Figure 3 Callout 2)
- (3). Electrical wiring grommet. (Figure 1 Callout 3, Figure 3 Callout 3)
- (4). Rear washer hose. (Figure 1 Callout 4, Figure 3 Callout 4)

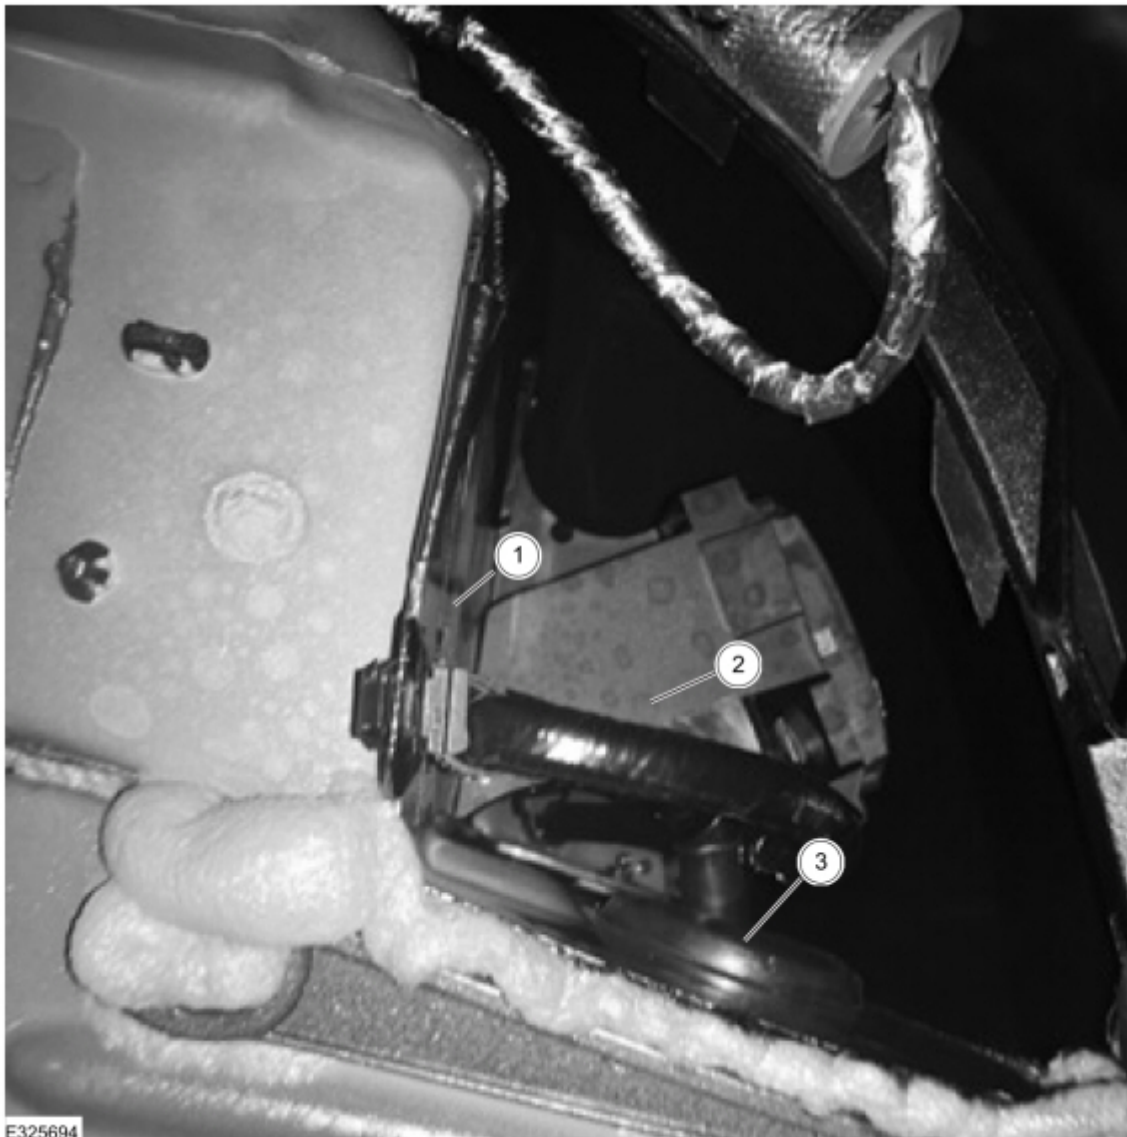
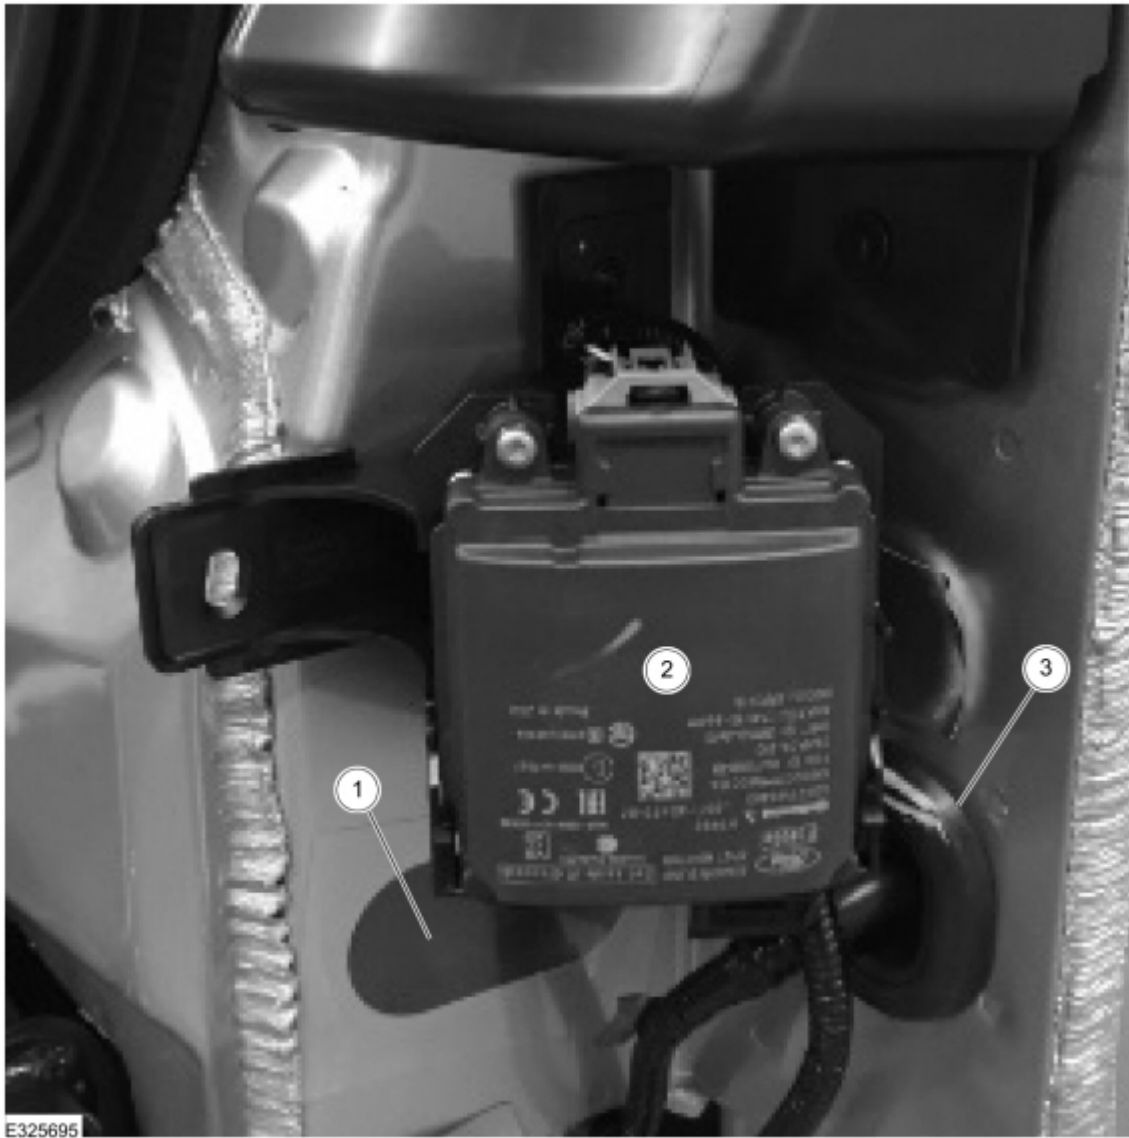
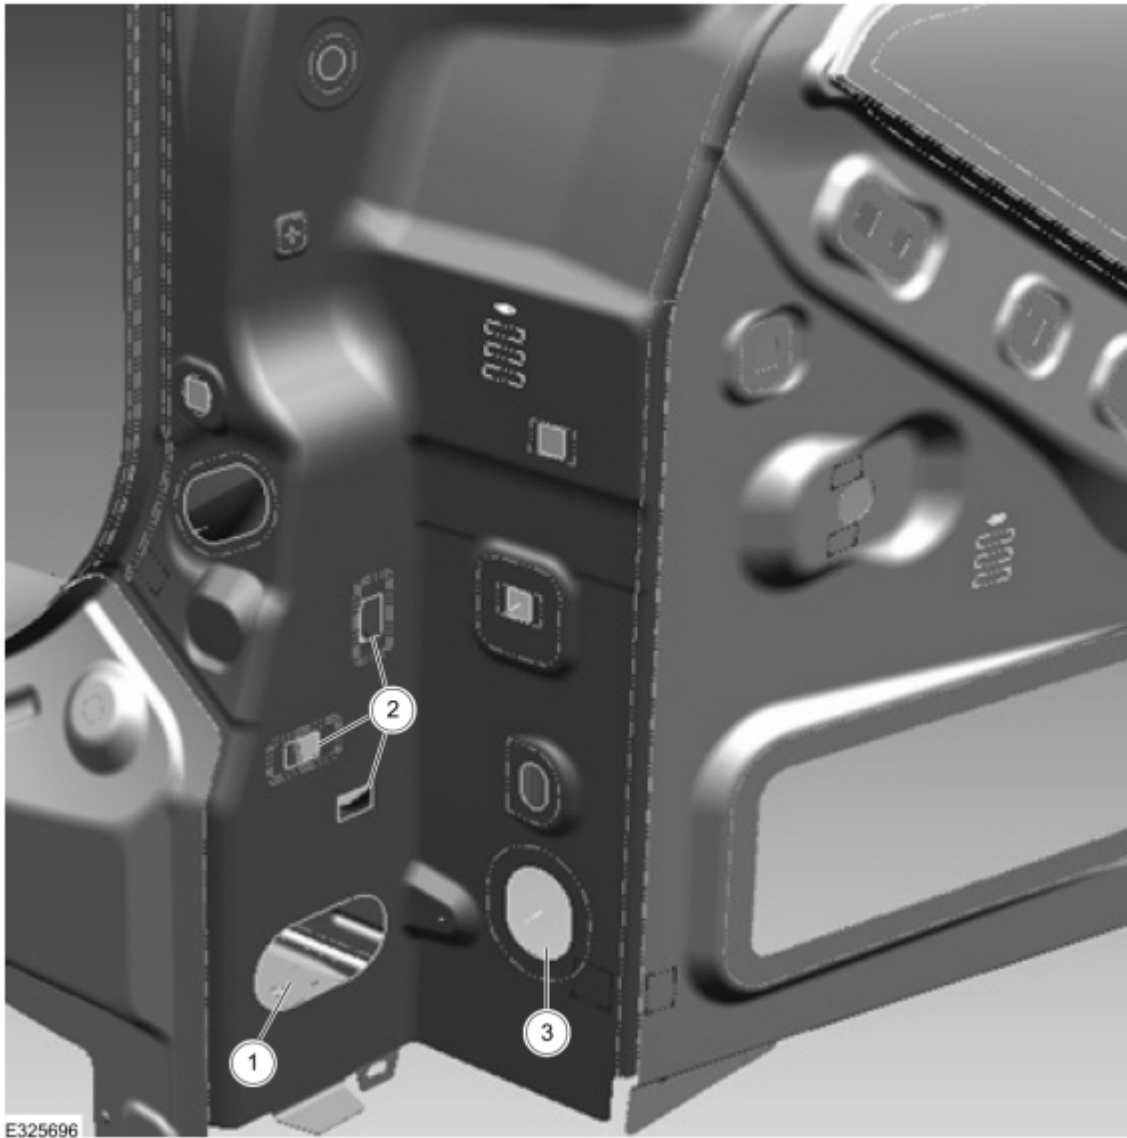
4. Inspect the right side rear corner area under the rear bumper cover for the following loose, disconnected, or missing items:

- (1). Visually inspect for delete tape completely covering the body hole. (Figures 4-6 Callout 1)
- (2). Press down on the blind spot information system (BLIS) module to make sure the BLIS module is fully seated into the body. (Figures 4-6 Callout 2)
- (3). Visually inspect the BLIS module harness wire grommet is seated. (Figures 4-6 Callout 3)

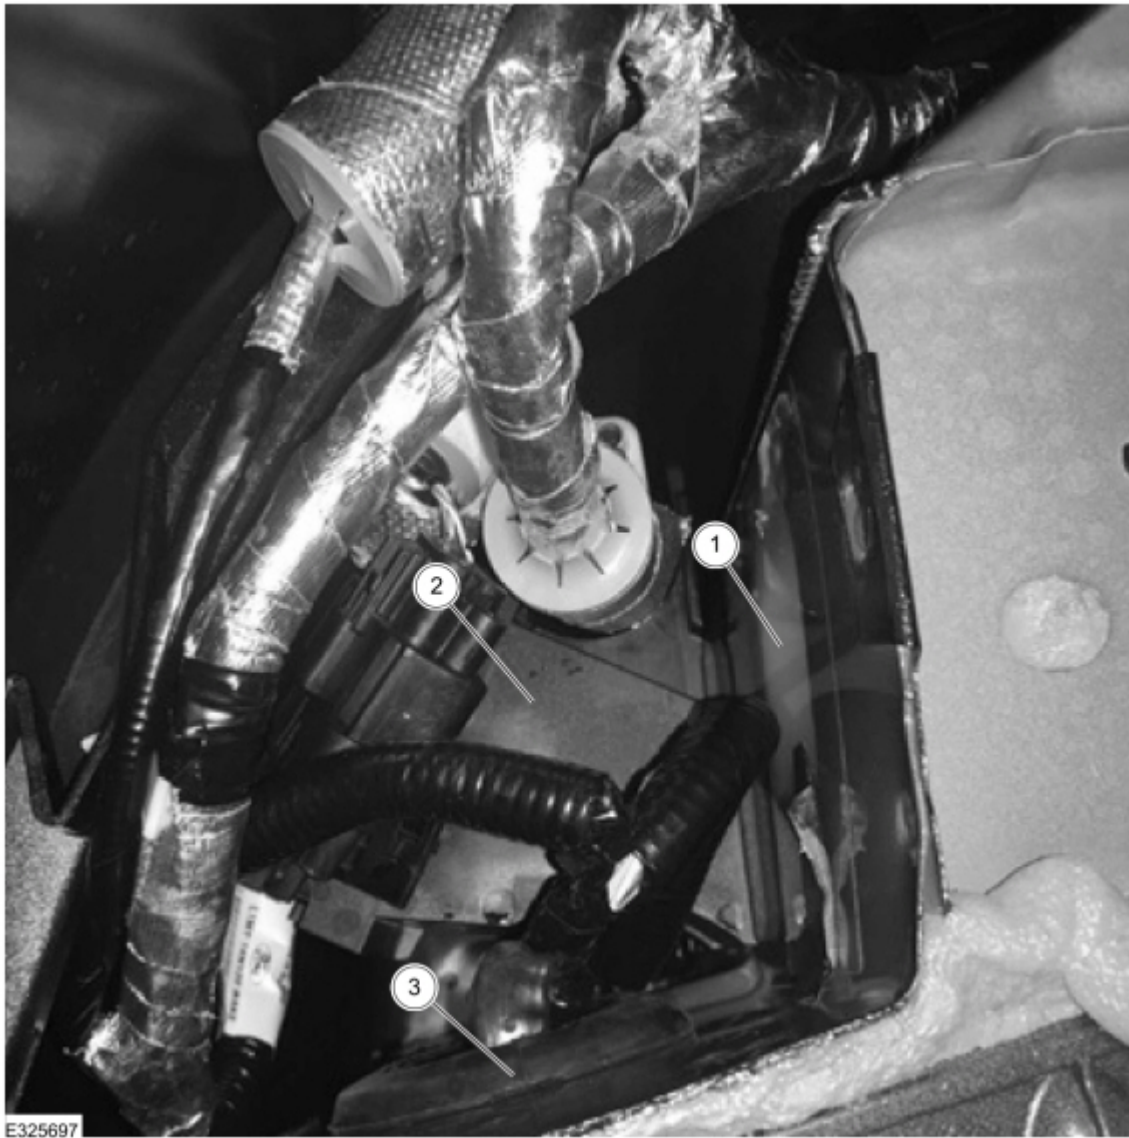
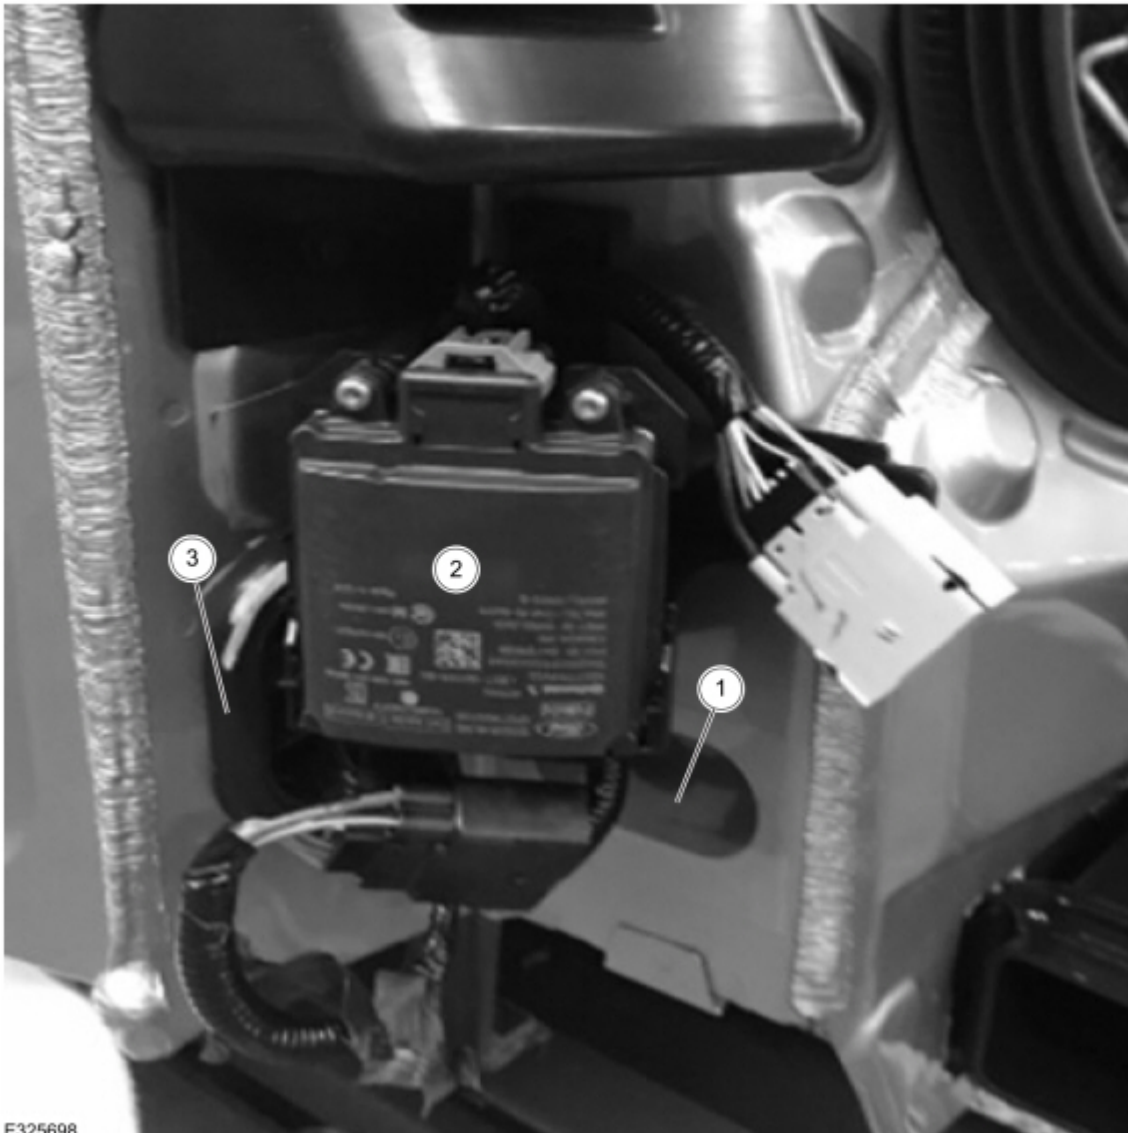
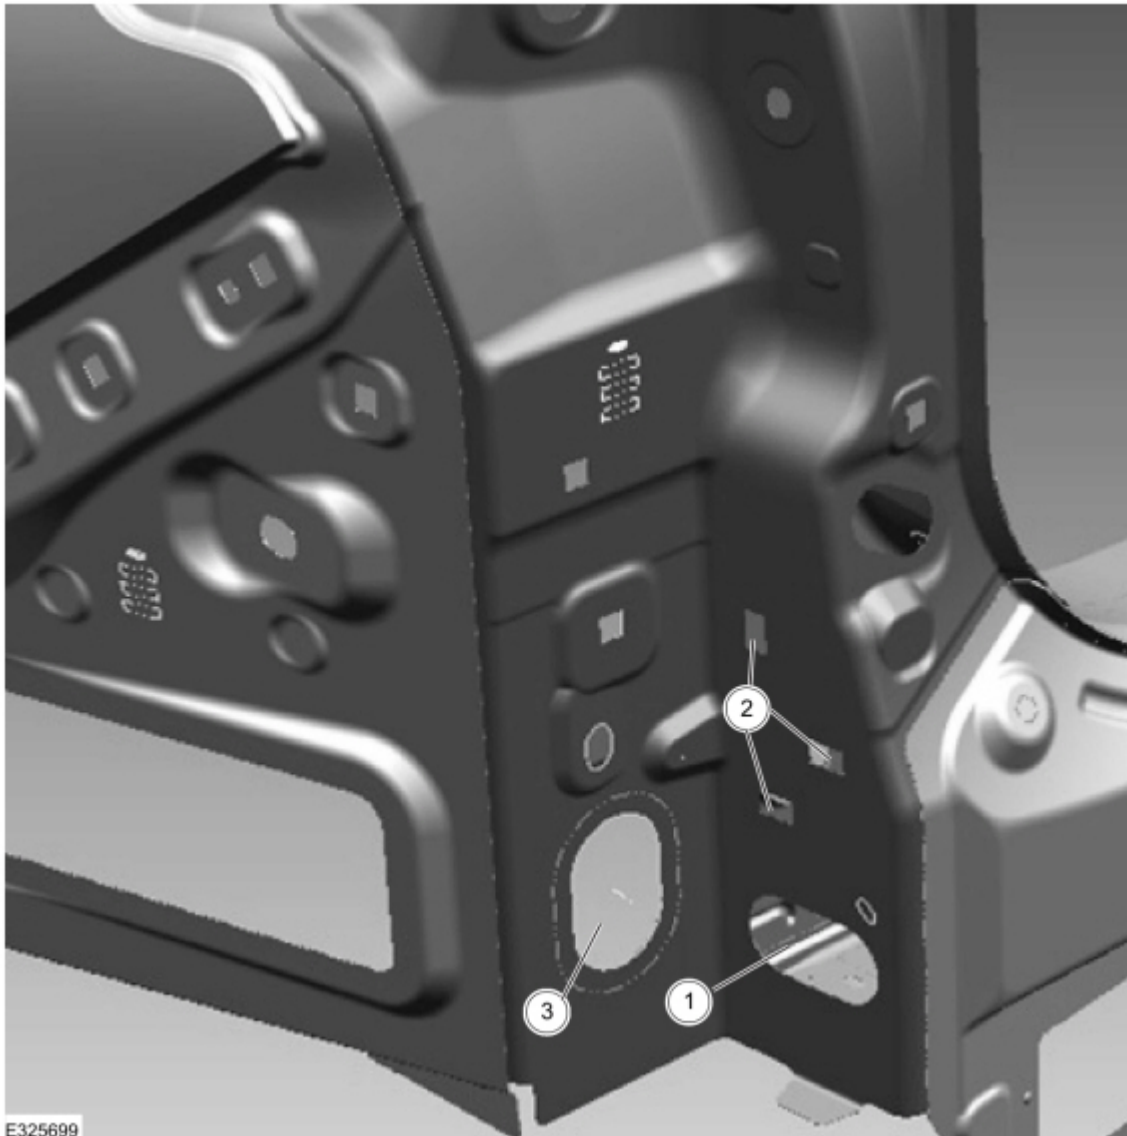
5. Inspect the left side rear corner area under the rear bumper cover for the following loose, disconnected, or missing items:

- (1). Visually inspect for delete tape completely covering the body hole. (Figures 7-9 Callout 1)
- (2). Press down on the BLIS module to make sure the BLIS module is fully seated into the body. (Figures 7-9 Callout 2)
- (3). Visually inspect the BLIS module wire harness grommet is seated. (Figures 7-9 Callout 3)

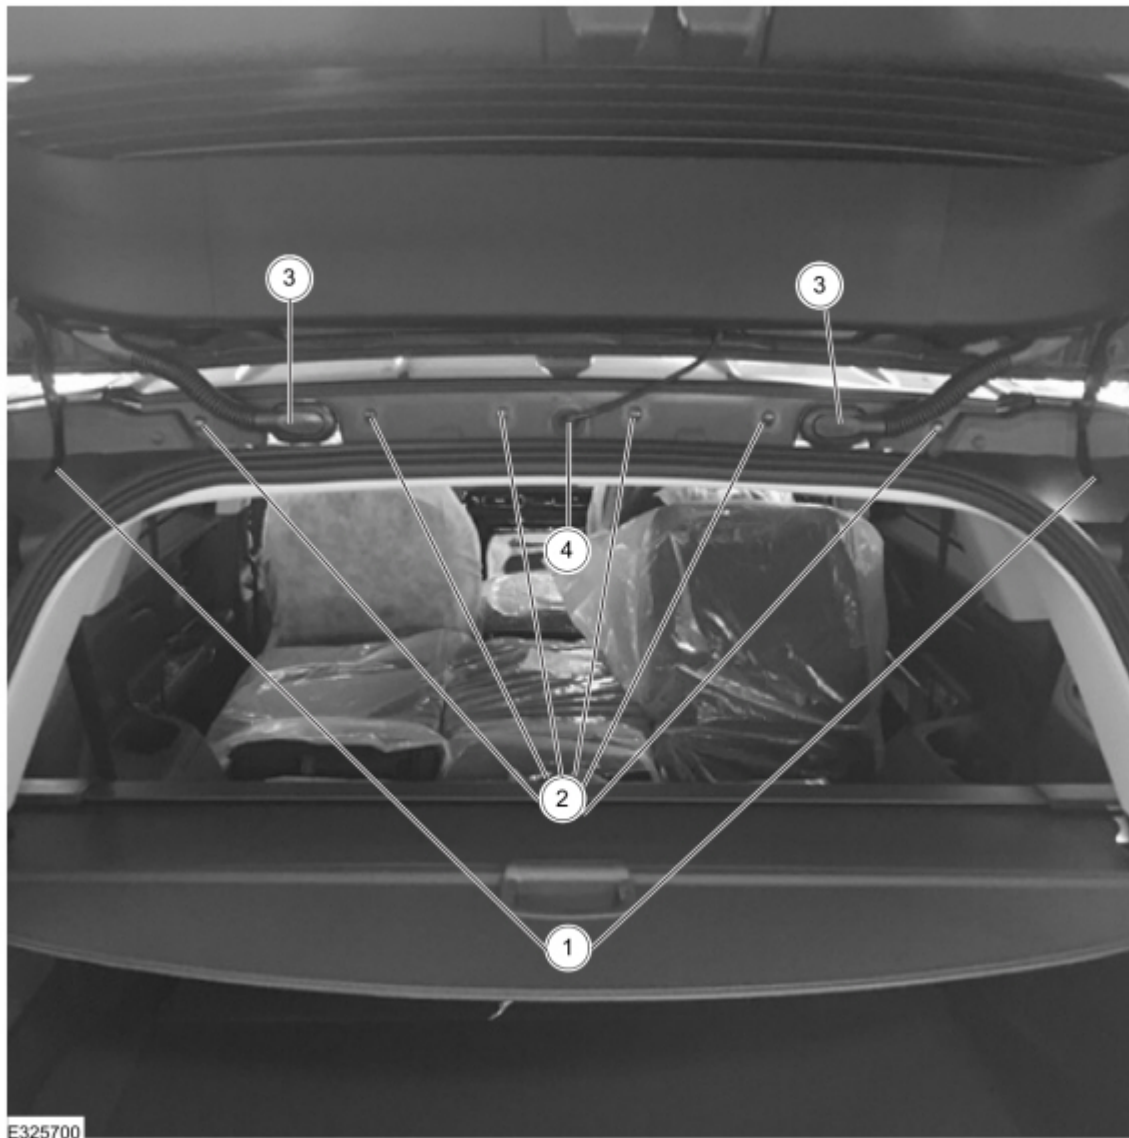
Figure 10

1. Open the rear liftgate.
2. Inspect the following for being loose, disconnected or missing:
 - (1). Power liftgate grommet. (Figure 10 Callout 1, Figure 11)
 - (2). Margin seal and margin seal pushpins. (Figure 10 Callout 2)
 - (3). Electrical wiring grommet. (Figure 10 Callout 3)
 - (4). Rear washer hose. (Figure 10 Callout 4)

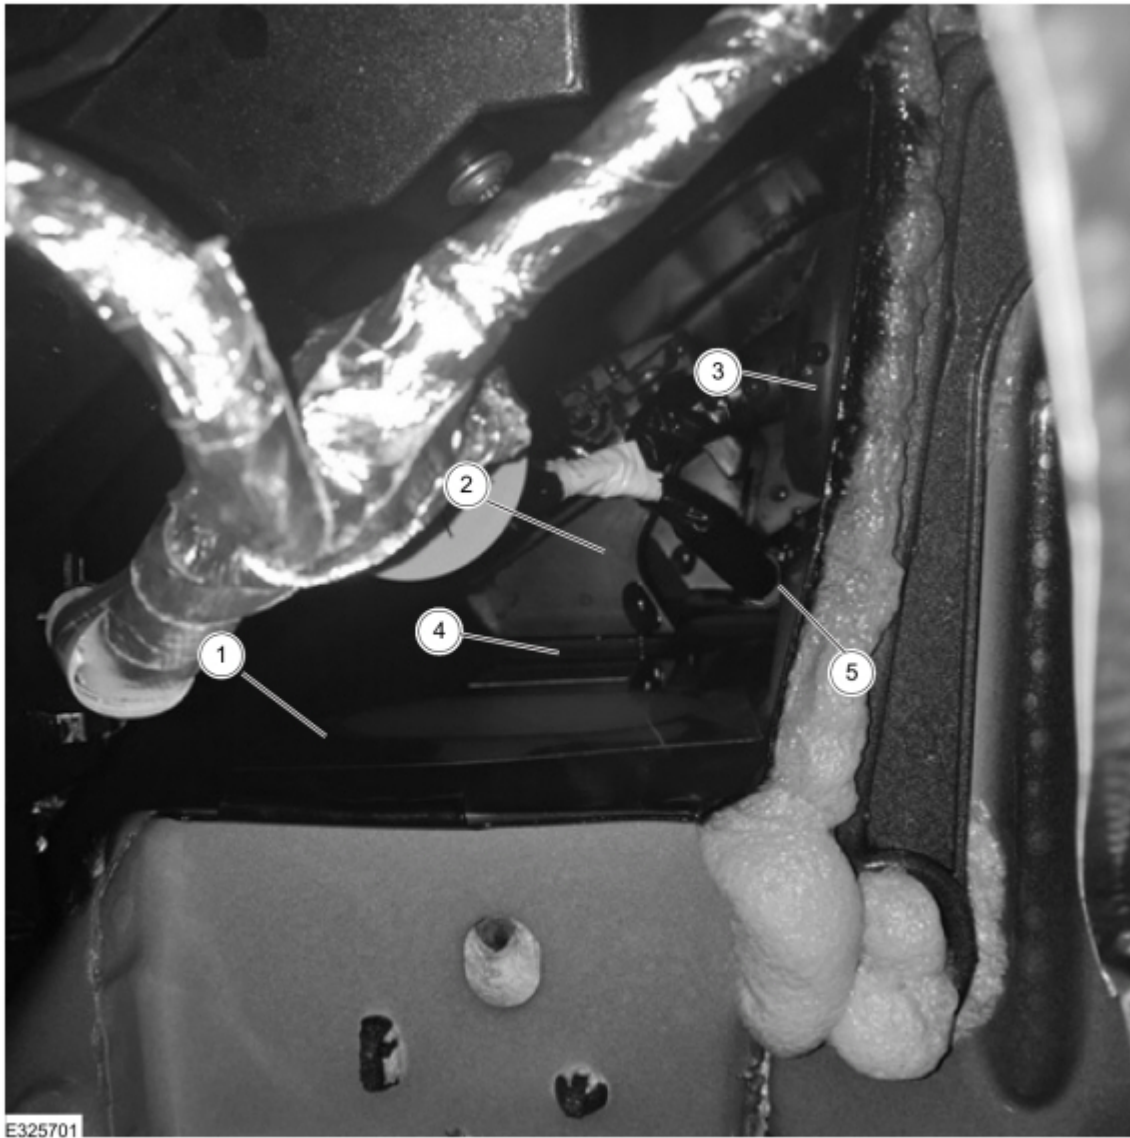
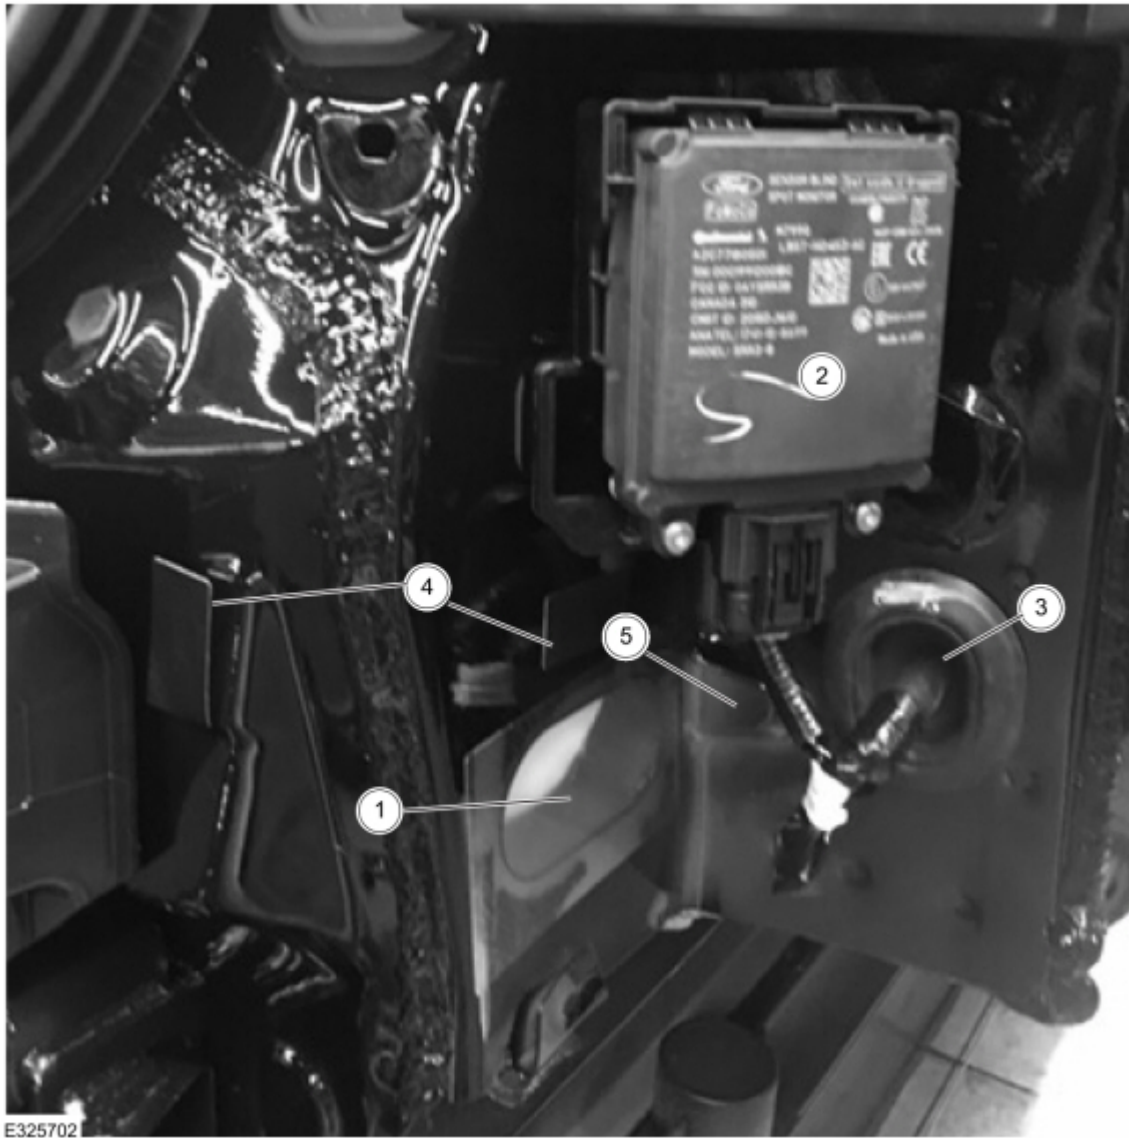
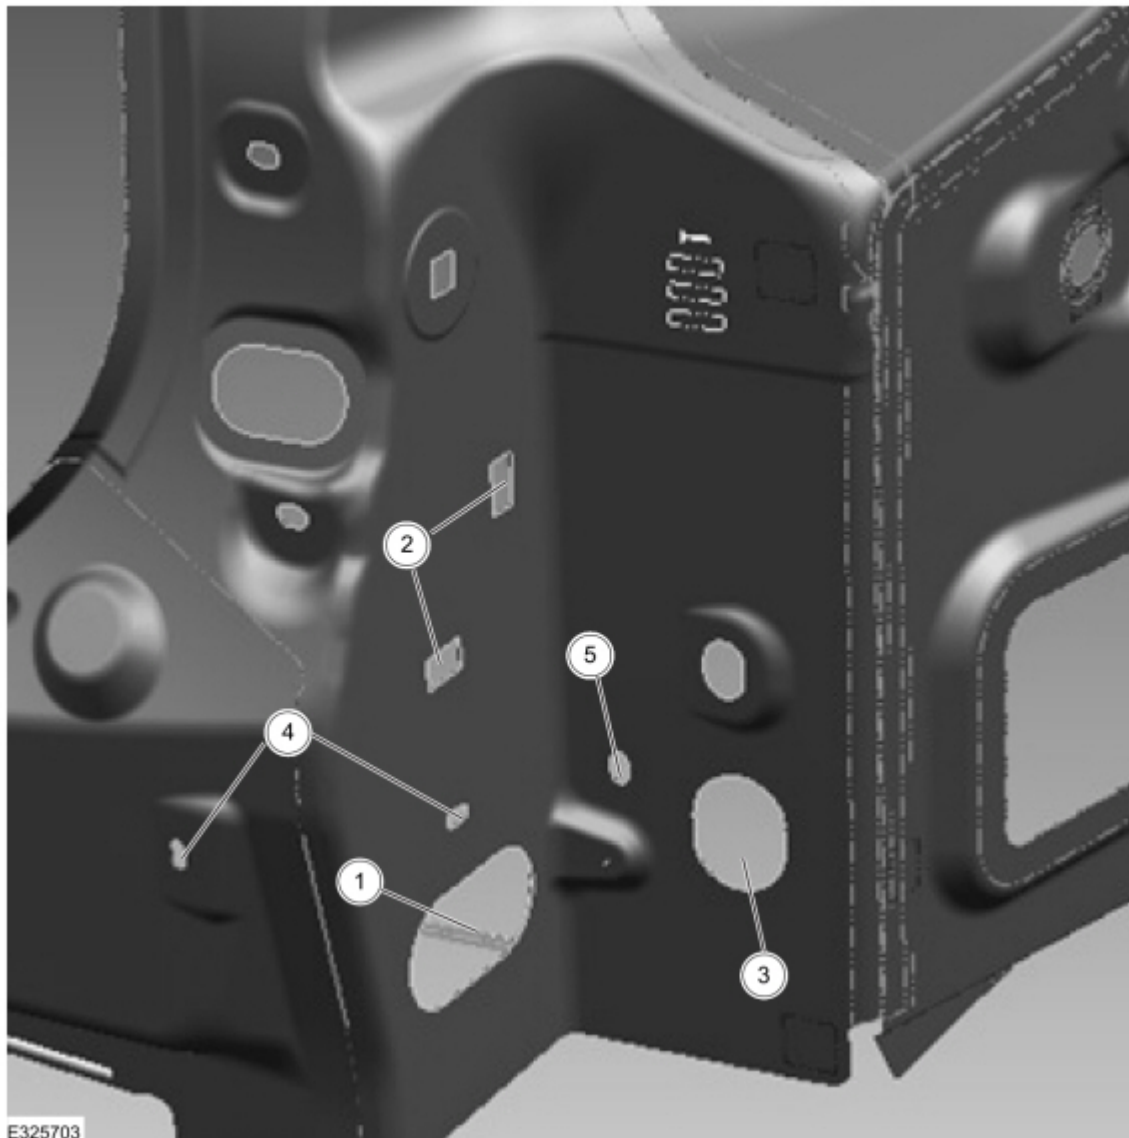
3. Raise the vehicle on a hoist.
4. Inspect the right side rear corner area under the rear bumper cover for the following loose, disconnected or missing items:
 - (1). Visually inspect for delete tape completely covering the body hole. (Figures 12-14 Callout 1)
 - (2). Press down on the BLIS module to make sure the BLIS module is fully seated into the body. (Figures 12-14 Callout 2)
 - (3). Visually inspect the BLIS module wire harness grommet is seated. (Figures 12-14 Callout 3)
 - (4). Make sure the wire harness grommet for the phone as a key feature is seated or the delete tape is completely covering the body hole. (Figures 12-14 Callout 4)
 - (5). BLIS grommet to module wire. (Figures 12-14 Callout 5)

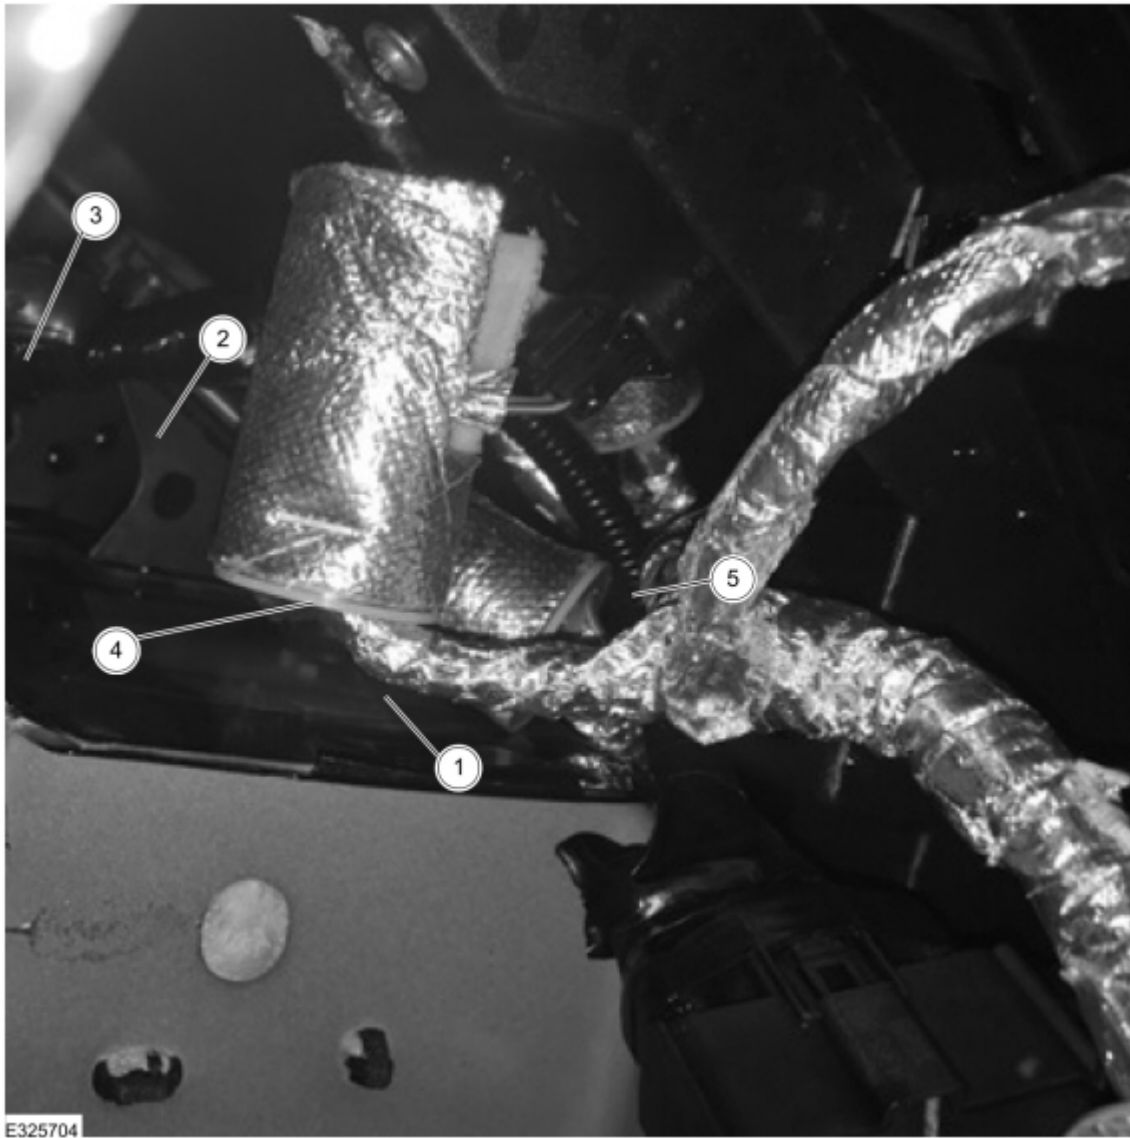
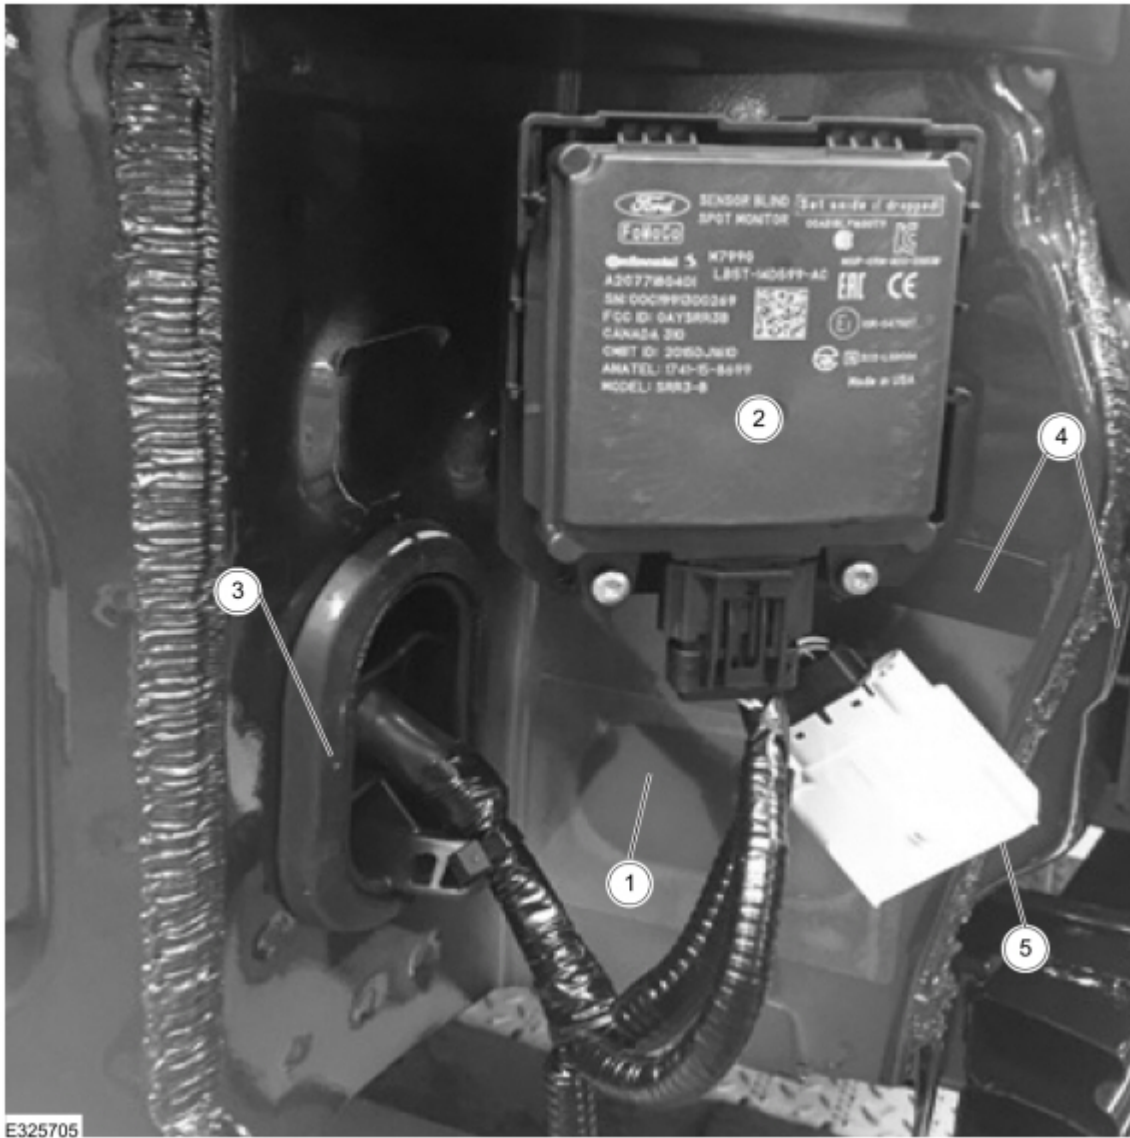
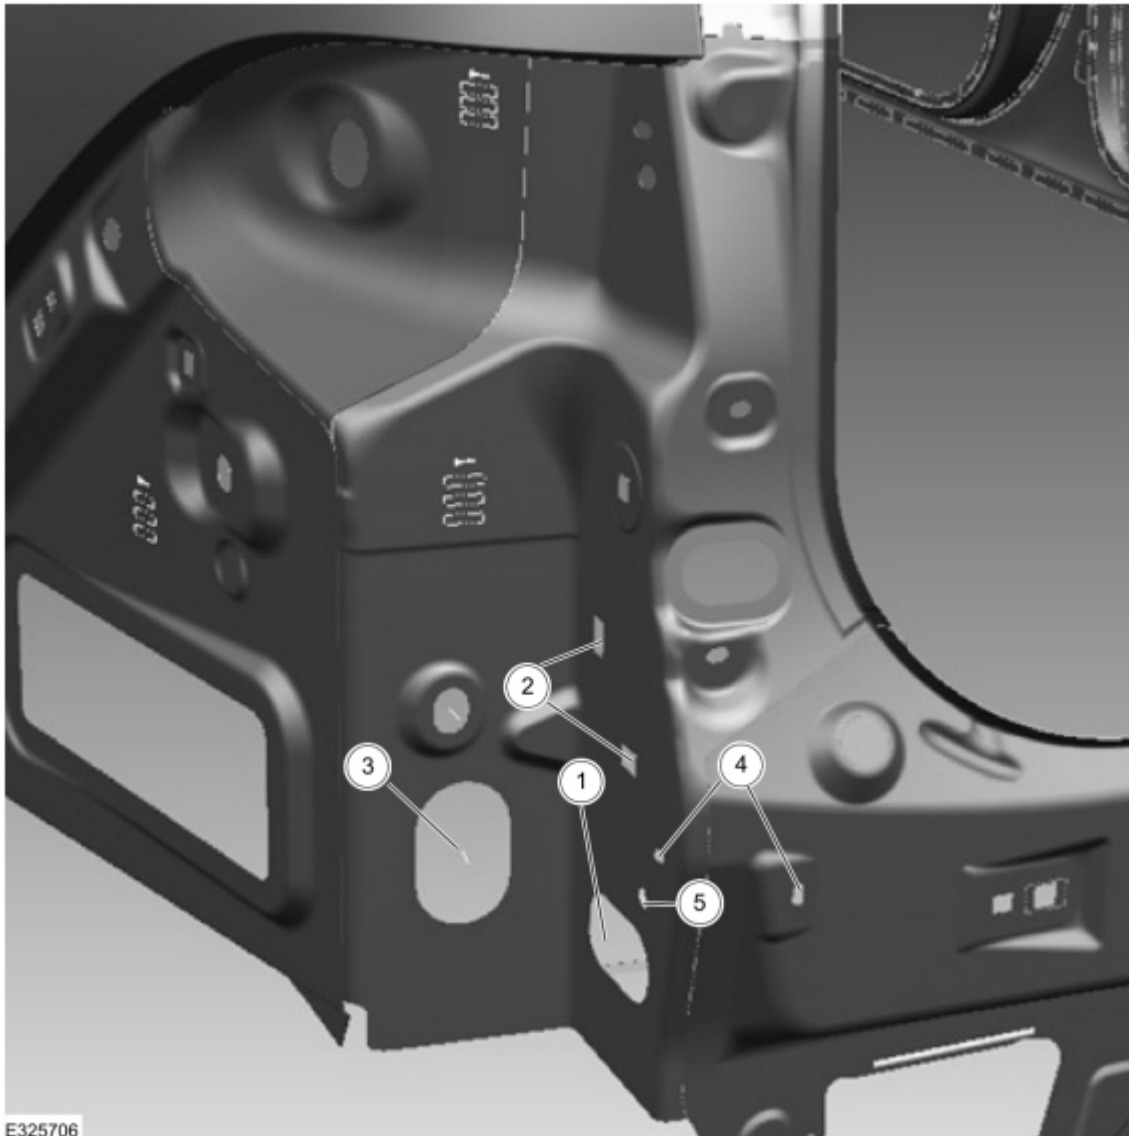
5. Inspect the left side rear corner area under the rear bumper cover for the following loose, disconnected or missing items:

- (1). Visually inspect for delete tape completely covering the body hole. (Figures 15-17 Callout 1)
- (2). Press down on the BLIS module to make sure the BLIS module is fully seated into the body. (Figures 15-17 Callout 2)
- (3). Visually inspect the BLIS module wire harness grommet is seated. (Figures 15-17 Callout 3)
- (4). Make sure the wire harness grommet for the phone as a key feature is seated or the delete tape is completely covering the body hole. (Figures 15-17 Callout 4)
- (5). Rear fascia wire. (Figures 15-17 Callout 5)
