SERVICE BULLETIN

APPLICABILITY: 2020MY Legacy and Outback
SUBJECT: Denso Gen 4 Cockpit One (CP1) Infotainment System Operating TIPS

NUMBER: 15-259-20R
DATE: 02/19/20
REVISED: 12/01/20

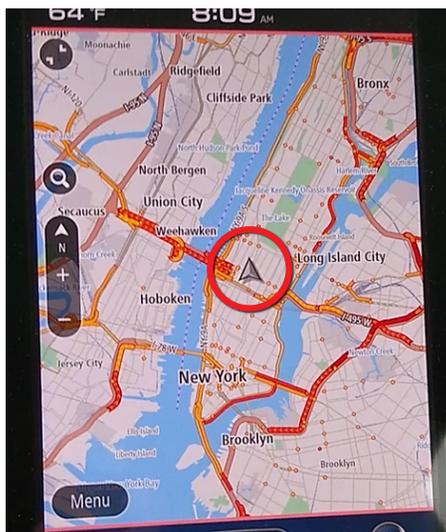
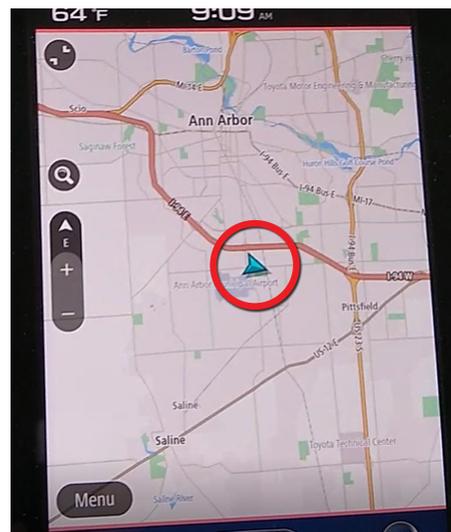
It is possible during Delivery Mode for the NAVI GPS display to show Manhattan, NY location all the time. This is a default setting for GPS in this mode. Other indicators of Delivery Mode are:

Following Delivery Mode or Memory Initialization
(map arrow is gray).

Normal Operation (map icon is blue/green).

If a vehicle presents with this concern, inform the customer that the map icon will change to cyan (blue/green) and the clock will reset to the correct time as soon as the GPS module receives the current vehicle location. In a case where the vehicle location shown on the Navigation screen does not update to show the correct location and the clock remains inaccurate, perform the applicable diagnostics to confirm the GPS antenna integrity and secure harness connection.

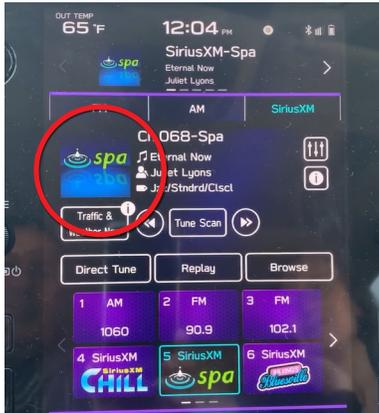
It is a normal operating characteristic for the SXM station artwork to disappear from the CP1 / Gen 4 Infotainment system display whenever the vehicle is in motion. Artwork is restored when the vehicle stops.

Artwork is displayed when stopped or parked.

Explain to customers questioning this condition that it is a normal operating characteristic intended to reduce distraction. Replacing the head unit will not change this characteristic.

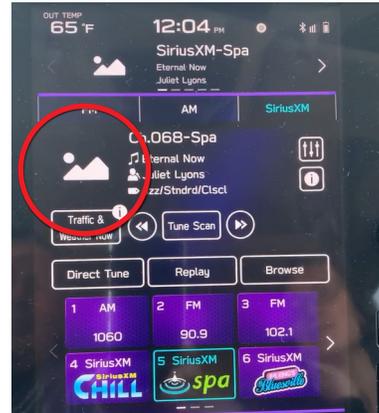
Artwork is NOT displayed when moving.

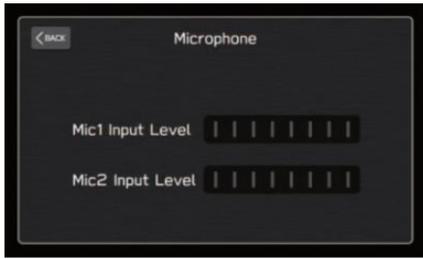
When performing the diagnostic checks for microphone operation using DIAGNOSTICS MODE (Dealership Mode/ Function Check/Microphone), the level gauge reading may appear weaker than expected or what may have been seen during prior testing. In some cases, a time lag or no or just one bar may be displayed when speaking into the microphone. This can occur both input levels and does not necessarily indicate a concern with the microphone.

Lower Display Screen on
"Base" Models

There is a known bug with the RC2003 software update released in June 2020. See Appendix B in TSB 15-261-20R to confirm if the software of the unit being repaired is impacted by this bug. This bug affects only the display of the microphone test and in no way impacts actual microphone operation.

With the microphone display being impacted, it is recommended to use other diagnostic methods. Alternatively, troubleshoot the microphone operation using the Voice Recognition feature to confirm the unit receives voice input correctly or, make a voice call. If concerns remain, perform continuity and voltage drop testing to confirm if a poor contact or connection may exist. Reference the applicable Service Manual for related wiring diagrams for the Cockpit Control Module and microphone wiring diagrams, with or without Telematics depending upon the vehicle.

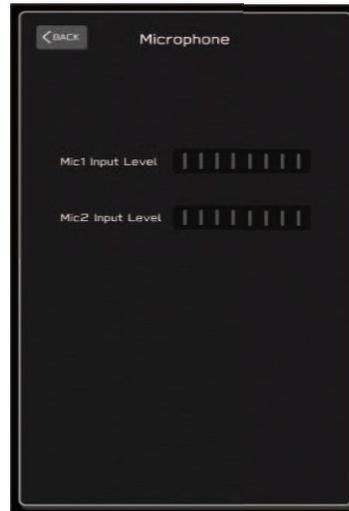
Display Screen on "Mid"
and "High" Models

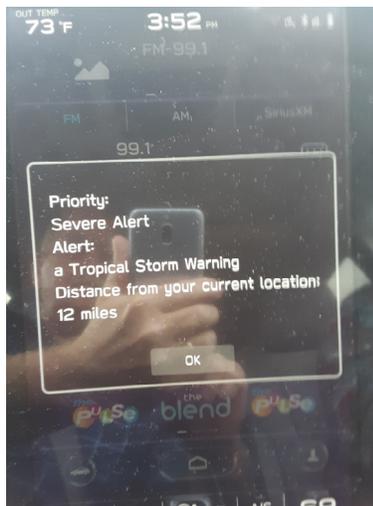
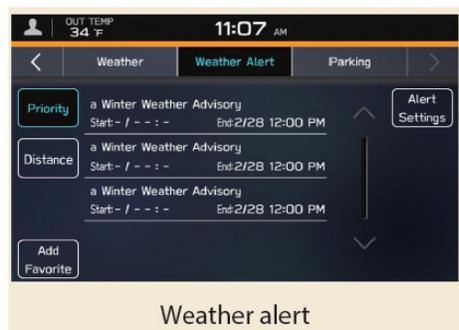
Weather alert

The Denso CP1 system is designed to receive severe weather alert information from Sirius XM (SXM) and display a pop-up window with the alert message as shown below.

Denso implemented SXM Weather Alert settings within the Gen 4 CP1 controls. These settings control all alert types as well as the ability to completely turn the alerts off. Unlike Gen 3 Harman, the settings for Weather Alert in Gen 4 Denso are in the SiriusXM Travel Link menu (Applications). See the Gen 4 screenshots below.

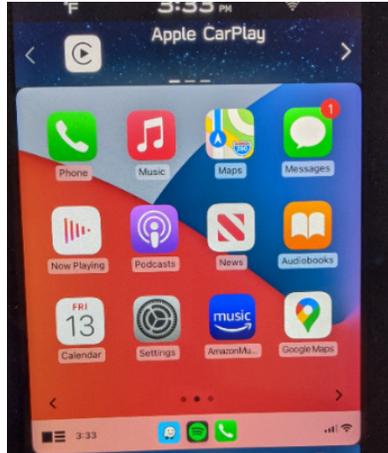
Gen 4 Denso CP1 CID

A number of reports have been received stating the Audio Output (radio, CD, USB etc.) gets interrupted when the Apple CarPlay app is launched or a Navigation app (e.g. Waze) or audio streaming application is (e.g. TuneIn) is started from the Apple CarPlay environment.

This is a normal operating characteristic as the iPhone takes control. This may also occur when the phone is used for other purposes while CarPlay is active such as: texting, replying to e-mails or other phone-side actions.

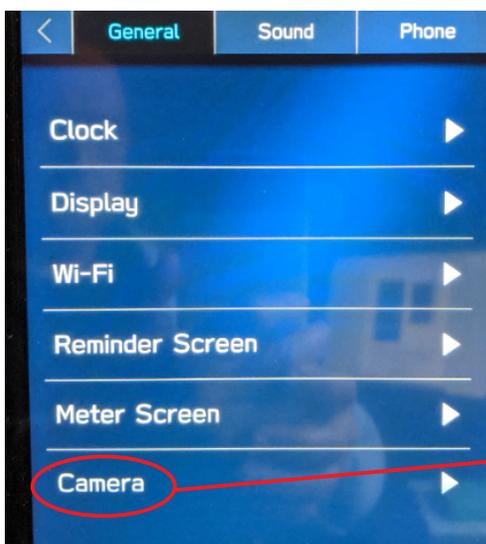
Camera setting PRESENT

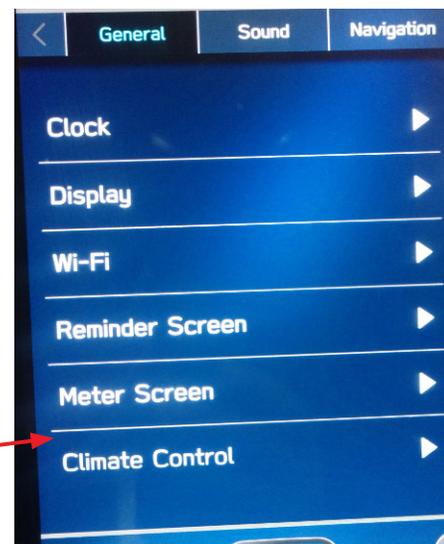
A report was received describing a missing “Camera” setting in Settings/General menu:

Camera setting MISSING

After further investigation, it was determined to be a result of a needed process not being followed during replacement of the combination meter. The new combination meter was installed but not programmed properly by completing the required Variant Work. Always follow the applicable Service Manual instructions on STIS and confirm completion of all the necessary steps before condemning a possibly related system or hardware component. The Service Manual image below is an *example* of the VARIANT WORK procedure required for Combination Meter System replacement. Always follow the applicable procedure for the vehicle being repaired.
