## Preliminary Information

### PIP5762 3.0L LM2 Diesel With Possible Oil Consumption, With or Without DTC P06DD

Brand:	Model:	Model Years:	VIN:		Engine:	Transmissions:
			from	to		
Chevrolet	Silverado 1500	2020	All	All	LM2	All
GMC	Sierra 1500	2020	All	All	LM2	All

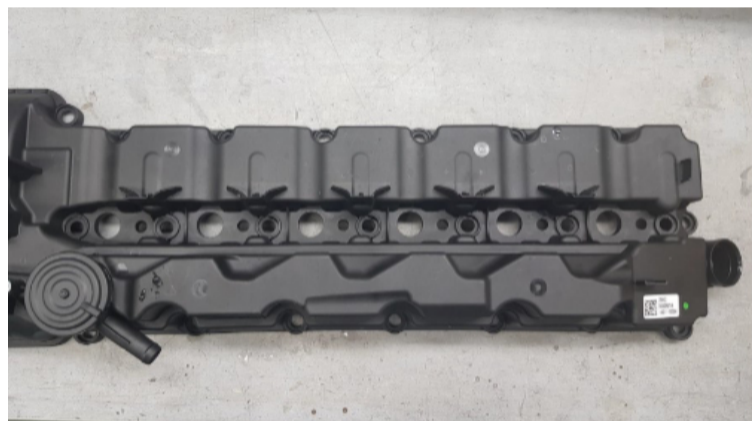
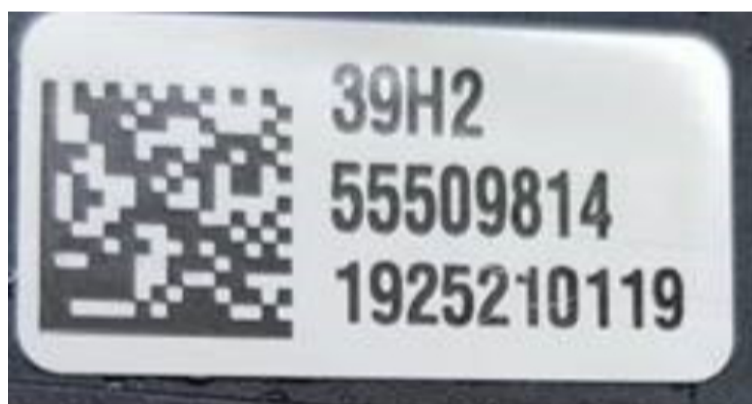
Involved Region or Country	North America
Condition	A customer may have a concern with oil consumption. The technician may find DTC P06DD set.
Cause	Camshaft housing (cover) may have a baffle plate weld that is not adequate.

Inspect the cam cover label for Julian dates and daily progressive number starting from 39H219 249 1 0098 through 39H219 253 1 0037.

If the serial number is NOT in the range above this PI does not apply. Refer to [PIP5751](#) and SI for appropriate diagnostics.  
If the serial number is from 39H219 249 1 0098 through 39H219 253 1 0037 and the customer's concern is oil consumption:

- 1) Replace the camshaft housing cover.
- 2) Replace the #2 glow plug.
