# Preliminary Information

## PIP5748D Particulate Matter Sensor Protection Tube Performance Diagnostic May Set A False DTC P1488 or P24DA

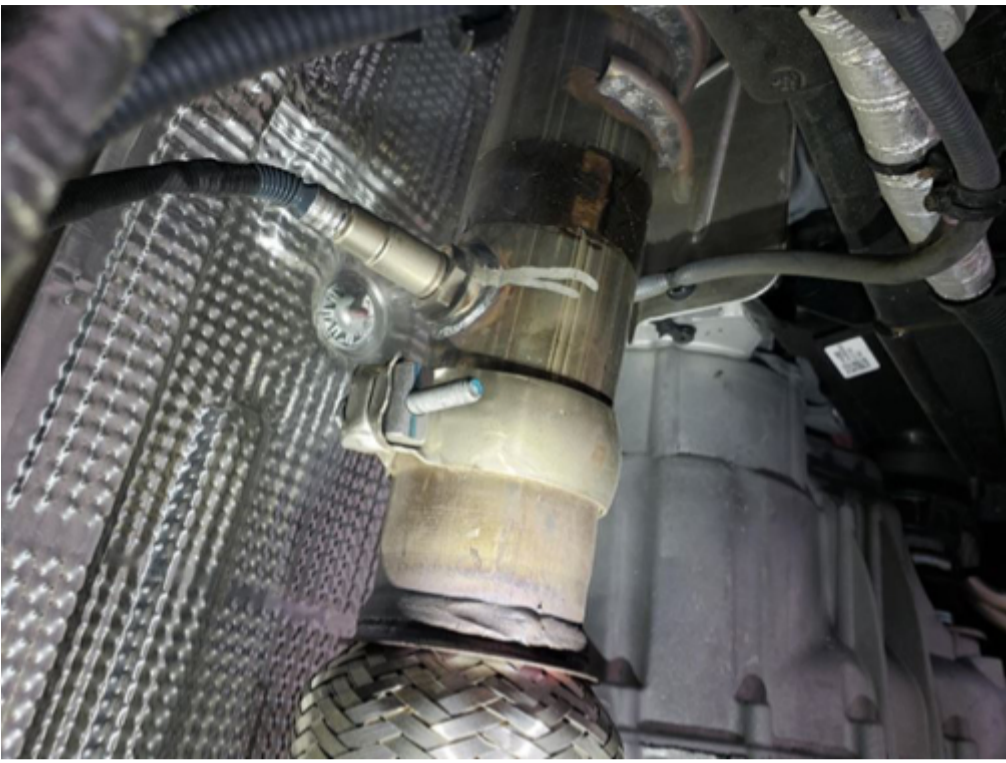
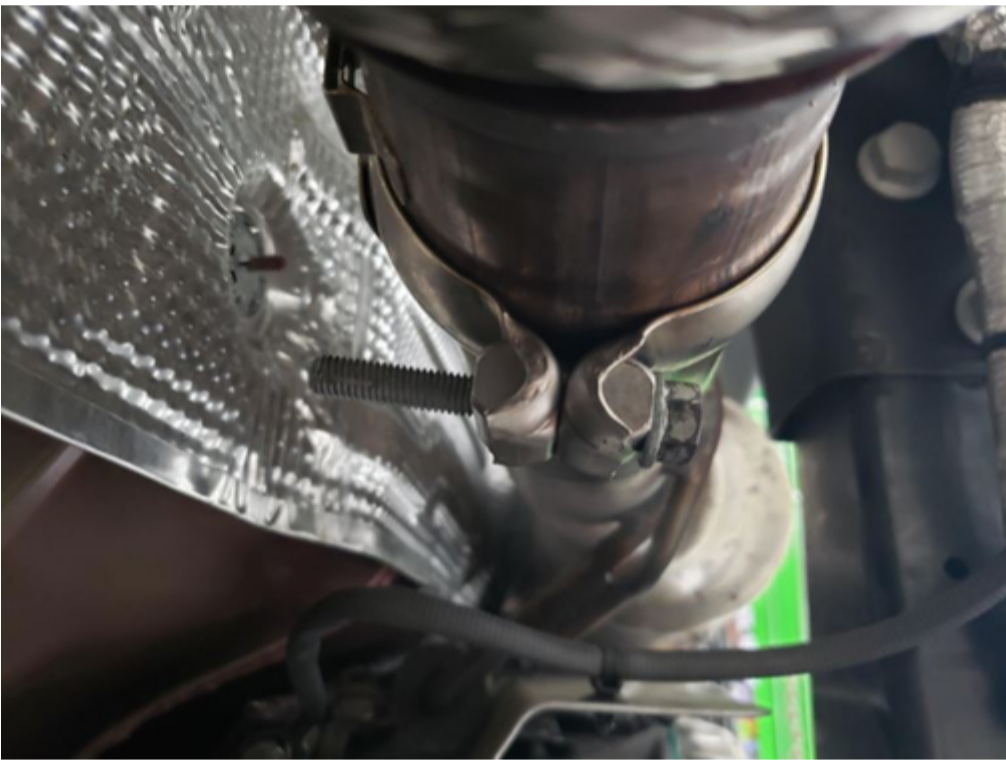
To test for leaks in the exhaust use the Power Smoke diagnostic leak detector (GE-52250 - refer to the latest version of [PIP5684](#)), but there are two important considerations. The smoke from the tester may not get through the DPF, so to test downstream of the DPF, administer the smoke downstream of the DPF. Also, the tailpipe sealing bladder doesn't reach the exhaust cooler so use duct tape around the pipe to seal the cooler holes. Repair any leaks as necessary but pay particular attention to the joint illustrated in the pictures below.

If this joint is leaking the clamp may have bottomed out before applying sufficient clamp load to the joint, or damage may have occurred from mis-alignment of the joint. Also, misalignment of the joint may contribute to the P1488/P24DA setting, even if the joint does not leak.

Separate the joint and check the witness marks for proper alignment. If the joint was found to be leaking, also inspect for deformations to either half of the joint and replace the components as necessary. If the clamp was found to be bottomed out, replace the clamp.

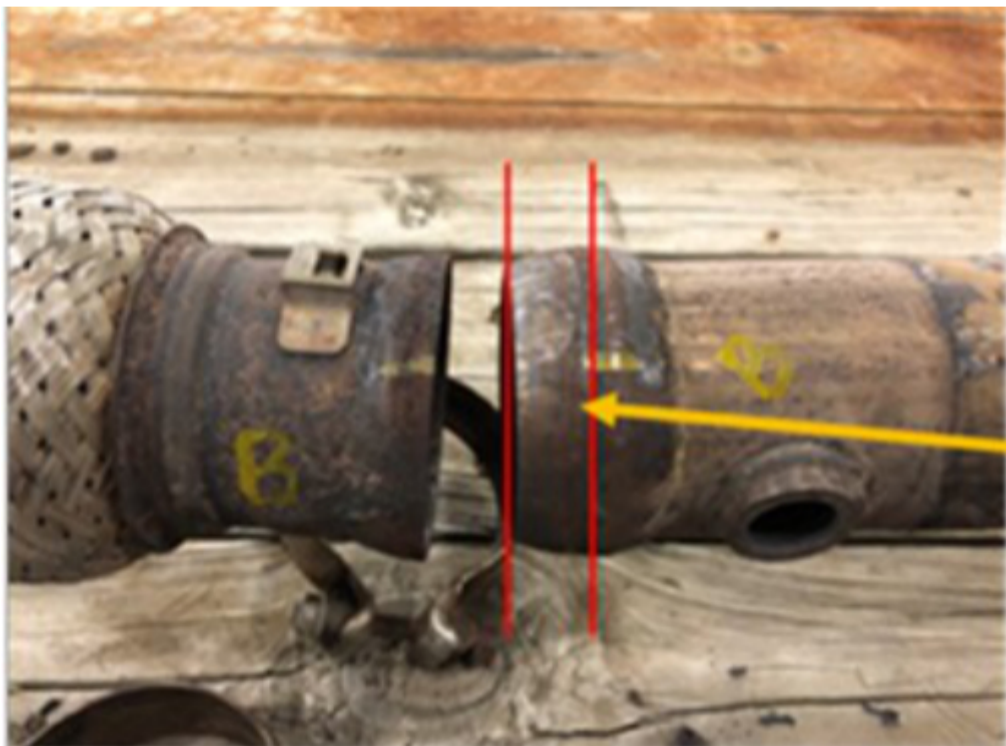
These witness marks indicate proper alignment

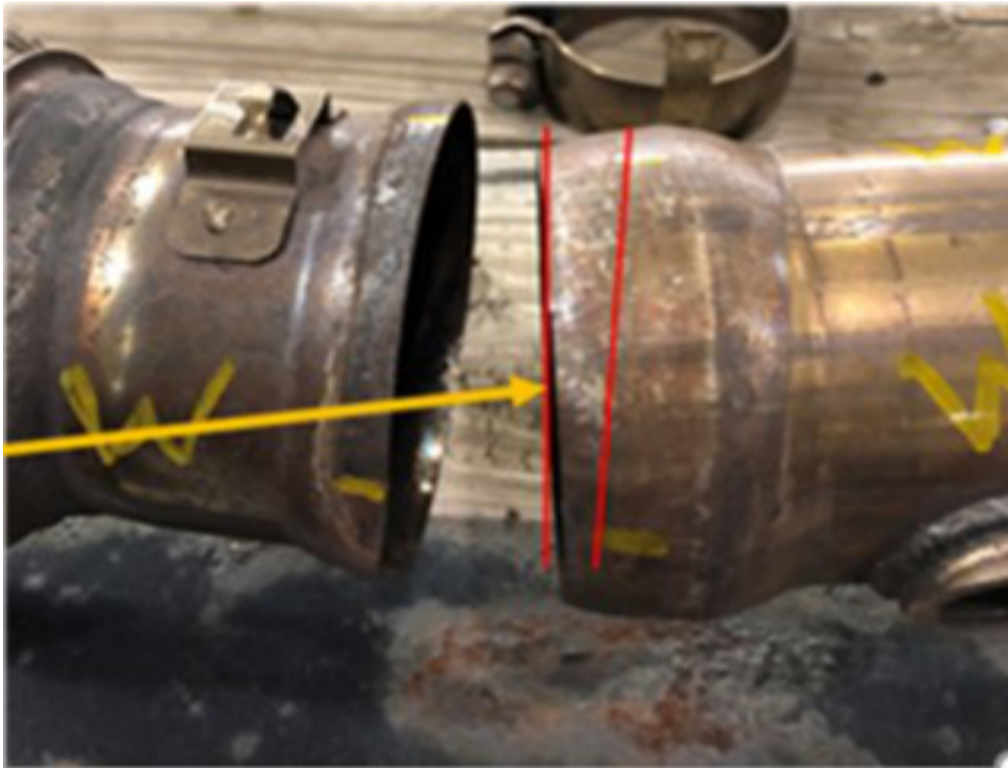
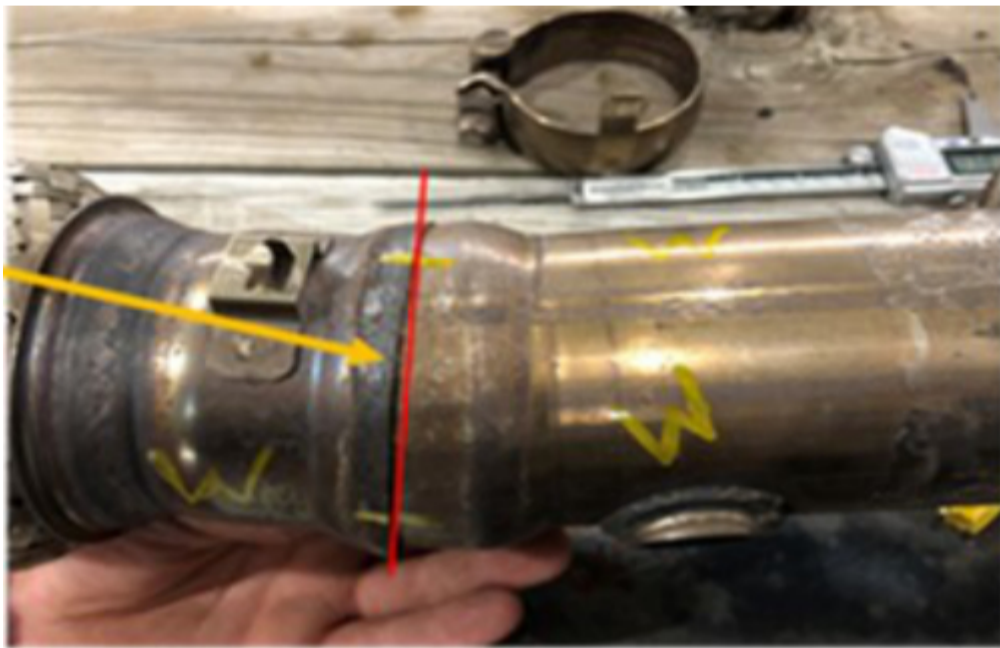
These witness marks indicate improper alignment
