SERVICE BULLETIN

APPLICABILITY: 2019-21MY Impreza
 2019-21MY Crosstrek (Including Hybrid Model)
 2019-21MY Forester
 2019MY Legacy/ Outback
 2019-21MY WRX
 2019-20MY BRZ- Navigation -equipped ONLY
 2019-21MY Ascent

NUMBER: 15-236-18R

SUBJECT: Reprogramming File Availability for Optimization of Harman Gen 3.1 and **Gen 3.1α** Audio and Navigation Head Units

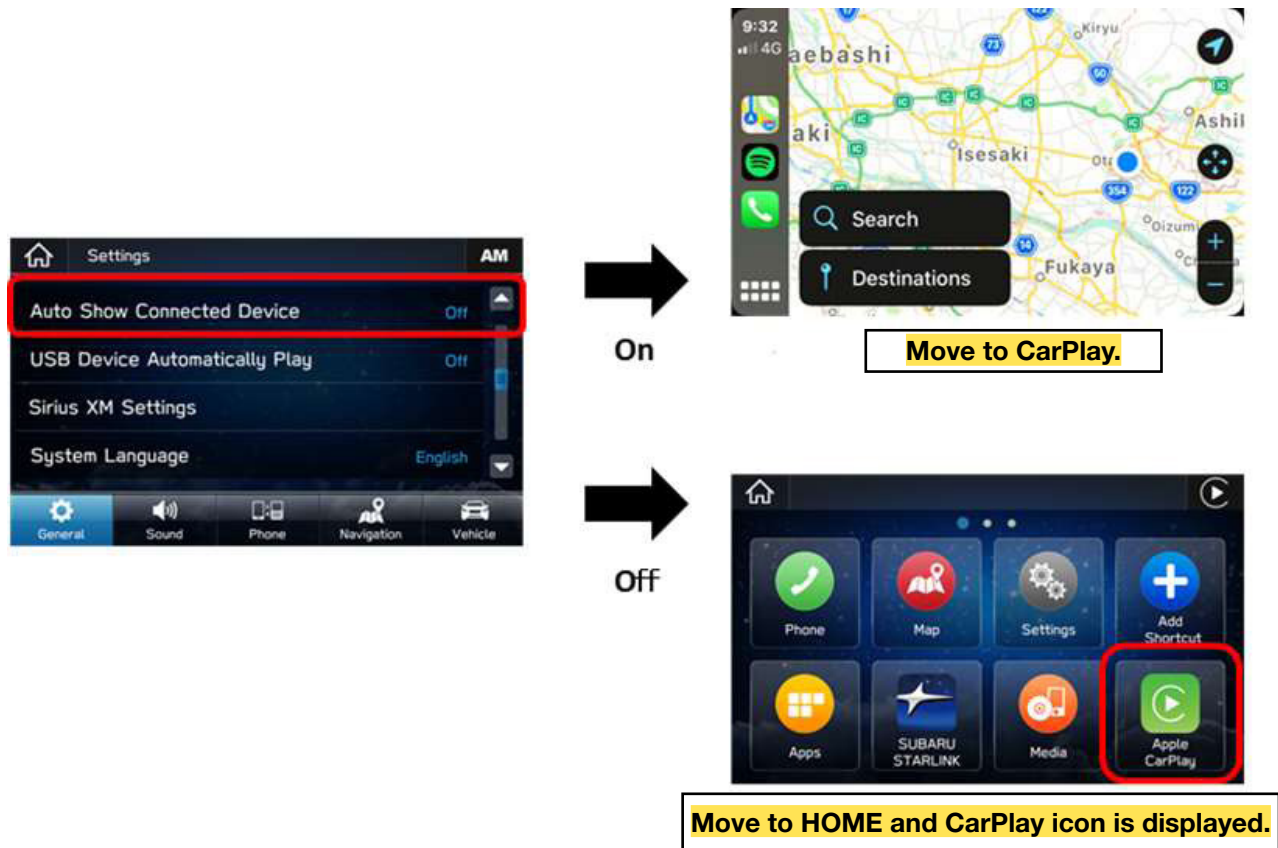
NOTE 3: When using a USB connection with iPhone (CarPlay active), move to CarPlay screen.

In a case where the iPhone was disconnected while playing music then reconnected while it is playing music, the system moves to CarPlay screen no matter what is set in <Auto Show Connected Device> in Setting (depending on iOS version of the iPhone.)
