SERVICE BULLETIN

APPLICABILITY: 2019-20MY Forester
2020MY Outback
2019-20MY Ascent

NUMBER: 12-300-20R

SUBJECT: Power Rear Gate (PRG) Switch Trim- Design Change

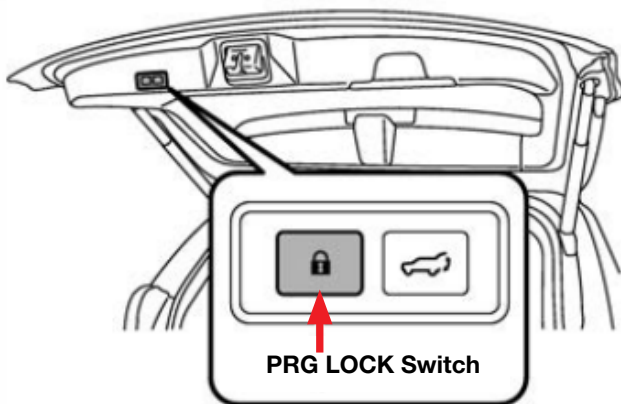
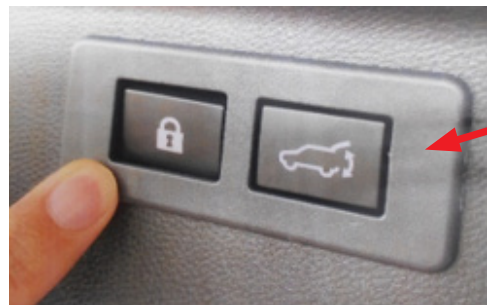
Trim Cover

This bulletin announces design changes made to the trim cover for the rear gate PRG control switches located on the bottom of the rear gate inner trim panel as shown below. In some cases, if the buttons are pressed in a certain way, they may become stuck below the surface of the switch cover and not function properly. Changes were made to enhance the rigidity of the part along with increasing the thickness of the locking tabs.

Here, the **LOCK** button is shown stuck below the surface of the switch trim cover.
