## SERVICE INFORMATION

**APPLICABILITY:** All Models with STARLINK Telematics System **NUMBER:** 15-195-16R

**SUBJECT:** Servicing and Claim Submission Requirements for STARLINK Diagnosis and Repair Involving the Data Communication Module (DCM) **DATE:** 04/28/20

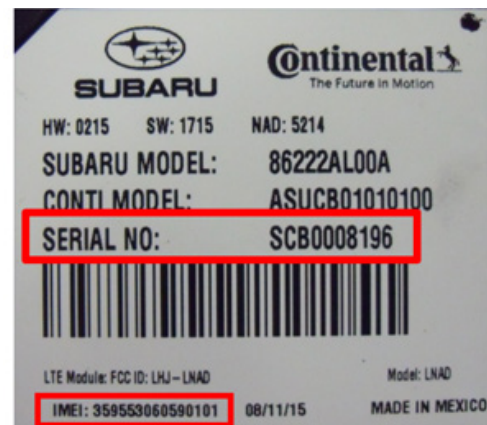
5) Effective Immediately, all claims for DCM replacement **MUST** include the 10-digit DCM Serial Number of the installed (new) DCM. This number is found on the DCM label shown here and **MUST** be entered in the Miscellaneous Detail field of the claim entry.
