TECHNICAL SERVICE BULLETIN

Illuminated ABS Warning Indicator With DTC C0020 - Built On Or Before 24-Dec-2020

21-201725 January
2021

Ford 2020 Explorer
2020 Police Interceptor Utility
Lincoln 2020 Aviator

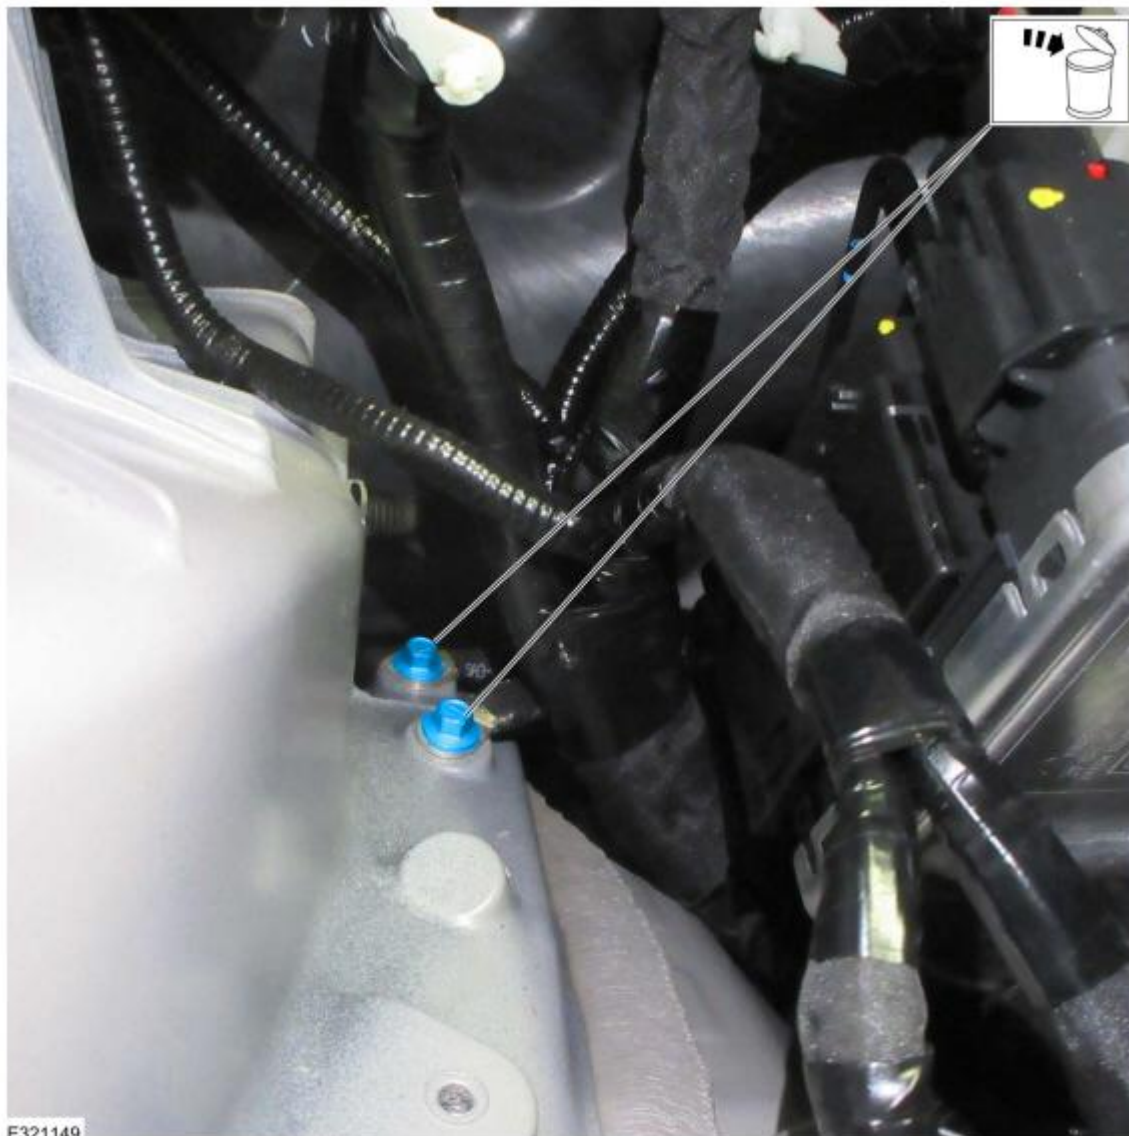
Figure 2

Issue: Some 2020 Explorer/Aviator/Police Interceptor Utility vehicles built on or before 24-Dec-2020 may exhibit an illuminated anti-lock brake system (ABS) warning indicator lamp with diagnostic trouble code (DTC) C0020 stored in the ABS module. It may not be necessary to replace the ABS module/hydraulic control unit (HCU) to resolve DTC C0020. This may be due to a poor ground connection and/or improper plating on the attachment bolts at G108. To correct the condition, follow the Service Procedure to replace and properly tighten the ground cable fasteners.

3. Remove and discard the fasteners for ground G108. Refer to Wiring Diagram, Cell 10-4. (Figure 2)

4. Make sure no shrink tube adhesive is interfering with the fastener clamping force or ground path through the fastener. Clean as necessary with a razor blade.

NOTE: Do not remove any paint from the body as the ground path conduction is through the bolt threads.

5. Tighten the new fasteners securing the ground cables to 12 Nm (106 lb-in).
6. Apply Motorcraft® Electrical Grease to the fastener and ground cable eyelet.
7. To install, reverse the removal procedure.
8. Clear DTCs from the ABS module.
