## SERVICE INFORMATION BULLETIN

**APPLICABILITY:** 2012-2016MY Impreza 2.0L Models  
2013-2017MY Crosstrek

**NUMBER:** 02-169-17

**SUBJECT:** Cylinder Head Casting Design Change

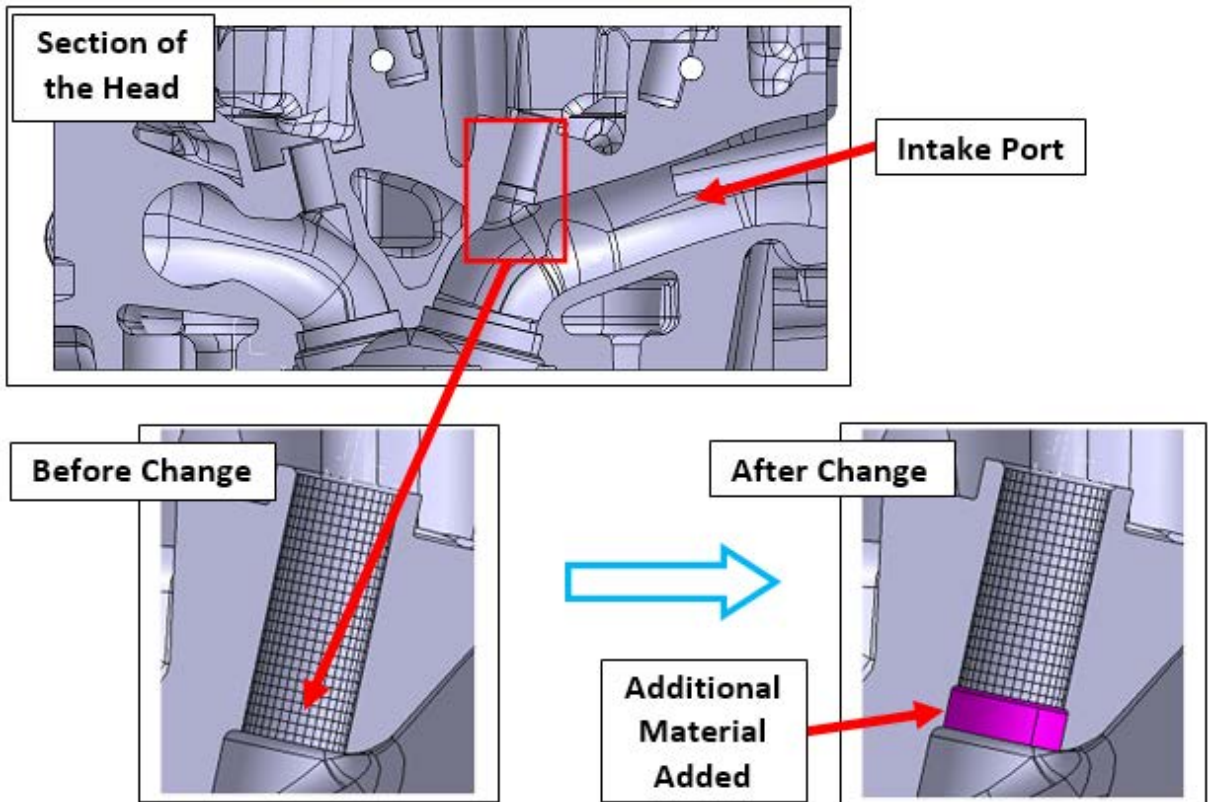
This Service Information bulletin outlines an enhancement made to the 2.0L cylinder head casting part numbers provided below. Additional material has been added in the valve guide boss area above the intake port to provide additional support for the guide and eliminate cracking. In rare cases, (depending on the severity of the crack), some engine oil consumption may result from engine vacuum drawing oil through the crack and into the intake port.

The following cylinder head assembly part numbers are provided to use as a reference only. Always confirm with your Parts Department the most up-to-date part numbers are ordered for the VIN being repaired. The illustration below provides additional detail of the change.

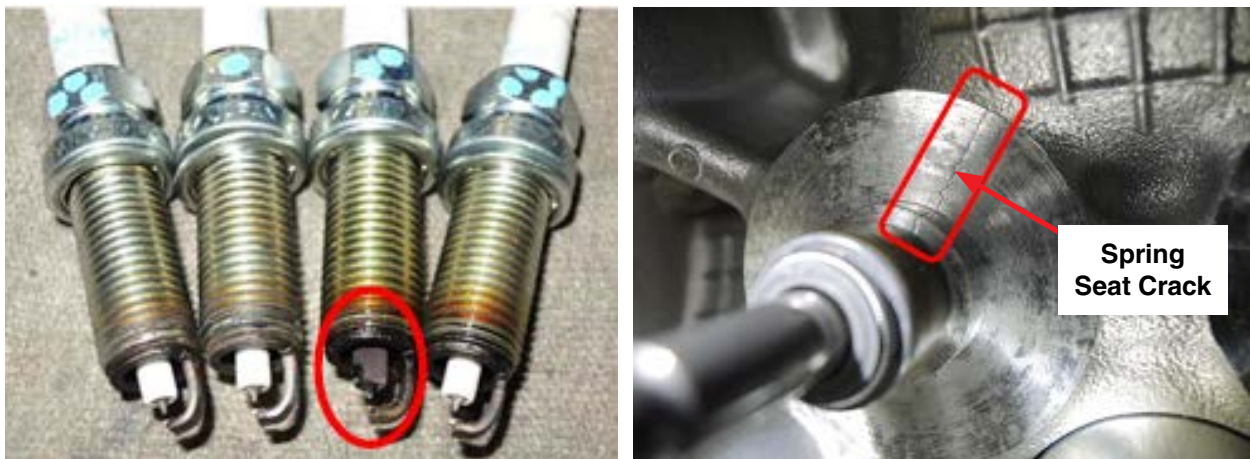
When receiving a customer concern of smoke from the exhaust, one of the checks should be to look at the condition of the spark plugs. If inspection shows only one (or two on opposite banks) with evidence of burning oil while the other plugs appear normal as shown in the left photo below, there may be a crack in the valve guide boss area. In some cases, the crack may extend up into the valve spring seat area as shown in the photo on the right. Finding comparatively heavy oil deposits on the back of one cylinder's intake valves while the others appear normal would be another indicator. If a crack is not readily visible, use the dye / penetrant / developer method to help locate and identify it. See the April, 2011 edition of TIPS for more information on using this method of leak detection.
