INTRODUCTION:

This bulletin announces availability of a redesigned stay (reinforcement) to address isolated customer concerns of a creaking-type sound from the r/rear seat cushion / backrest hinge area. The sound occurs when the stay contacts the backrest hinge assembly and can be heard when going over bumps and / or making a left turn when body twist is induced. The new part has extra clearance added to eliminate the contact.

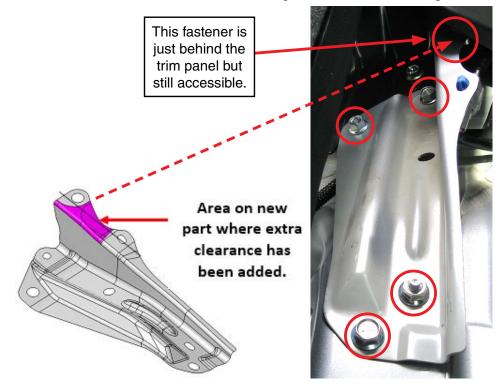
The new stay part number is **52168VA0019P.** The illustrations and photo show the stay's location in the right rear floor section under the rear seat, fastener placement and the change to the new part.
