# Service Bulletin

Bulletin No.: 17-NA-334

**Subject:** Information on Diesel Engine Soot Deposits at the Variable Turbine Geometry (VGT) Pin

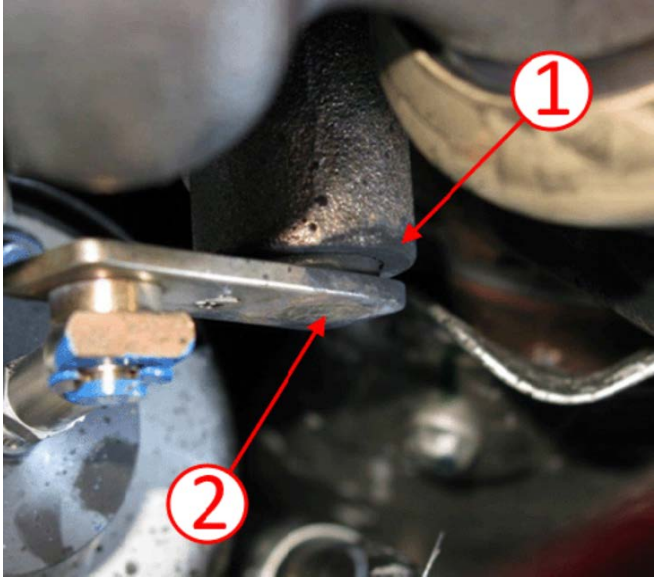
| <b>Condition</b> | <p style="text-align: right;">4879702</p> <p>Some customers may comment that combustion deposits or soot (1) can be seen coming from the turbo actuator pin/arm (2).</p> |
| <b>Information</b> | <p>This is normal operation and will not affect the function of the turbocharger. There is a small gap between the seal and the shaft to allow for proper rotation.</p> <p><b>Do Not</b> replace the turbocharger.</p> |
