# Service Bulletin

Bulletin No.: 18-NA-056

**Subject:** Side Object Sensing Alert Module Not Working Correctly and/or Incorrect Side Mirror Notification

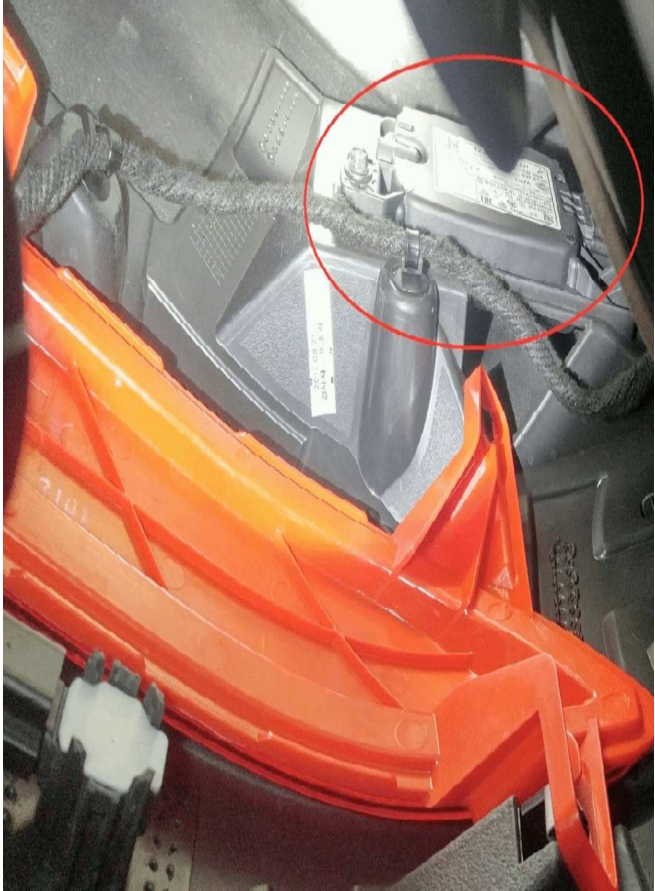
4974639

<p><b>Note:</b> Most radar reflections may be found worse on the driver side than the passenger side.</p> <p>This condition may be caused by unwanted radar reflection being detected and triggering the false alerts.</p>
<b>Correction</b>	If the side blind zone has been found not working properly, apply a piece of aluminum butyl tape to the bottom of the side object sensing alert module.
