Service Bulletin

Bulletin No.: 20-NA-175

Subject: Vertical Misalignment Between Cab and Pickup Box on Driver Side of Vehicle

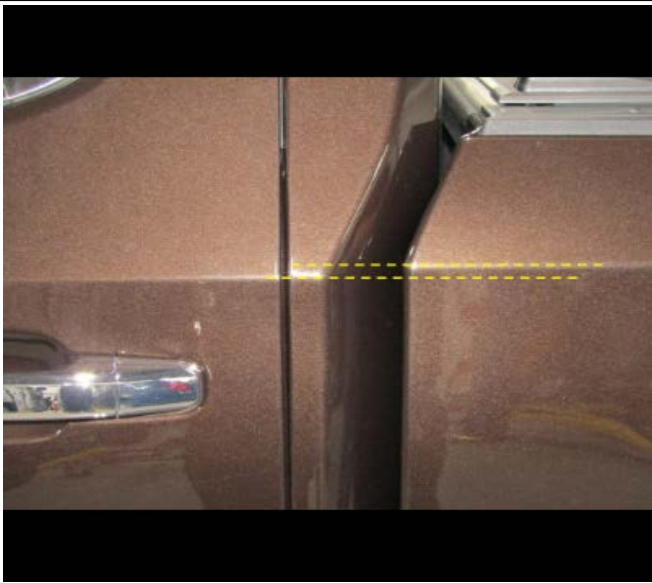
<p>5645798</p> <p>Some customers may comment on noticing anywhere from 2 –10 mm (0.08 – 0.4 in.) vertical misalignment of the body feature line between the cab and the pickup box, on the driver's side of vehicle.</p>		
Cause	The cause of the condition may be pickup box structure variation.		
Correction	Realign the left side of the cab and install shim washers, following the steps in the Service Procedure below.
