Service Bulletin

Bulletin No.: 20-NA-220

Subject: Rear Camera Inoperable

Brand:	Model:	Model Year:		VIN:		Engine:	Transmission:
Dialiu.	woder.	from	to	from	to		
Chevrolet	Silverado 2500/ 3500 HD	2021	2021				
GMC	Sierra 2500/3500 HD

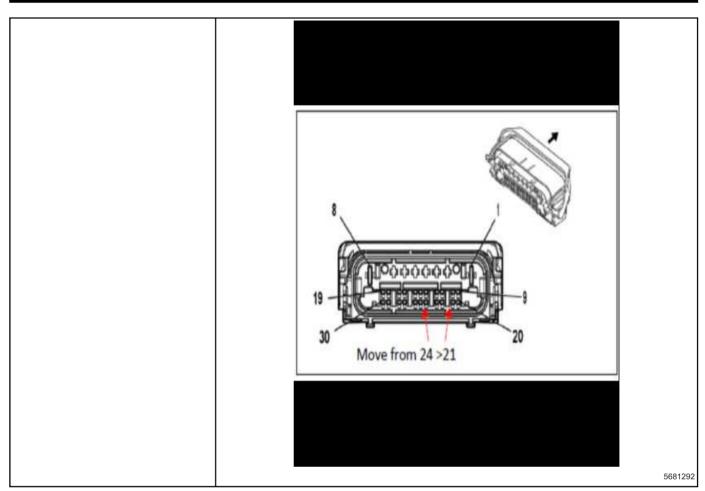
Involved Region or Country			
Additional Options (RPOs)	Equipped with RPOs 5N5 & ZW9 Rear Camera		
Condition	Some customers may comment on the rear camera being inoperative.		
	The cause of the condition may be that a change was implemented to the chassis harness from 2020 to 2021 trucks, there was an issue with camera flicker and circuit 1739 was moved from pin 24 to pin 21.		
Cause	The camera extension harness P/N 84852714 in the 5N5 Rearview Camera kit was not updated to correspond to the change in the chassis harness. This mis-match leaves the camera inoperative when installed by the dealer or upfitter and as such stalls the delivery to the end customer.		
Correction	Move wire from pin 24 to 21 of the terminal in the Rear Camera Harness. Refer to Repairing Connector Terminals (Terminal Repair) in SI.

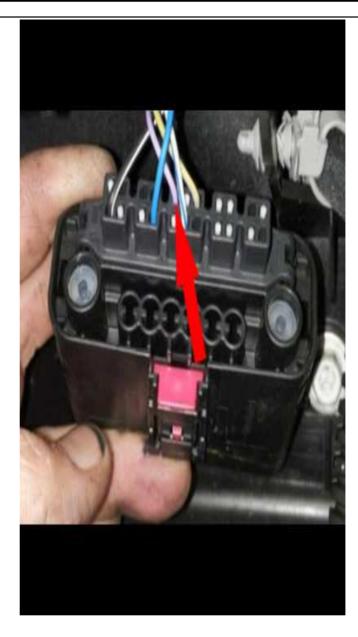
5681283

Wire connected to Pin 24
