# Service Bulletin

Bulletin No.: 18-NA-156

**Subject: A/C Inoperative and/or Insufficient Cooling**

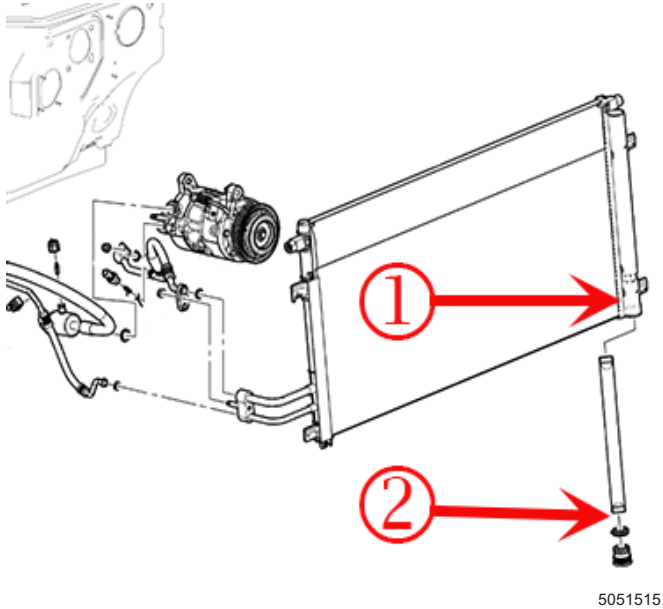
5051515

<b>Involved Region or Country</b>	North America and NA Export vehicles
<b>Condition</b>	Some customers may comment on the air conditioning inoperative and/or insufficient cooling.
<b>Cause</b>	Leaking seal(s) only at the Receiver/Dehydrator plug. As illustrated in the following photos, none have been found at the blind coupler or tube connections. If this concern is present there will be dye evidence at the Receiver/Dehydrator plug connection.
<b>Correction</b>	Replace the Receiver/Dehydrator plug assembly using part number 22996648. When replacing the Receiver/Dehydrator plug assembly apply a light coating of AC oil to the O rings prior to installing the assembly. <b>Important:</b> Dealers: Only order kits for known leaking vehicles. Due to limited availability we wish to maximize inventory at CCA.

If you encounter a vehicle with the above concern, inspect the receiver dryer plug (2) at the bottom of the desiccant tube (1) on the driver's side of the condenser for signs of leaking. If a leak is found, replace the receiver and dehydrator. Refer to *Receiver and Dehydrator Replacement* in SI.

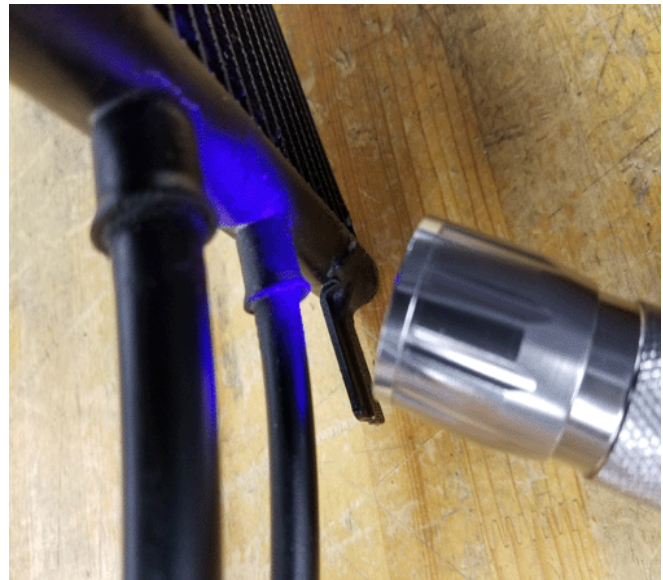
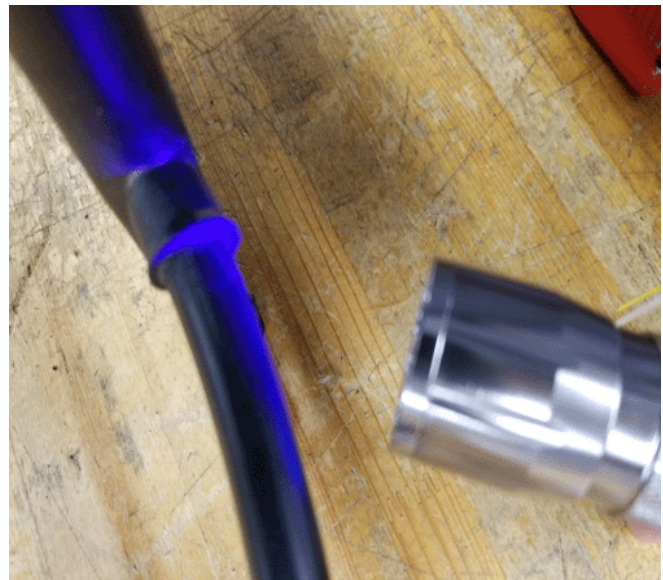
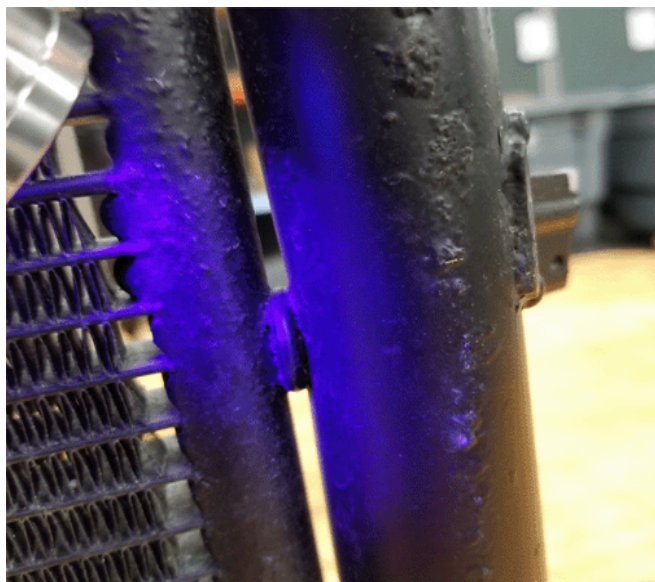
### No Evidence of Dye Will Be Found Around the Following Areas

#### Around the Blind Coupler

**Note:** Condenser shown in following pictures, is out of vehicle to provide a better view of areas of concern.

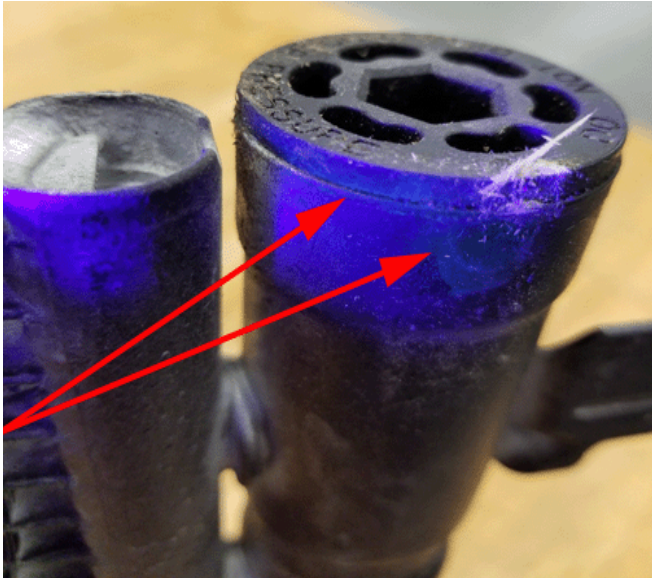
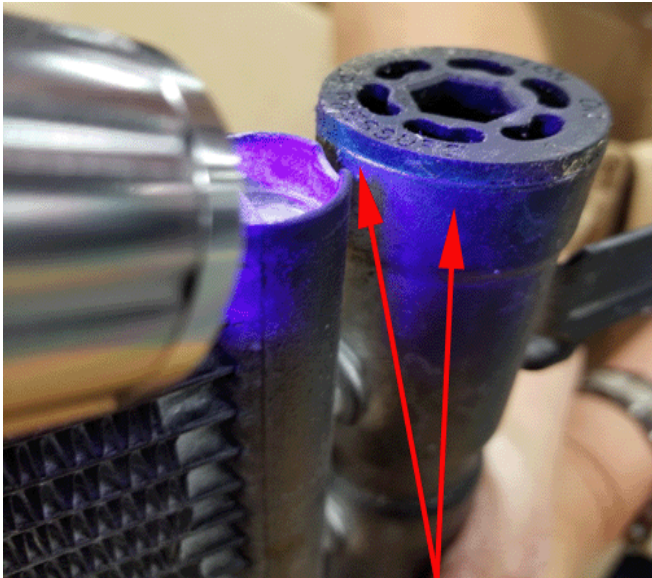
### Low Mileage Vehicles Dye Will be Difficult to See

Dye is water soluble and rain may make this difficult to detect dye. Arrows indicate dye evidence

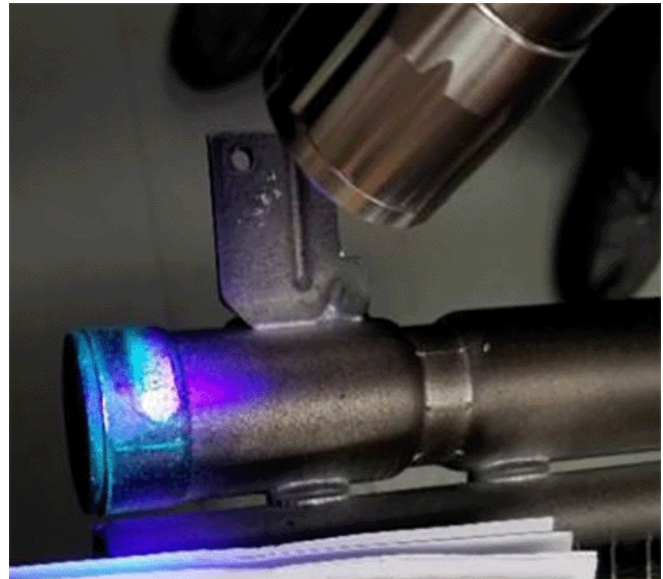
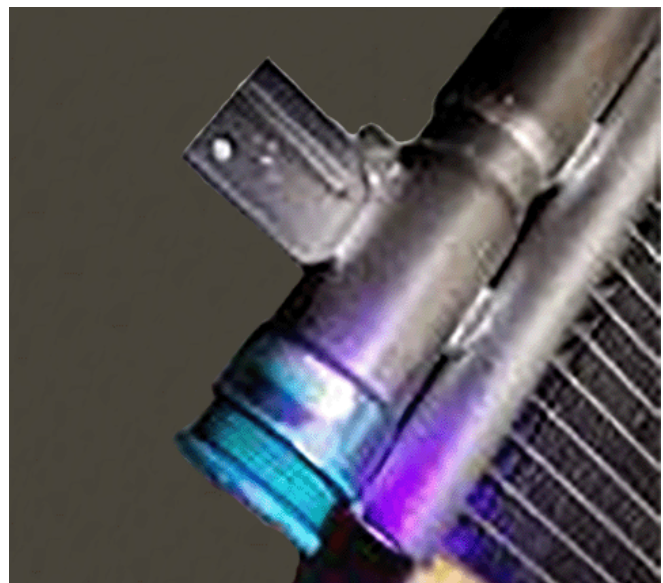
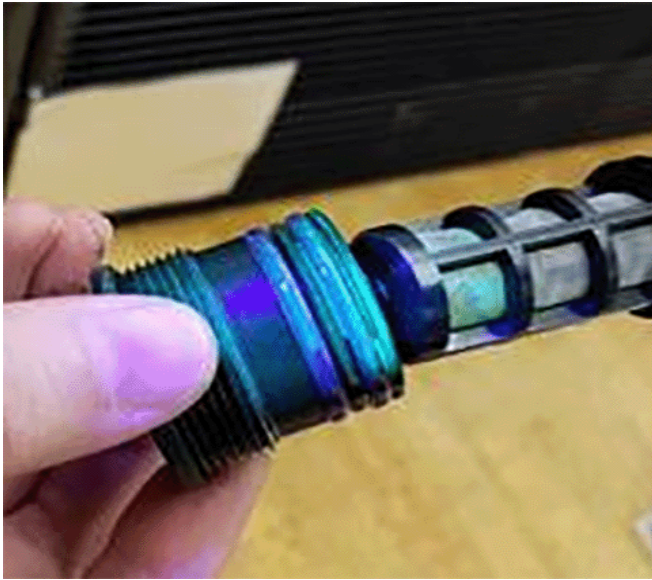
### Higher Mileage and More Severe Leaks (Dye Will Appear More Prominent)

The dye will show in the plug threads and below the seals.
