February 18, 2021

Version 4

## 2019-21 Passport/Pilot: Popping or Crackling from the Speakers; No Sound from the Audio System; Network Loss Message and/or Display Issues

Supersedes 20-058, dated September 10, 2020, to revise the information highlighted in **yellow**.

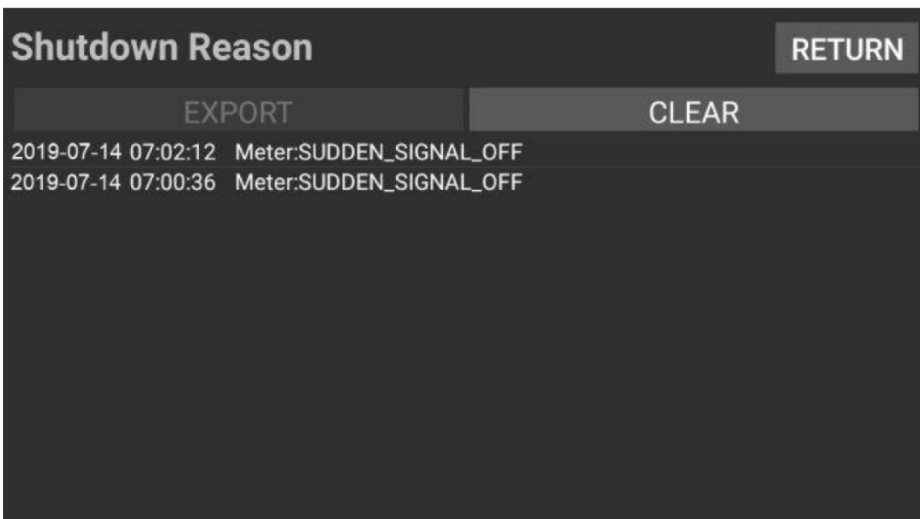
In this example, the cause of the failure can be identified as **Meter:SUDDEN\_SIGNAL\_OFF**.

Write down any failures; they will be collected on the warranty claim. Then, clear the data.

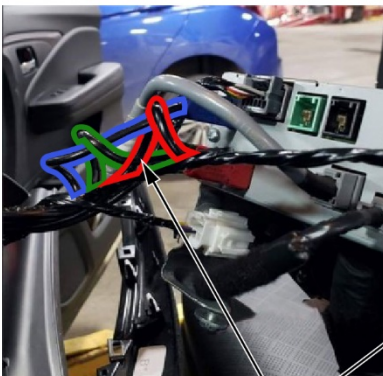
**BEFORE**

23. Install all of the removed parts in the reverse order. **When installing units, make sure the harness is routed correctly. A mis-routed harness can put pressure on the wires and connectors causing connection issues. Do not pull on the units or MOST feeders while the FAKRA connectors are connected to help prevent communication issues.**

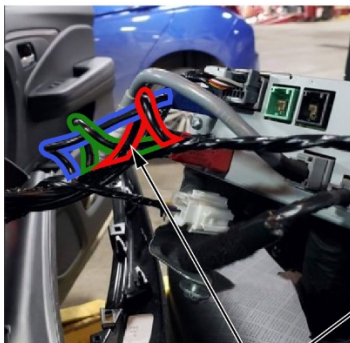
BEFORE

28. Install all of the removed parts in the reverse order. When installing units, make sure the harness is routed correctly. A mis-routed harness can put pressure on the wires and connectors causing connection issues. Do not pull on the units or MOST feeders while the FAKRA connectors are connected to help prevent communication issues.
