# Service Bulletin

Bulletin No.: 19-NA-256

**Subject: Diagnostic Tips for Knocking, Rattle, Squeak and/or Squeal Type Noise from Engine – Engine Replacement Recommendations for HFV6 Gen 1 and Gen 2**

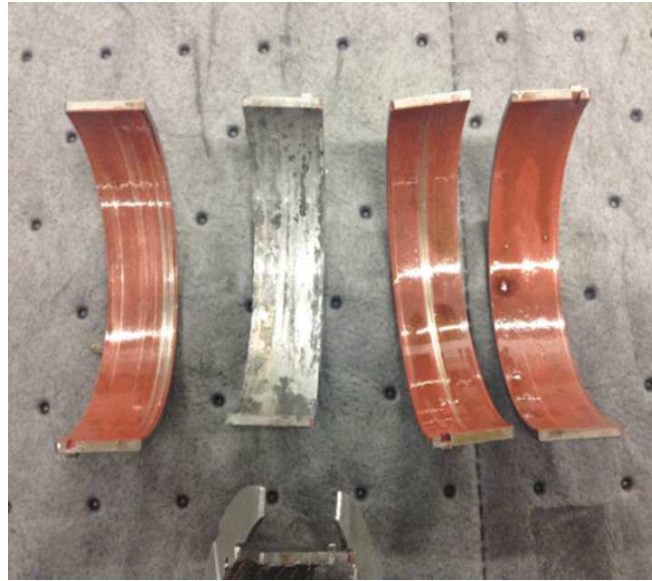
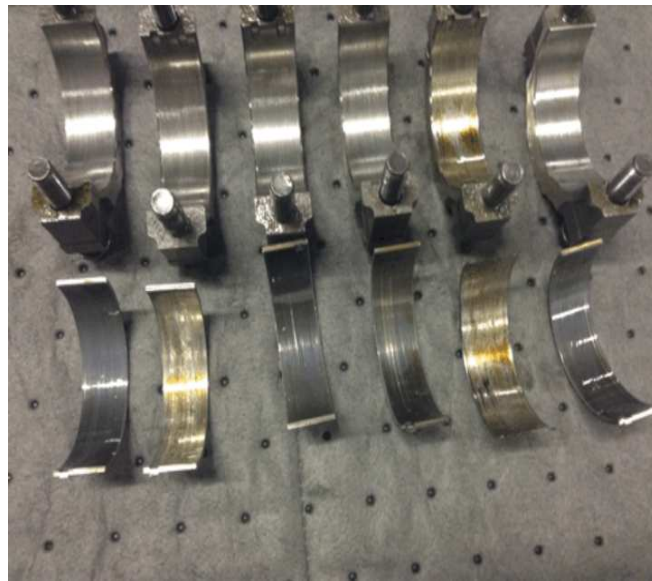
1. Verify there is metal in the engine oil by removing the oil pan.
2. Remove the main or rod bearing caps:
  - If the main and/or rod bearing are not the cause of the debris, refer to SI for further diagnostics.

- If the main and/or rod bearings are found to be the cause of the debris, before deciding whether to replace the engine or repair it, refer to the Service Procedure below before making that determination.

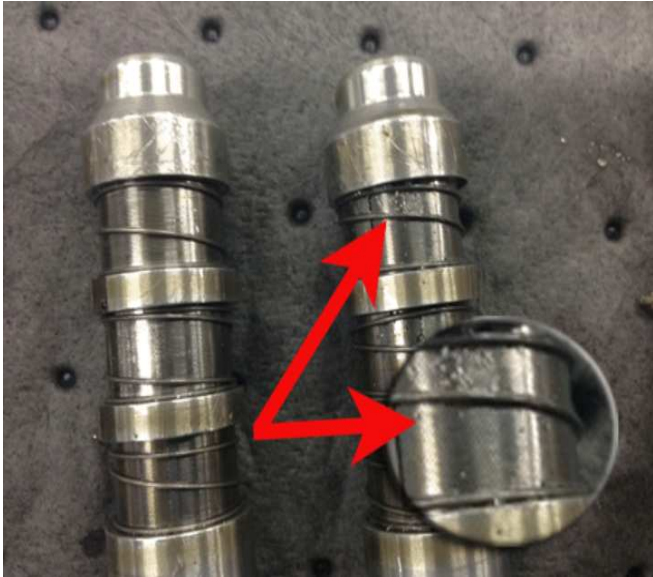
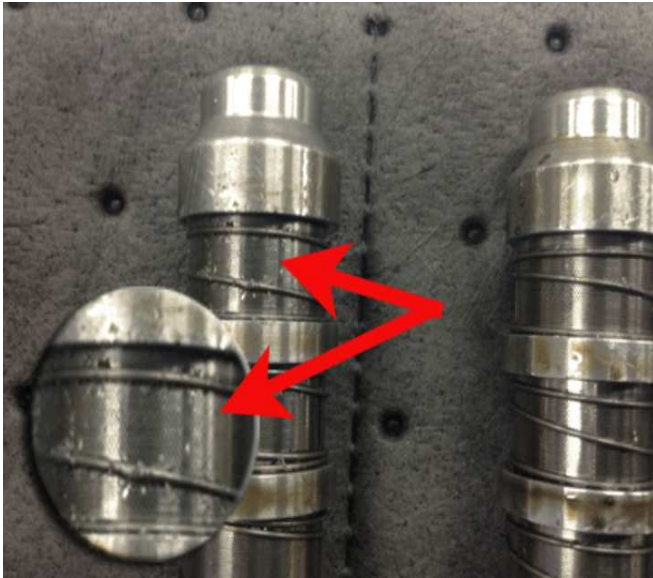
1. Inspect the oil control solenoids for metal debris. This shows the oil filter is in by-pass and unfiltered oil with bearing debris was pumped into the oil lubrication galleys, throughout the engine.

Any of the above 3 instances would be cause to replace the engine instead of repair.

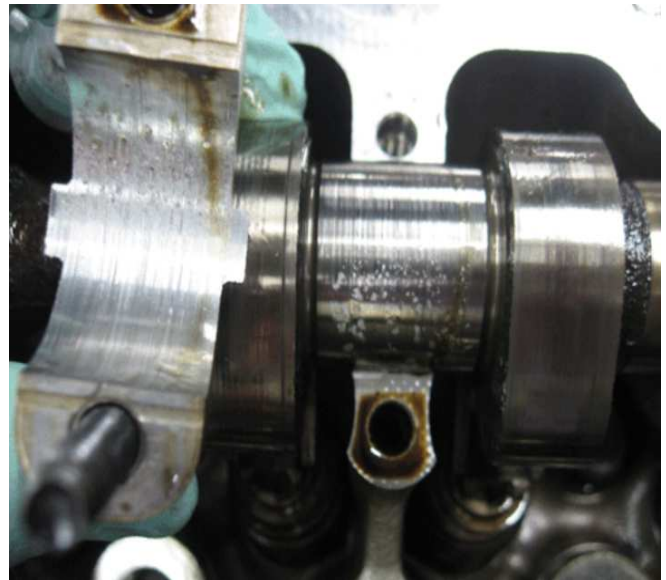
3966789

2. Inspect for damage to the cam caps journals and camshaft journals on the heads (obvious signs of metal through the cap).

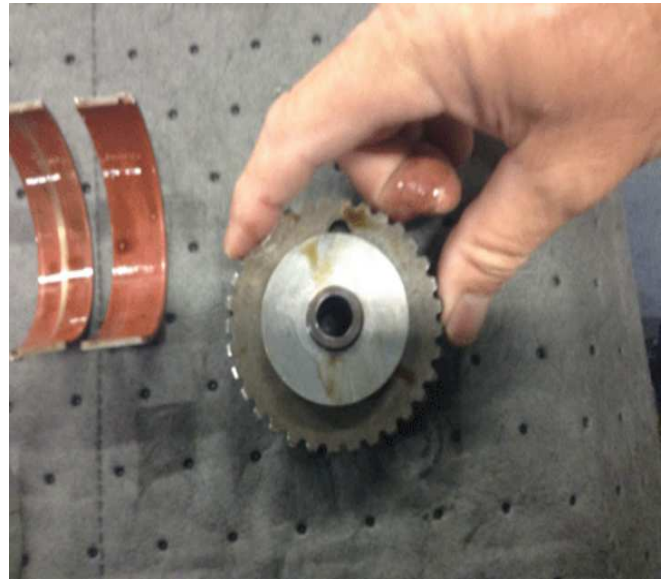
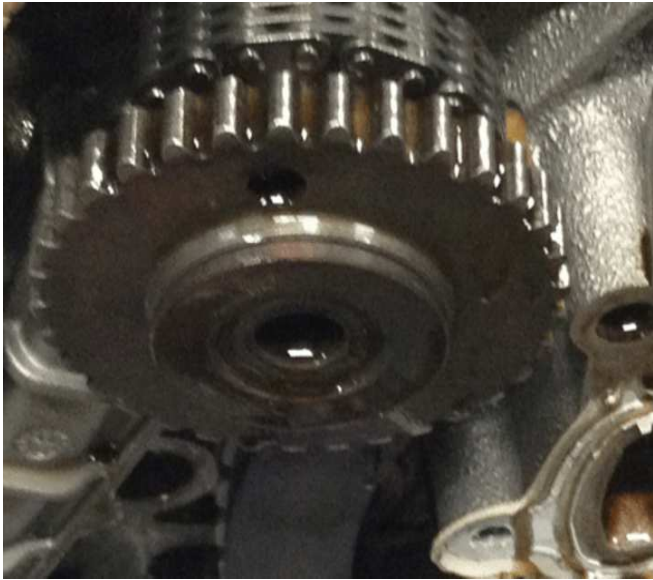
3. Inspect the timing chain idler sprockets for stiffness when turning (Should turn smooth and free).
