Service Bulletin

Bulletin No.: 20-NA-203

Subject: Information on Manual Regeneration Displayed on Drivers Information Center (DIC)

Brand:	Model:	Model Year:		VIN:		Engino:	Transmission:
		from	to	from	to	Engine:	Transmission.
Chevrolet	Silverado	2018	2018			L5P	
	Silverado 2500/3500	2019	2021				
GMC	Sierra	2018	2018				
	Sierra 2500/3500	2019	2021

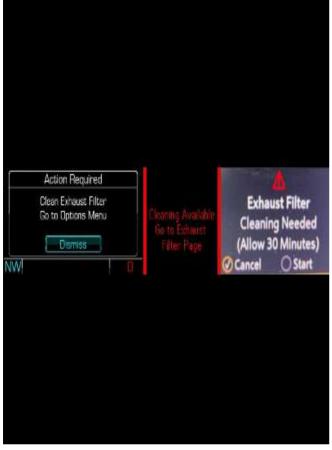
5654544

At approximately 90% soot load in the DPF, one of the messages in the graphic above will be displayed on the DIC.

These messages indicate that Manual Regeneration is available. No action is required; however, the operator may choose to perform a manual regeneration. See performing a manual regeneration below. If the message is dismissed and the vehicle has not performed a regeneration, this message will appear again on the next key on cycle.

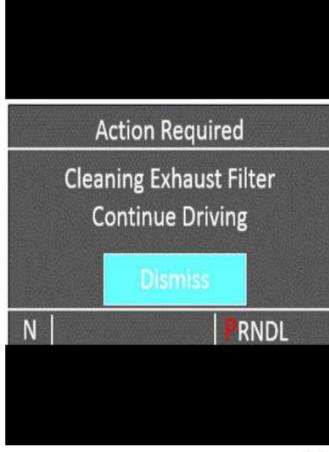
5654545

If the soot level climbs to a level near 110 - 115% in the DPF while the vehicle is moving and the vehicle is still not able to start an automatic regeneration, the message in the graphic above will display.

If the message is displayed, continue driving safely at a steady speed as close to the posted speed limit as possible until the message turns off. This can take up to 30 minutes.

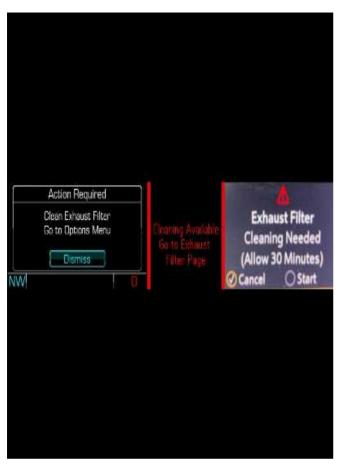
5654544

If the vehicle is shifted to park, one of the messages in the graphic above will appear.

These messages indicate that Manual Regeneration is available.

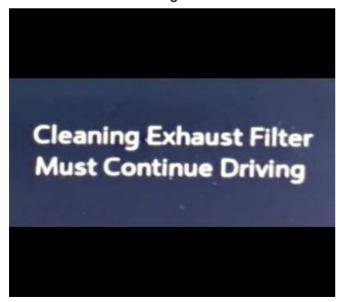
5654703

If the soot level climbs to a level near 130% in the DPF while the vehicle is moving and the vehicle is still not able to start a regeneration, the message in the graphic above is displayed.

If the vehicle is placed into park, the above message will not change and there will not be an opportunity to perform a manual regeneration. The vehicle must be driven to initiate an automatic regeneration. Continue driving safely at a steady speed as close to the posted speed limit as possible, until the message turns off. This can take up to 30 minutes.

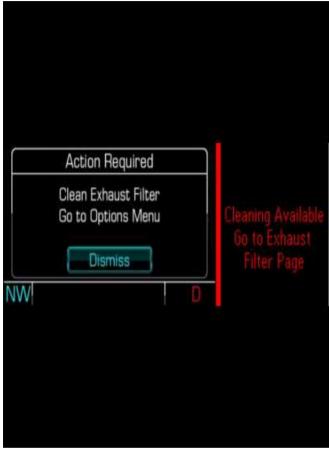
5654593

If the vehicle is being driven and the message in the graphic above is displayed, the operator may choose to stop the vehicle to perform a manual regeneration.

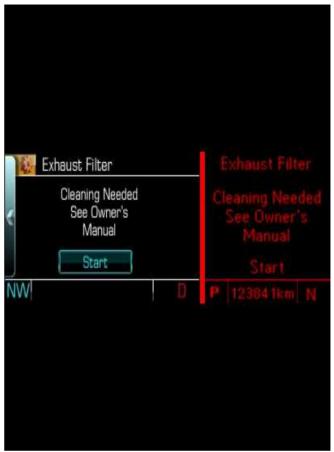
5654712

When shifting to park, scroll through the DIC pages to find the Exhaust Cleaning menu. Depending on whether the vehicle has a base or up level cluster, it may be under the Settings menu. The DIC will display a reference to refer to the Owners Manual as shown in the graphic above.

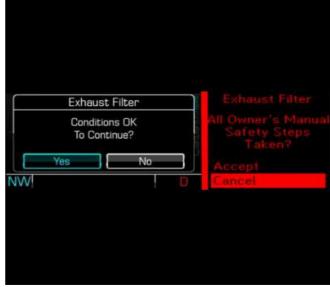
5654762

After making sure all the safety conditions have been met, press the trip odometer reset stem or the Check-Mark on the steering wheel control for at least one second to select Start on the DIC. The DIC will display in the graphic above.

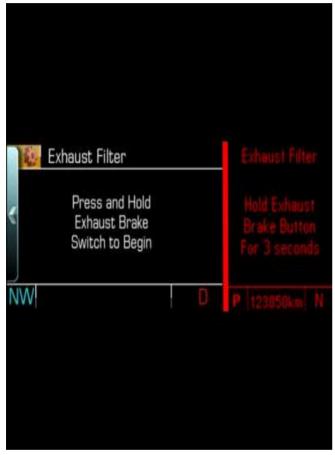
5654697

If all requirements for the manual regeneration are met, the DIC will display to Press and Hold Exhaust Brake Switch to Begin as shown in the graphic above.

Hold the exhaust brake switch on the center stack below the climate controls for more than three seconds, and then release it, to begin the regeneration process.

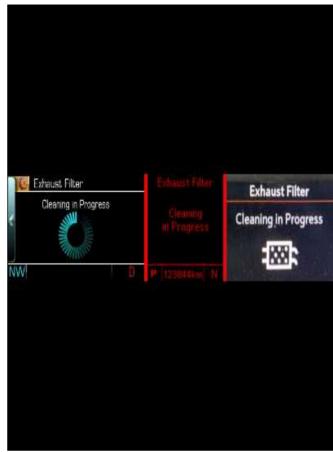
5654694

When manual regeneration begins, the engine speed increases, the engine cooling fan sound increases and the message in the graphic above will be display.

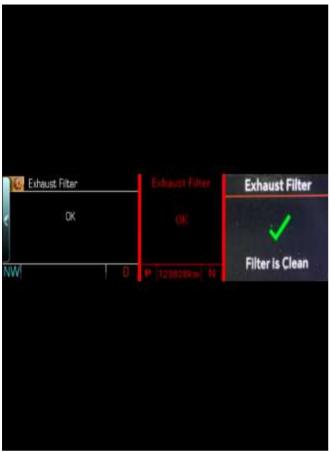
The message will remain when cleaning is not necessary.

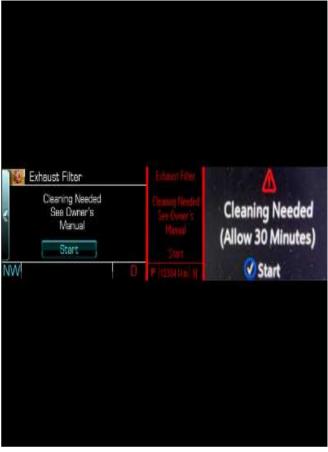
5654666

For vehicles equipped with FPF AND ANM, the message in the graphic above will be display.

If a manual regen was just performed, the presence of this message is not an indication that the vehicle needs another regeneration. The DPF is clean. This is displayed because manual regeneration can only be initiated if the above message is displayed. Since a vehicle with ANM is permitted to perform a regeneration at any soot level in the DPF, once the regeneration is complete, the above message needs to be displayed. Provided that the engine idled up, the exhaust sound changed and/or there was a different smell from the exhaust, be assured that there is a very low soot level in the DPF when this message reappears.
