# Service Bulletin

Bulletin No.: 20-NA-208

**Subject:** Assist Step Running Boards Inoperable and Not Functioning with Door Operation

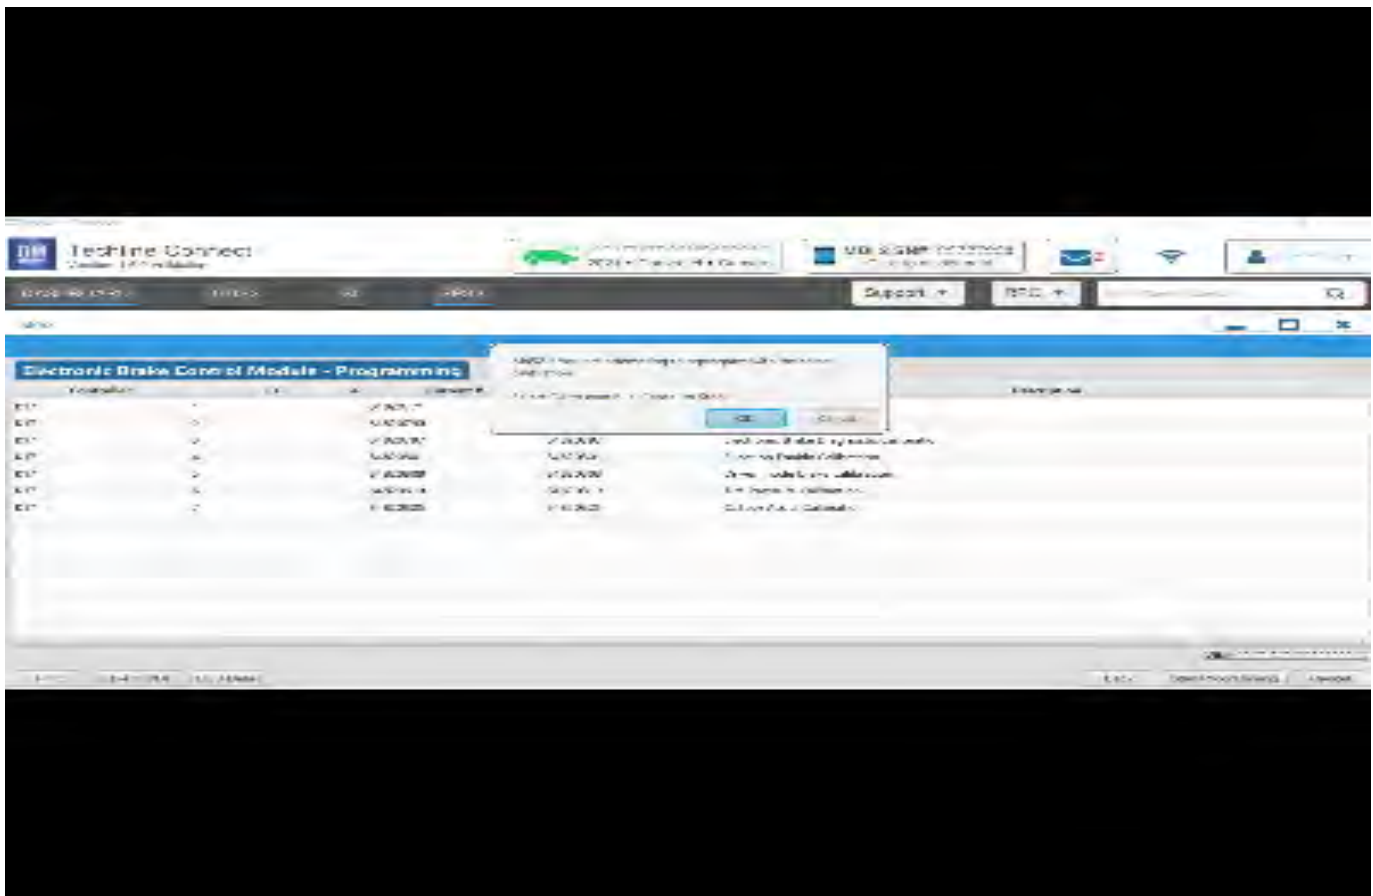
564477

**Important:** Techline Connect and TIS2WEB screens shown above.

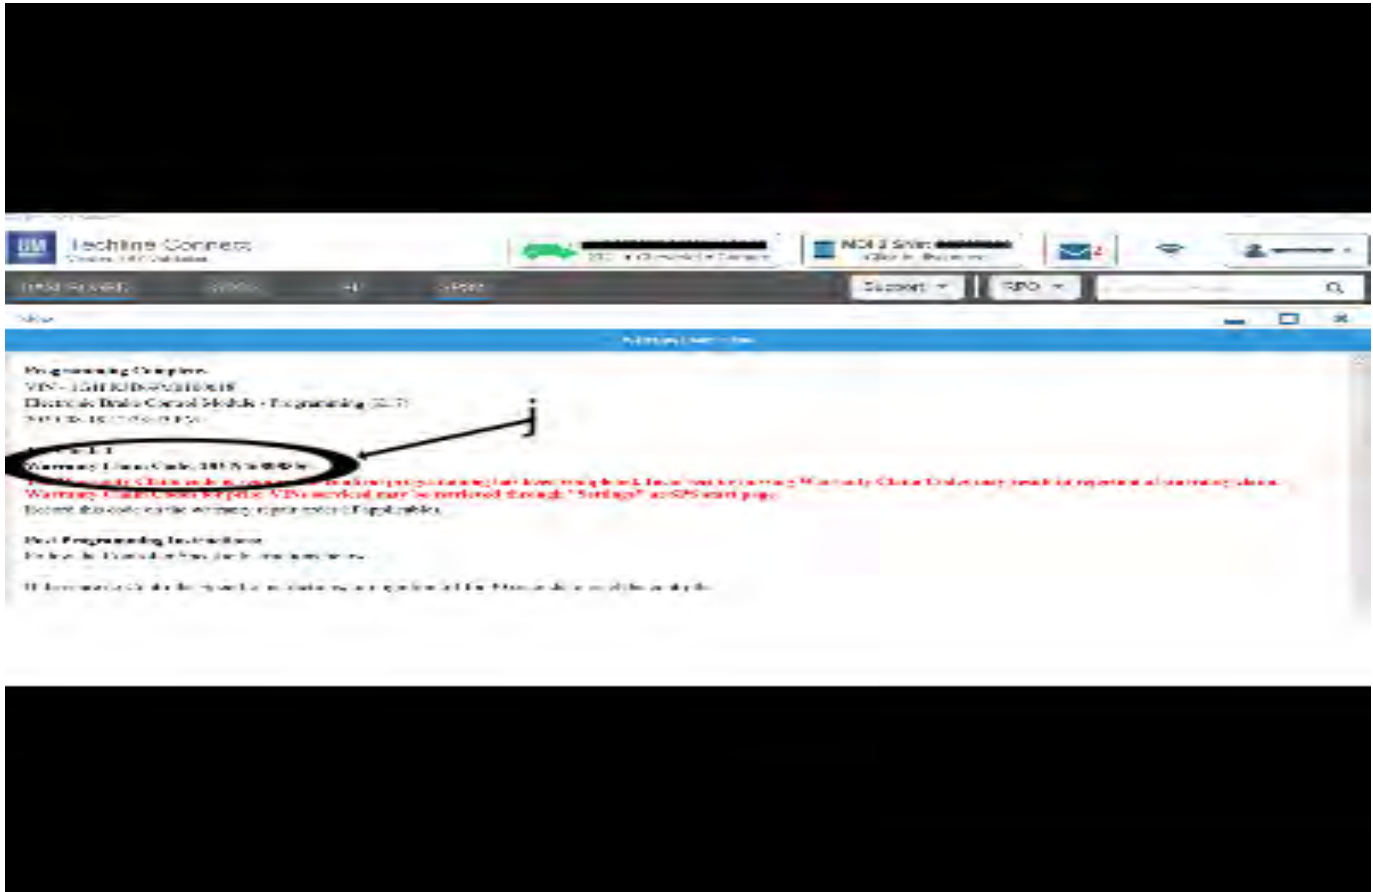
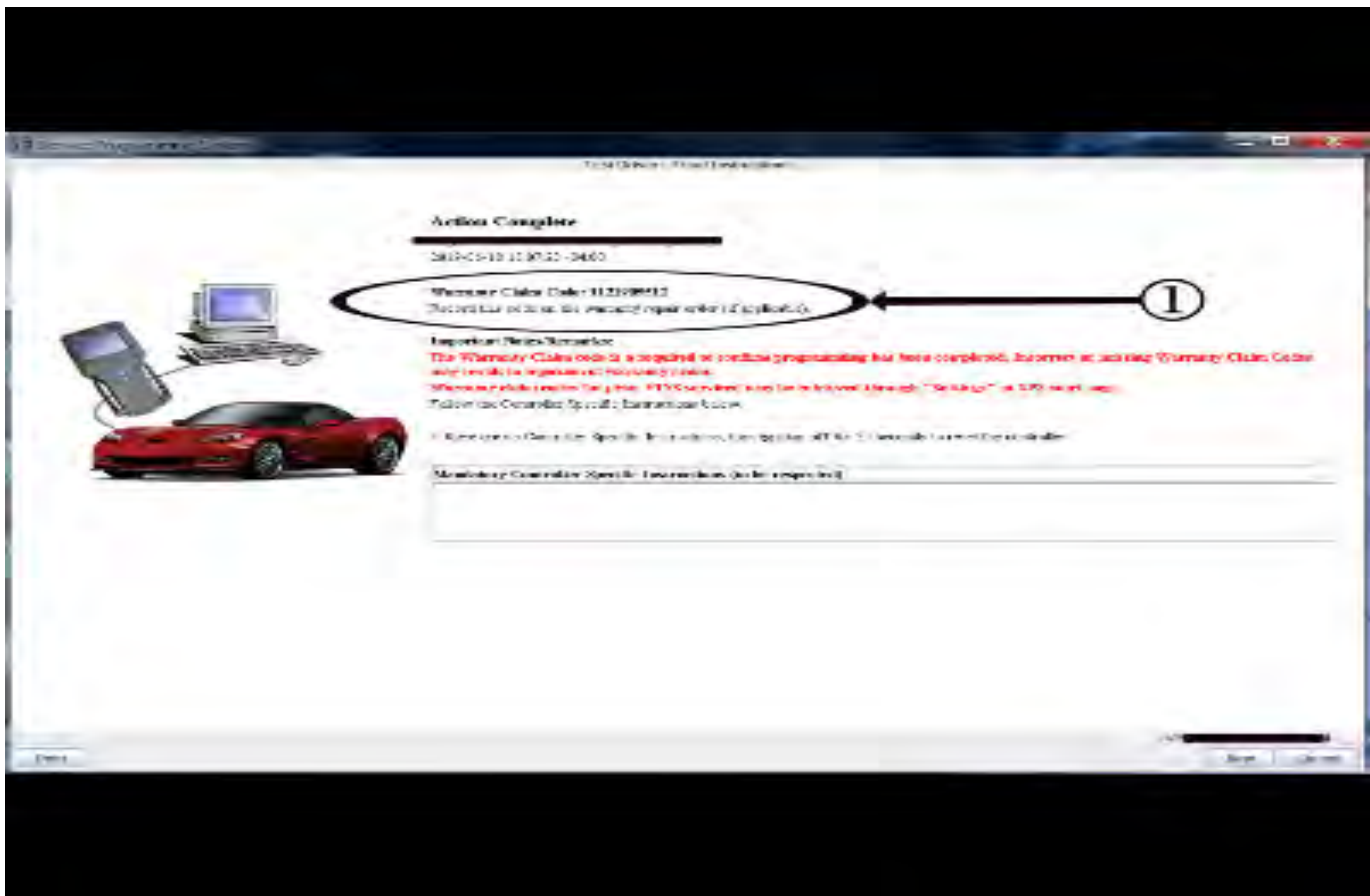
5431209

**Important:** To avoid warranty transaction rejections, you **MUST** record the warranty claim code provided on the SPS Warranty Claim Code (WCC) screen shown above on the job card. Refer to callout 1 above for the location of the WCC on the SPS screen
